Luxclassics

MERCEDES-BENZ 190SL

A pictorial retrospective of the complete restoration

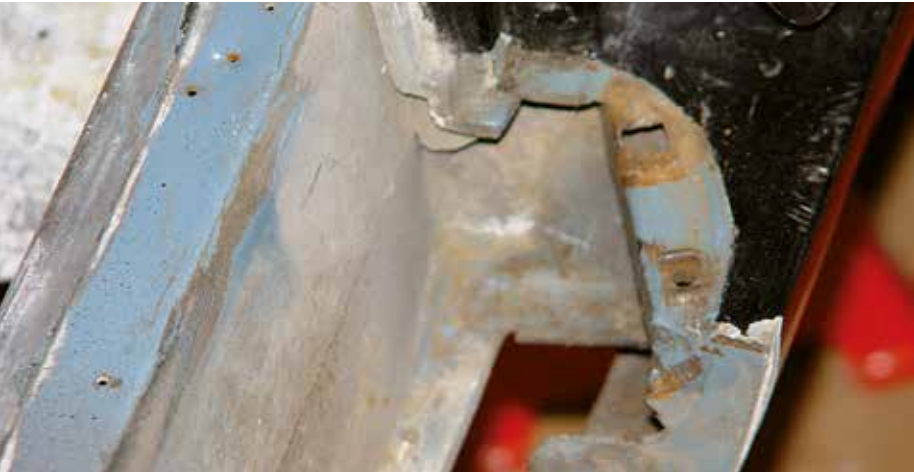
Stripping the many layers of paint and body filler from the outer shell followed, revealing even the slightest old panel damage. Nothing to be too concerned about. The windshield 'A' pillars were removed together with the side sill panels joining the 'A' post to 'B' post at lower door openings. The steel panels attached to the aluminium 'A' and 'B' posts and cowl showed no unusual corrosion, just surface rust.

Corrosion spots are generally found around the wheel arches, headlamp bowls, sills, rear wing stone guard area, boot and floor panels caused by damp and the effects of electrolytic induced corrosion of the steel panels in the proximity of its aluminium supporting frames. The original factory panels are rust free and still attached to the aluminium supporting frames with the special twist nails keeping it's originality and indicating no history of replacement due to collision or rust replacement.

The aluminium doors, boot and bonnet were equally in very good condition. The only repair section required was to the right hand rear wing stone guard area and non-original speaker holes in the interior rear parcel shelf.

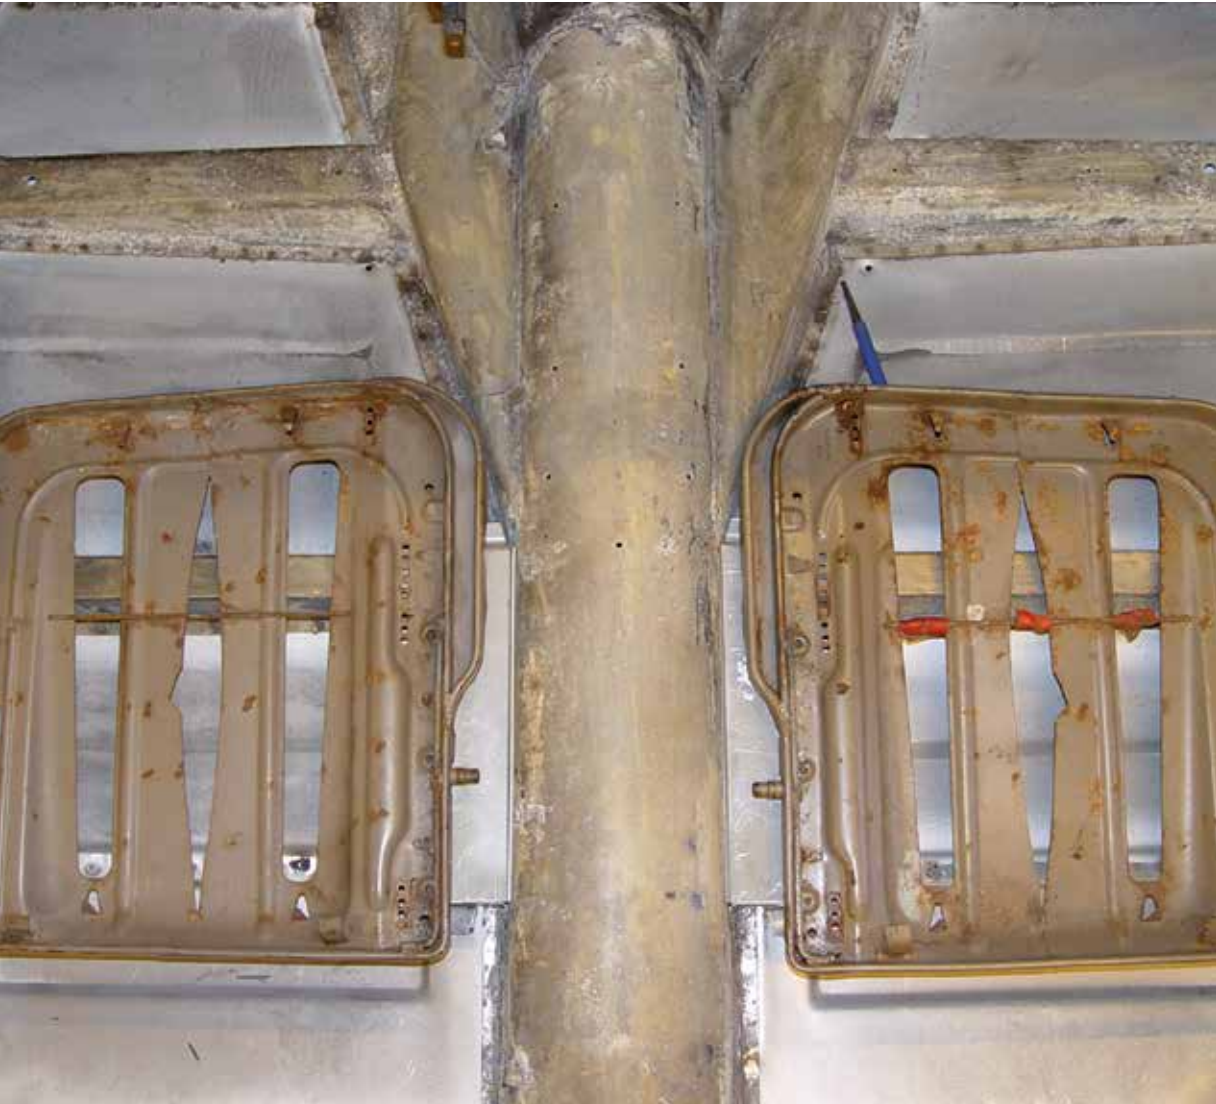
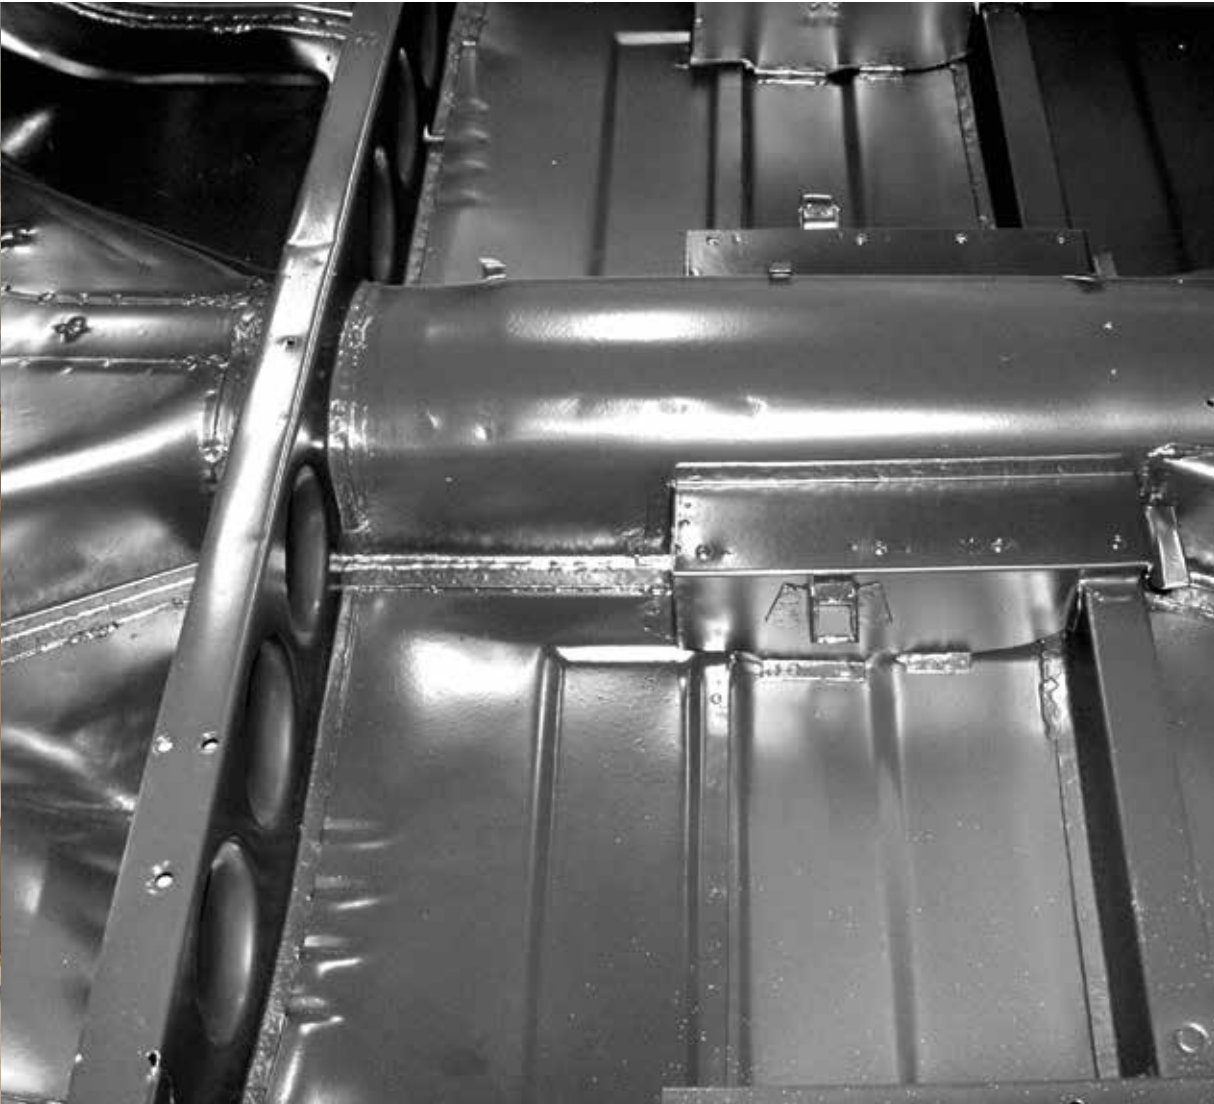
The chassis reconstruction started with repairs to the front right chassis inner frame, where a six inch rust section was cut, bead blasted, acid washed and a repair panel fabricated and welded, keeping originality. The four seat box sections together with the four floor pans and two front lower firewall repair panels were cut out for replacement, de-rusting as we went along. The replacement floor pans are thicker than the original and zinc coated steel. The zinc coating creates a barrier against rust and can be painted over once prepared well. All chassis members were checked carefully by tapping with a pick hammer to ensure that they are not weak, especially the trailing arm supports which could become critical if the trailing arms were to break loose at high speed. All new replacement Mercedes-Benz panels were either spot welded or plug welded in place before spraying with weld through primer. The lower firewall panel and chassis repair panel were butt welded and ground flat.

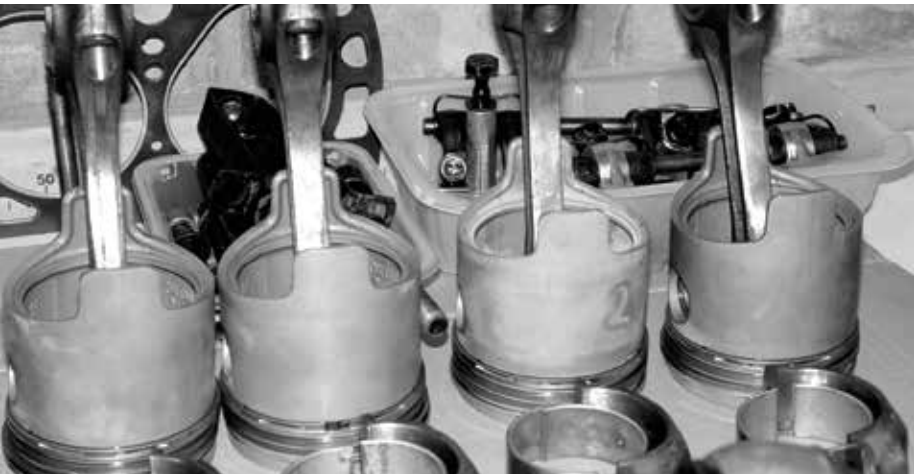
The cylinder head was also dismantled at this stage; revealing that the head had previously been over skimmed by more than 1mm and was warped. The Mercedes-Benz Technical Data Manual is precise about this 1mm as over skimming the head will cause the pistons and valves to contact each other. A replacement head was sourced with no particular problems. Waterways were flushed out and all external fittings were removed as a matter of course and set aside for later examination.
