Luxclassics

MERCEDES-BENZ 190SL

A pictorial retrospective of the complete restoration

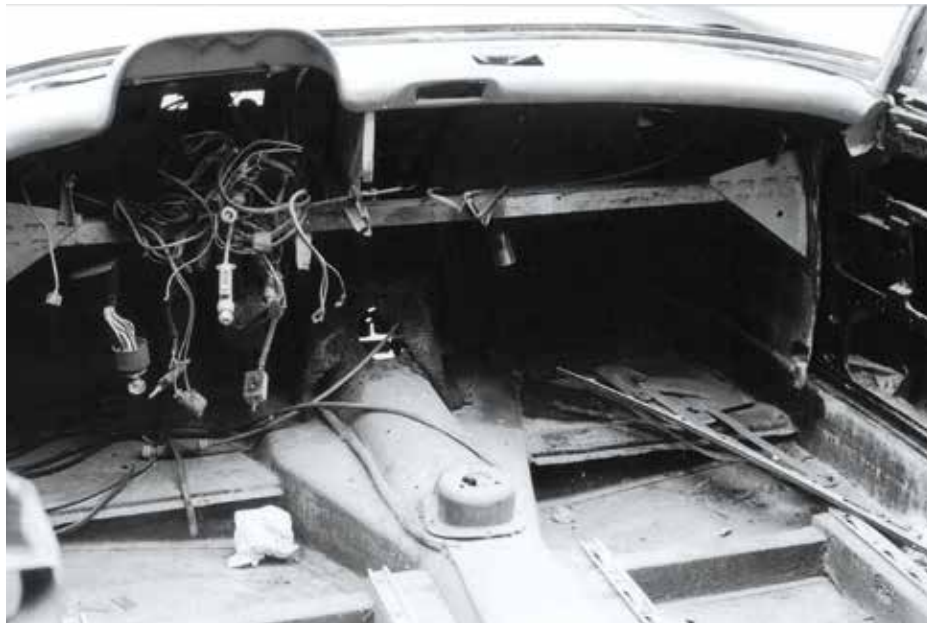
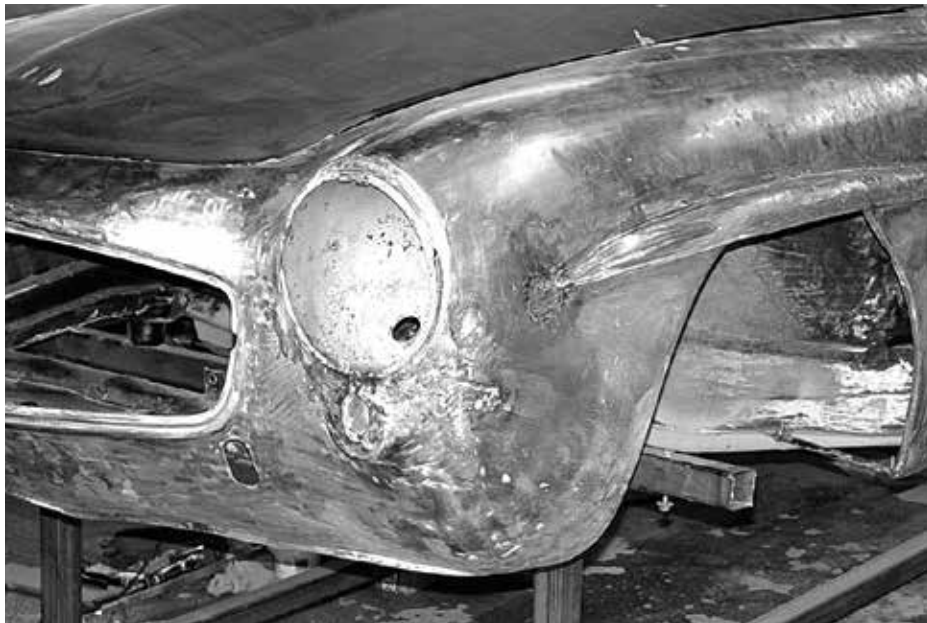
03 | STRIP & INITIAL ASSESSMENT

The 190SL is one of the earliest cars to be built in the 'monocoque' or 'unit body' design. With the exception of the rocker panels, which are screw on, the steel body panels, frame and floors are welded and nailed with special twist nails and held together to form a very strong single unit. The doors, bonnet and boot are aluminium together with the 'A' and 'B' posts and dash cowl and dash. The aluminium parts will generally not need to be replaced but all of the outer body panels are made of steel and may need to be repaired or replaced. It was fortunate that with the exception of one or two minor areas there was virtually no rust on the body panels. These were however, in places an inch thick in body filler.

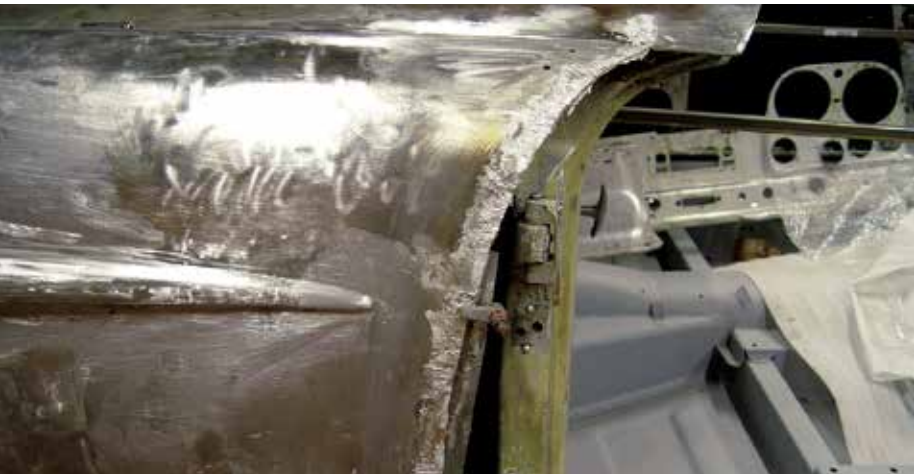
The steel outer body panels were stripped to bare metal by hand and finished off using a mini air hand sander with 3M™ 2" Roloc Bristle discs. No grit blasting was necessary as there was only surface rust that could be taken care of by hand and chemical de-rusting. Once any hammer work and or lead loading was done the cleaned panels were acid washed before a sealer coat of epoxy primer was applied preventing further rust due to moisture in the air. The aluminium doors, boot and bonnet were treated similarly but the final sand was with fine sanding pads so as to not marl the soft material. Concurrent to this work the aluminium removable dash panel and glove box lid were chemically stripped and prepared with epoxy primer for later painting. The hard top was bead blasted and sealed with epoxy primer ready for the paint process. The front wing splash panels were blasted of all paint and primer to their bare aluminium state and sealed for later painting with semi-gloss black paint.

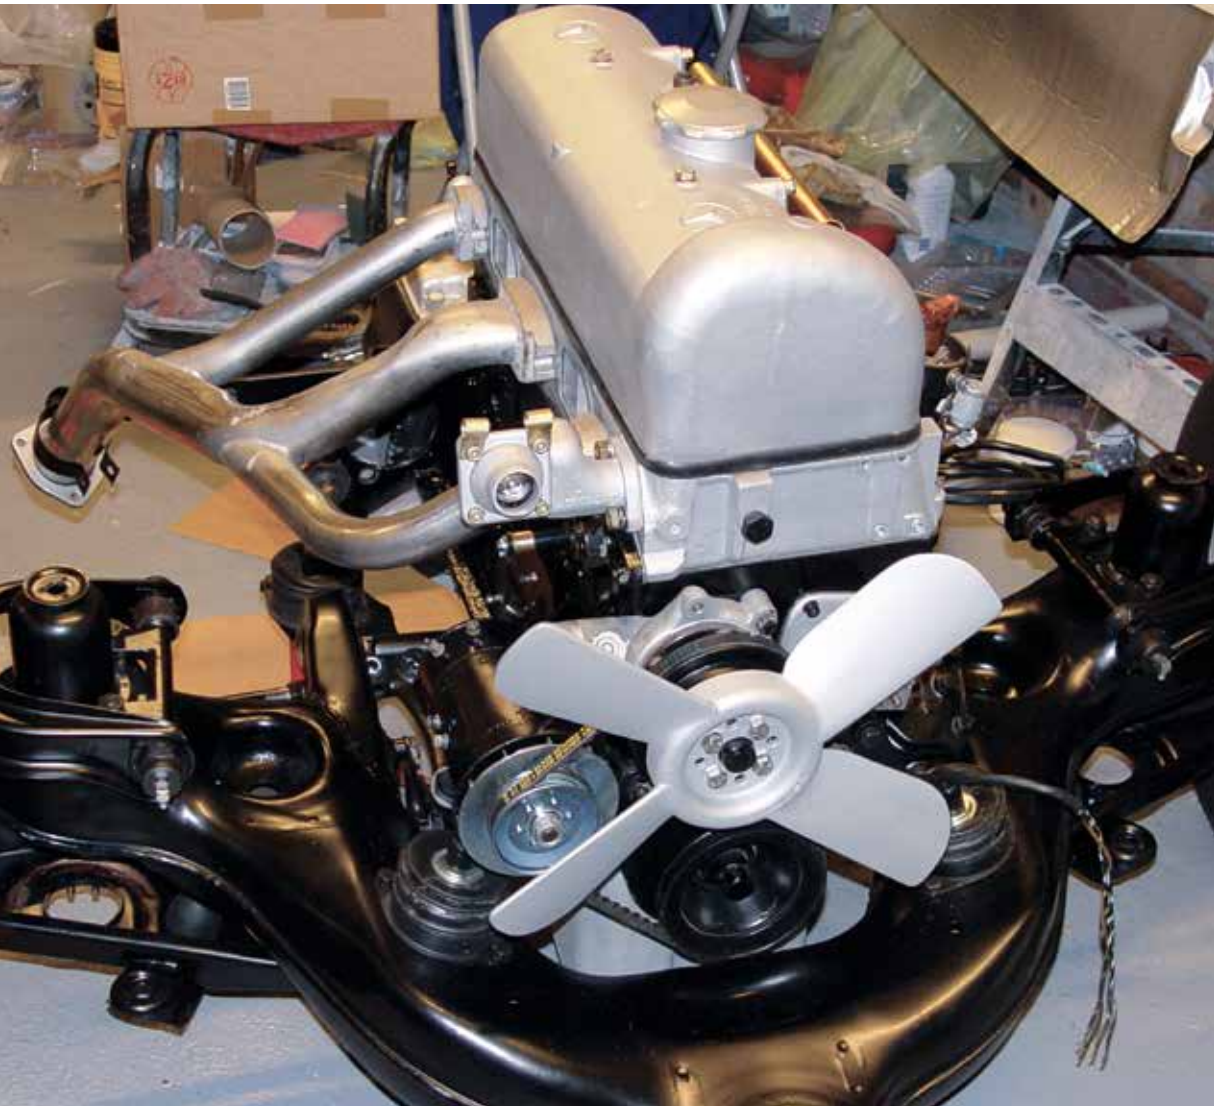
The cylinder bore dimensions were checked against the Mercedes Benz workshop data and compared with the wear on the pistons. Although these were within specification it was decided to have the cylinders bored to the next stage and fit new 85.5mm pistons (first stage rebuild). Having assessed the block was fit to reuse, the first stage of the restoration was to thoroughly flush out and ensure all waterway scale was removed.

The machining of the cylinder head and block was entrusted to an experienced machine shop. The cylinder head and block mating surfaces were lightly skimmed to ensure tight fit of the mating surface between the head gasket and block. The final stage in preparing the cylinder block was to hone the cylinders to the correct size consistent with the pistons being used, in this case Mahle™ pistons.

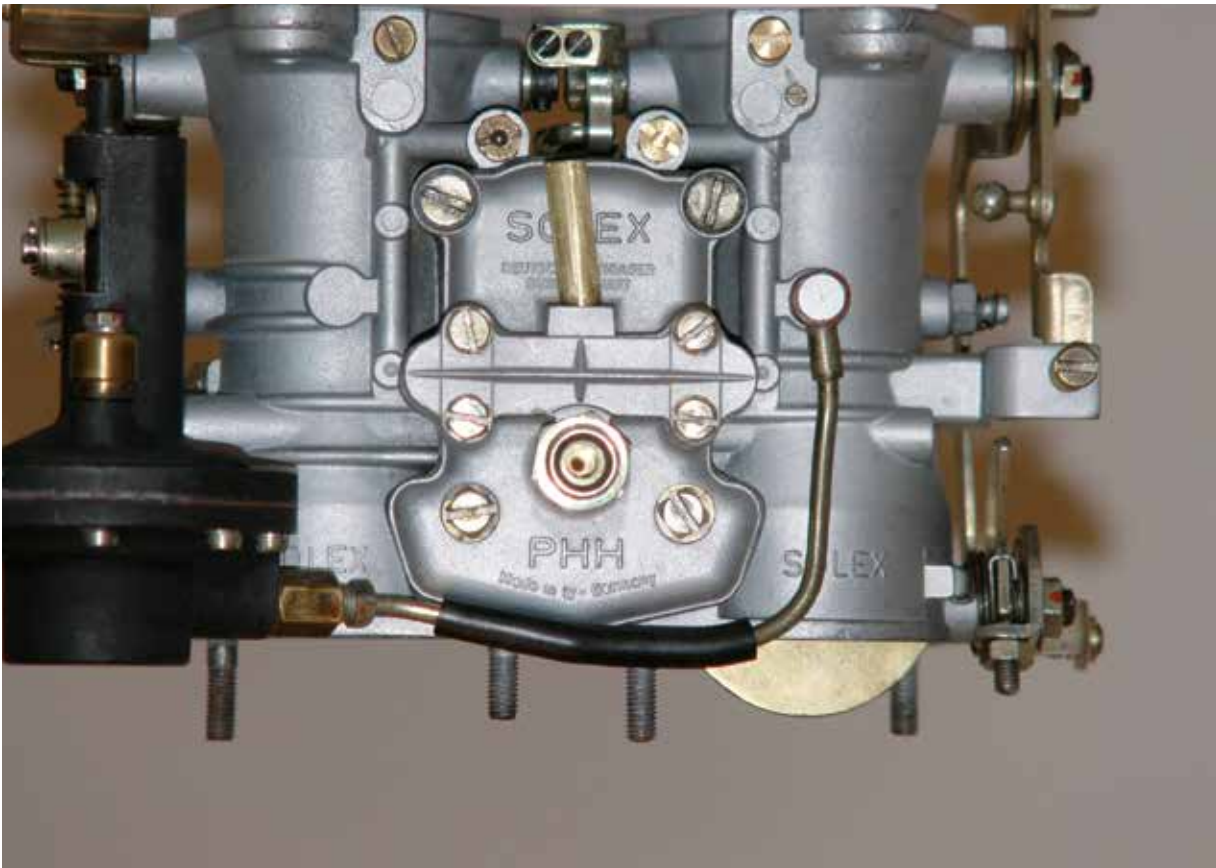
1. Loose throttle shafts As they are mounted directly in the engine casting the radial lash causes an excessive amount of air to be admitted into the engine. As a result idling remains at a level between 1,500 and 2,000 rpm and can not be adjusted.

2. Distorted housing As a result of the engine's rough idle and ride the carburetor was shaken loose. The problem was further compounded by the absence of the strut which supports the induction pipe - a common ailment. This strut is required so that its entire weight does not have to be borne by the carburetor flange. Washers between the carburetor flange and the rubber flange are often omitted during repairs. If the washers are missing, the bolts are inevitably drawn too tightly, which in turn causes the flange to warp and cut into and requires machining and fabrication of oversized throttle valves.

3. Worn ball neck heads These are often simply worn or the linkage can be out of adjustment. These problems are easily rectified at little cost.
4. Second-stage linkage This linkage and follower are also susceptible to faulty adjustment. From 2,500 rpm upwards this linkage should open the second stage throttle valve as a result of the breakdown of venturi vacuum that sets in at this stage. If it does not have the necessary 1/10 mm clearance when closed, this function is not guaranteed.

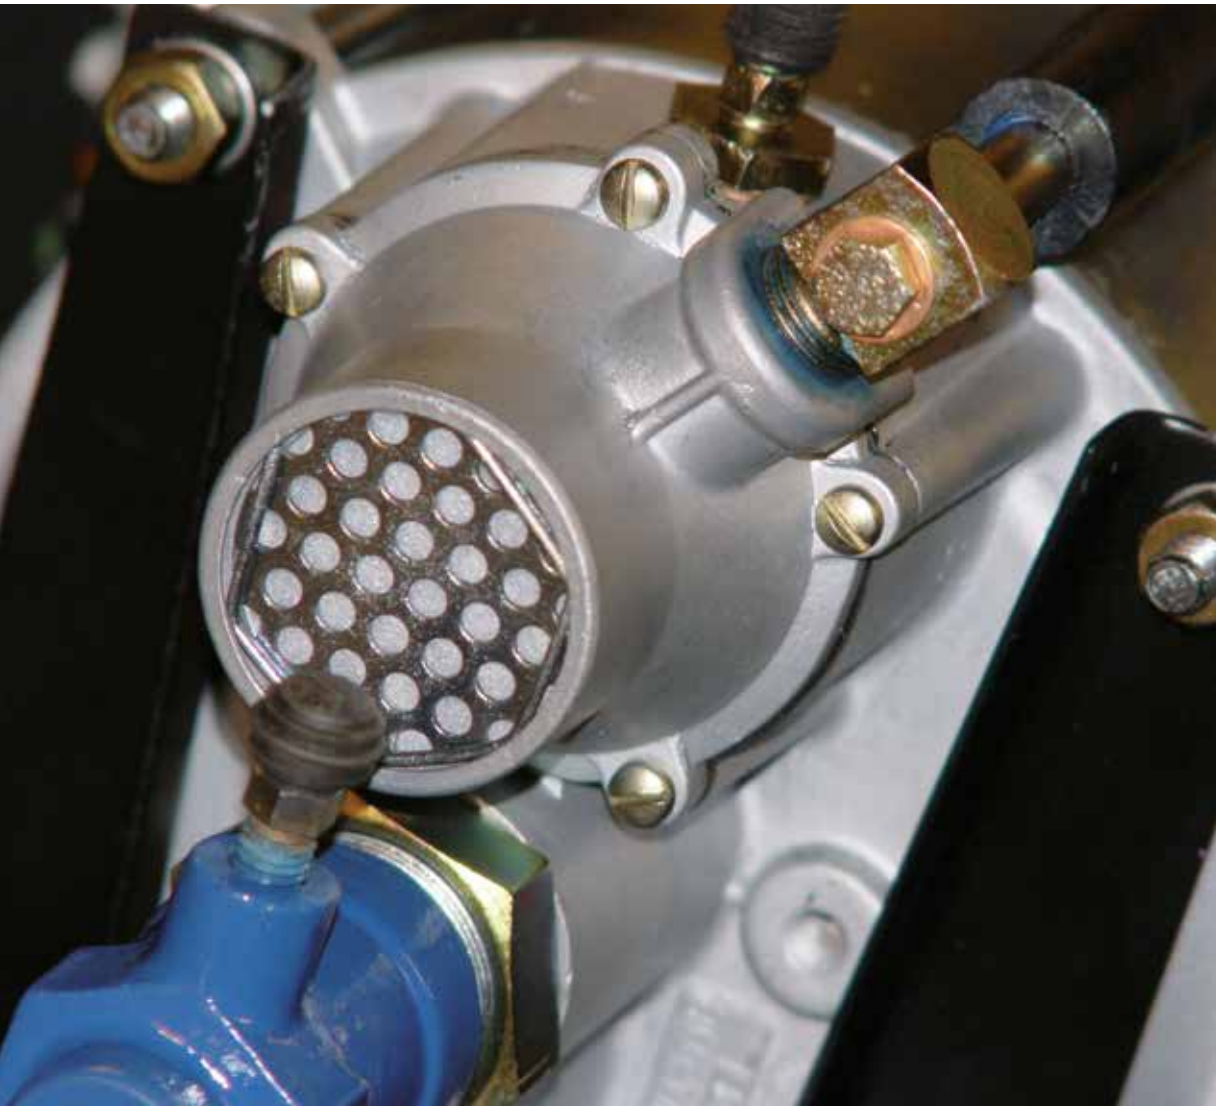
With the booster removed from the vehicle this was now stripped, starting with the clamps holding the booster shell from the front section exposing the power piston and spring. The shell was inspected for score marks and was cleaned and finished off with emery paper until smooth before plating. The power piston on this models was made from leather and was in great condition as it was possibly regularly lubricated. This followed removal, strip and inspection of the hydraulic slave cylinder, vacuum check valve, air cleaner, valve cover, diaphragm, valve piston and end plate seals. All parts were carefully cleaned and inspected for wear. All nuts, bolts, spacers, aluminium and steel parts were cleaned in alcohol and then cleaned in an "Ultrasonic Cleaning tank".

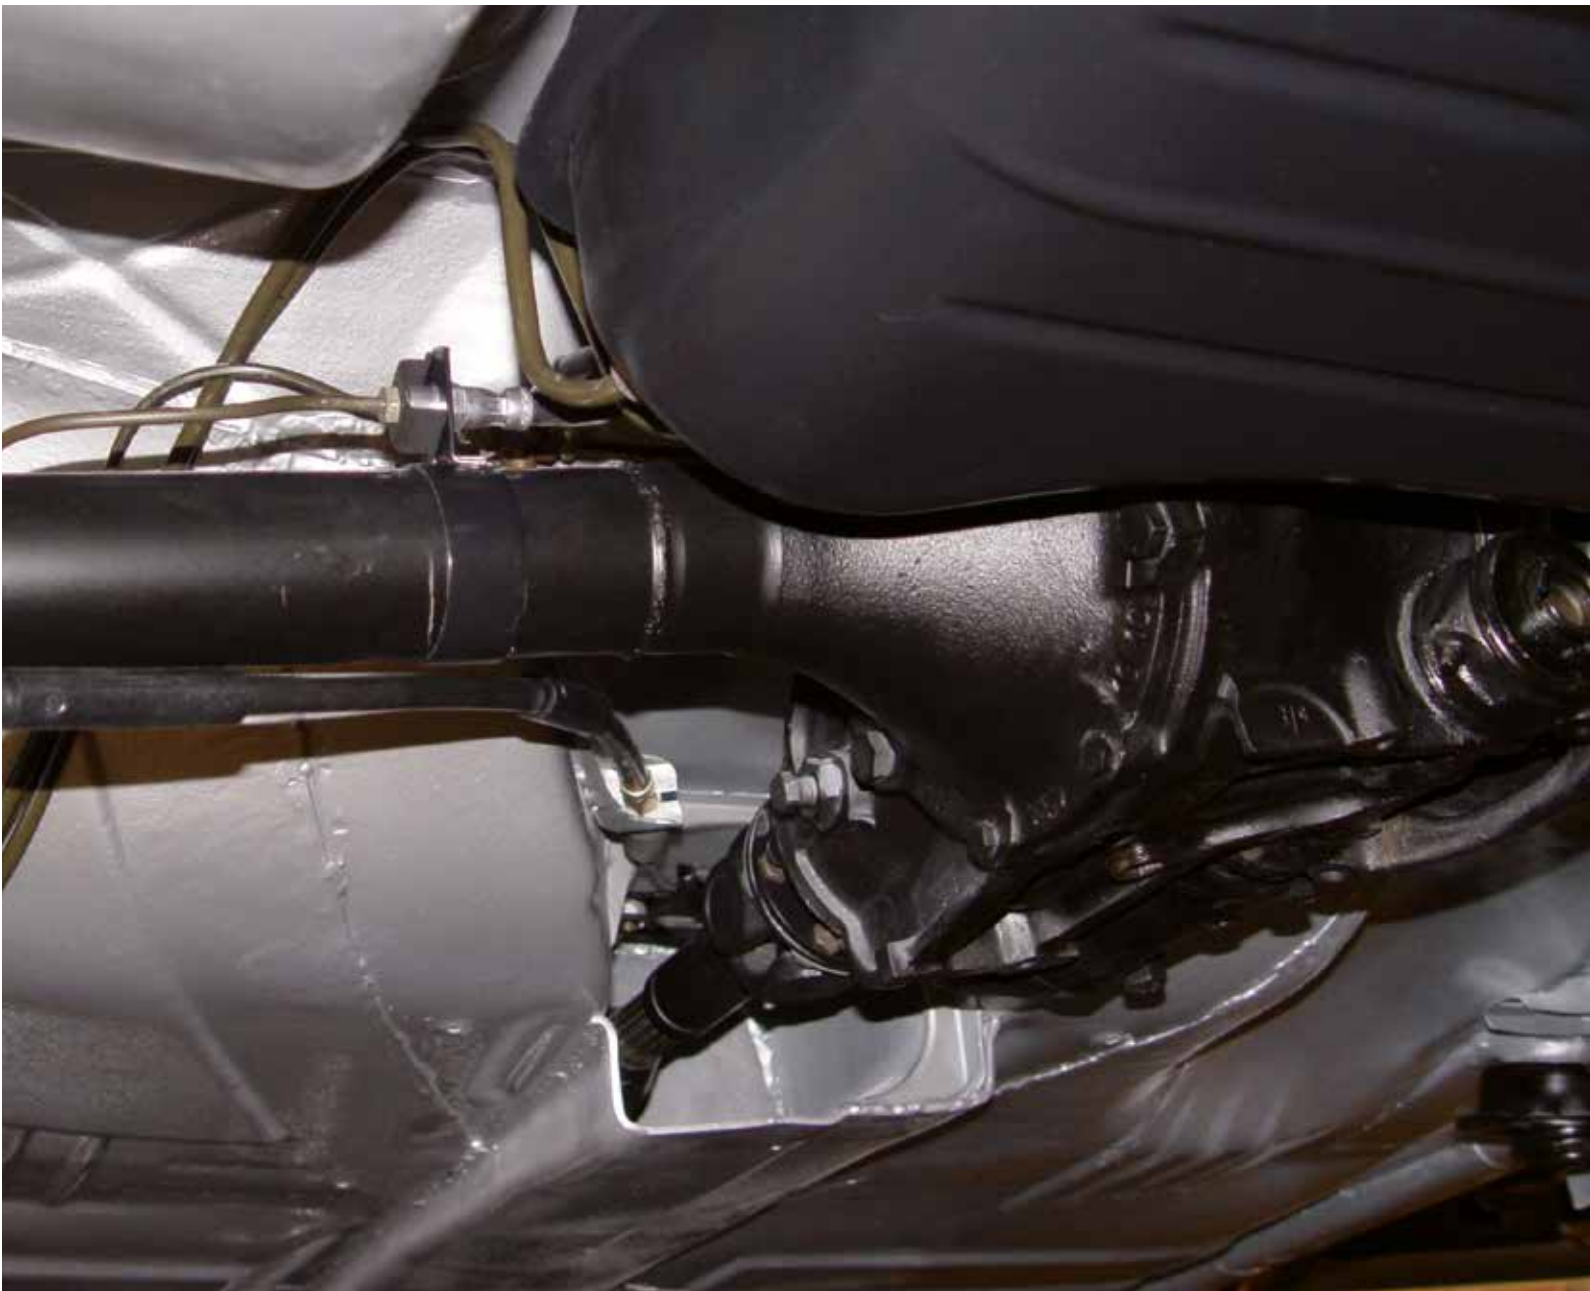
REAR AXLE REBUILD

Each part was assessed for wear before being stripped of paint grease and dirt by bead blasting and then cleaned and painted ready for reassembly. All hardware, bolts and nuts for the suspension unit were dipped in a metal blackening system and oiled.

All rubber components, wheel bearings, gaskets, seals, bushes, wheel cylinders, brake shoes and shock absorbers were renewed as a matter of course. The half shafts with new seals, gaskets and bearings were installed. New bushes pressed and reamed into the right axle shaft and centre bearing. With the rear axle on the workbench new brake cylinders, shoes and adjusters were installed together with the hand brake cable. The rebuilt rear axle was set aside for final assembly into the vehicle.

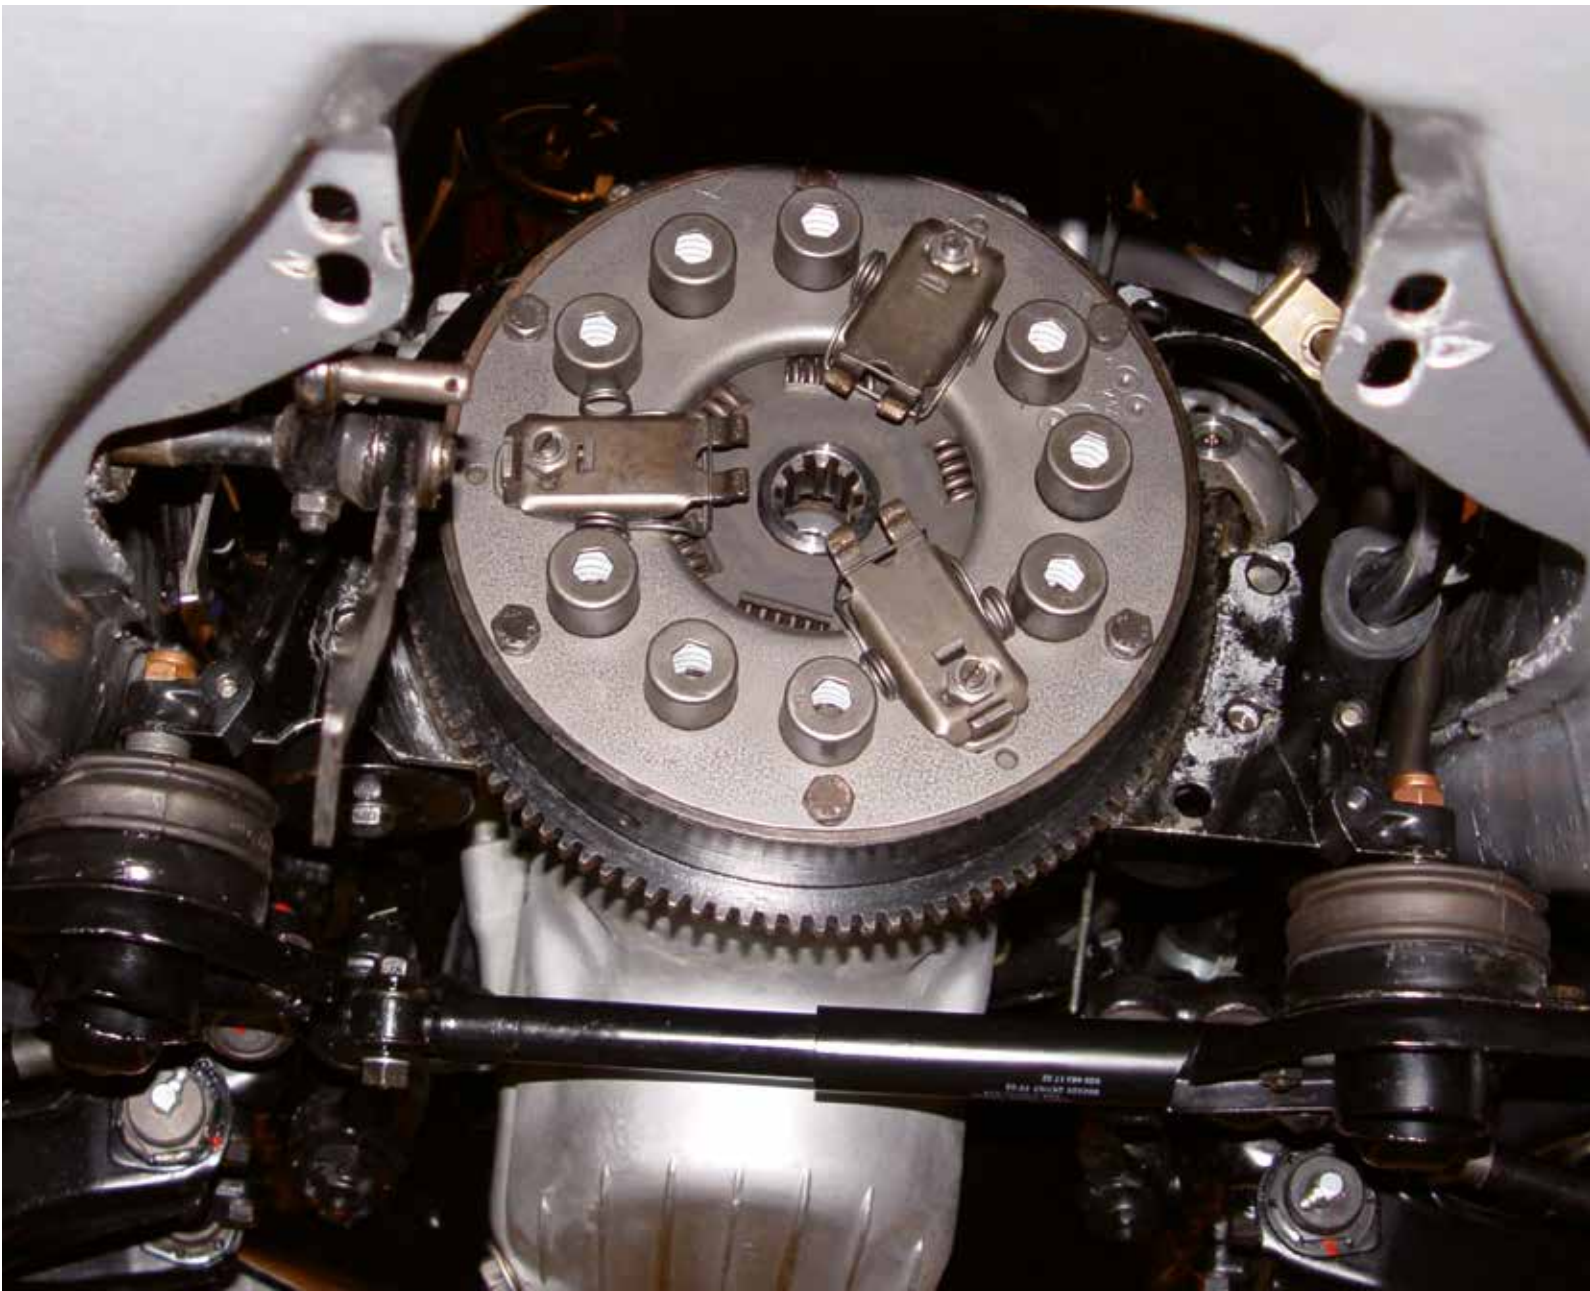
TRANSMISSION REBUILD

With all components removed from the transmission housing each bearing, gear, shaft and synchronizer were inspected for abnormal wear. There was no significant wear in the gears other than the brass synchronizer gears.

The transmission housing was stripped of paint, grease and dirt by bead blasting and then cleaned and painted ready for reassembly. All hardware, bolts and nuts were either plated or metal blackened ready for assembly. All gaskets, bearings, seals and synchronizers were renewed as a matter of course. Seals for the speedometer drive and front / rear housing were pressed out and new ones driven in. The rebuilt transmission was set aside for final assembly into the vehicle.

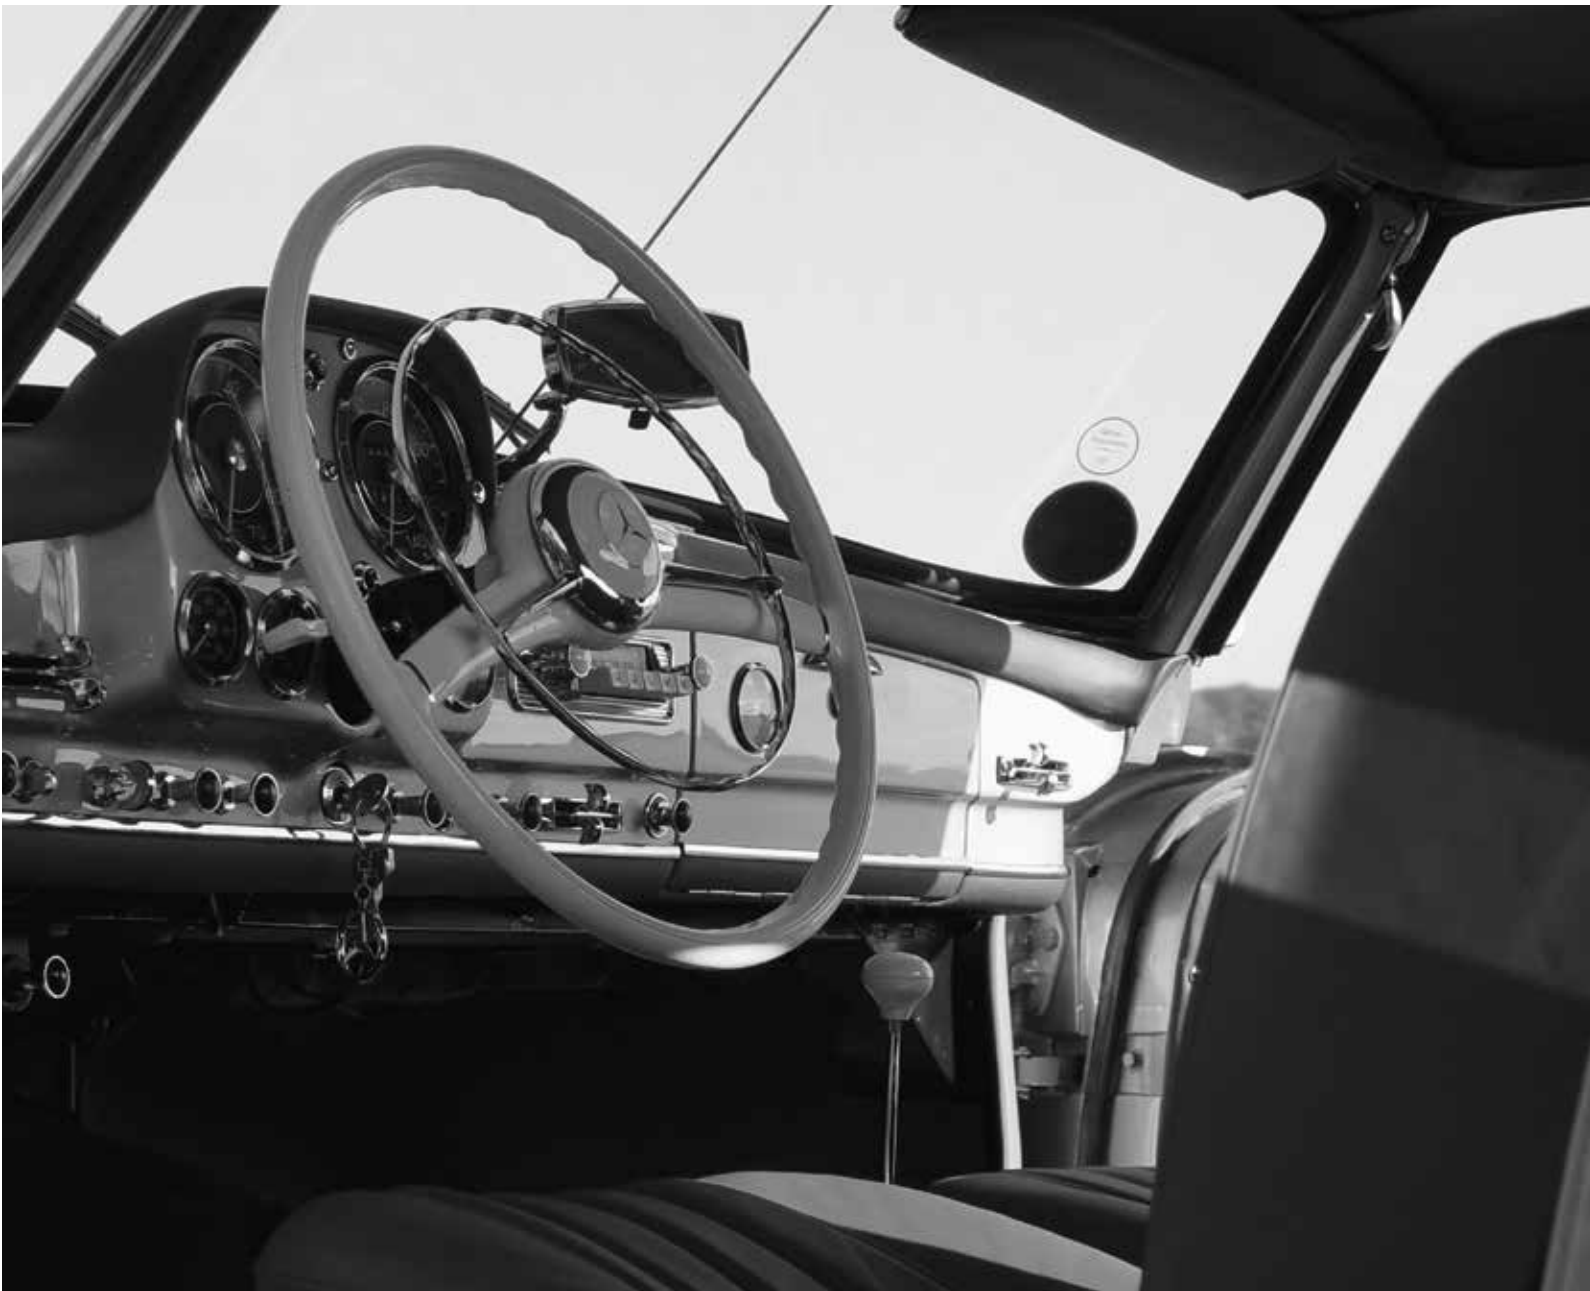
LEATHER TRIMMING & INSTRUMENT PANEL ASSEMBLY

Trimming the car requires not only patience but also passion for the detail and workmanship that makes the Mercedes-Benz 190SL what it is. Re-covering the dashboard with leather is the most challenging single task in restoring a 190SL interior. The dash was carefully covered with German fine grain supple 1088 light red leather. As the leather was skived (thinned to half its thickness) it was possible to cover the contours of the dash. The dash is first fitted, stretched and shrunk around the instrument hump, then stretched to fit the rest of the dashboard.

Welting strips were made to fit around the instrument hump and door 'A' and 'B' posts. The rear soft top compartment was additionally covered with the same leather. The seats and door panels were made up, using traditional materials to fill the seats. Next the instrument panel was covered using felt under the leather at knee curves and instruments and switches fitted to the panel. The glove compartment was covered in leather and the glove box lid was trimmed. The windscreen pillars were fitted. The chrome vent strips and vent levers were fitted before the front windscreen and chrome surround was fitted and the dash trimmed to fit. The instrument panel was fitted as were the remaining switches and gauges. The interior wiring was completed together with final fit of dash chrome and glove box lid. The door panels will be fitted once the soft top has been trimmed and final window adjustments.

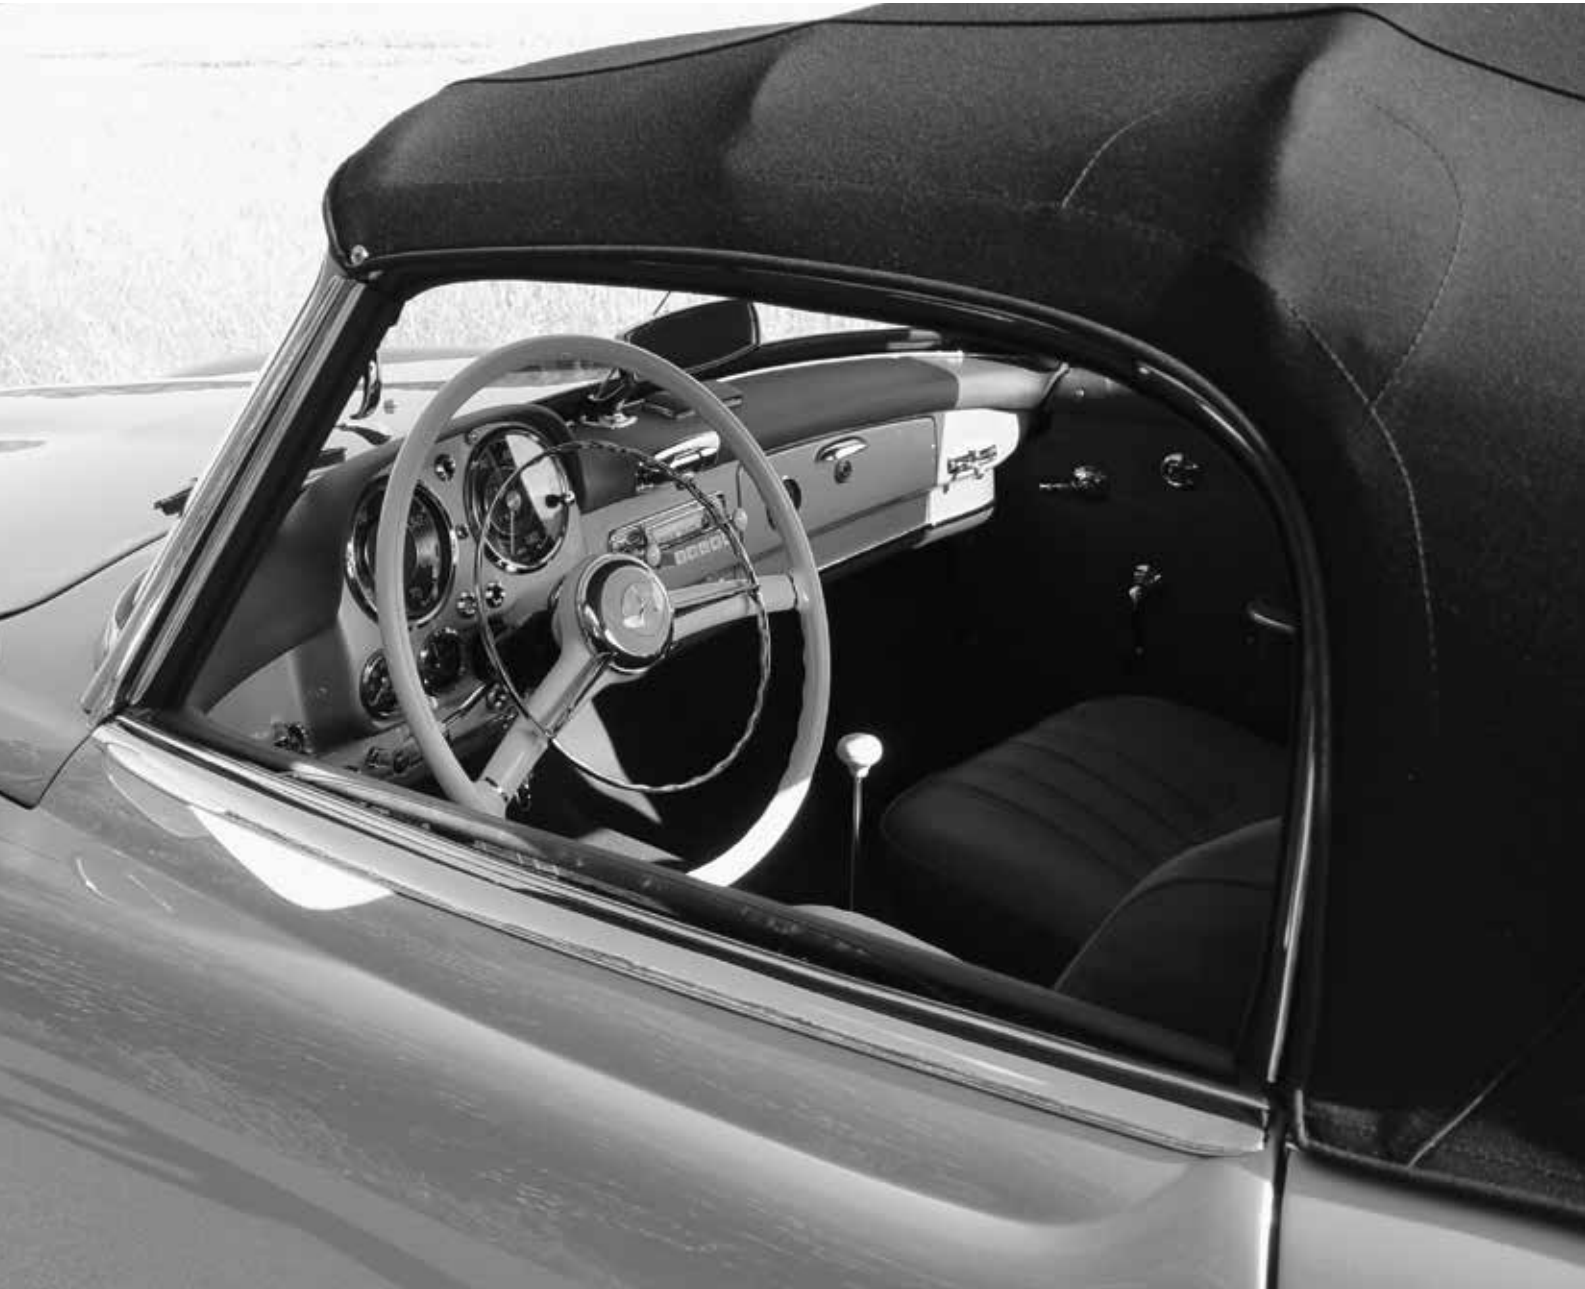
WINDOW ALIGNMENT

The final stage of the soft top restoration was to adjust the door glass so that the glass fitted correctly around the window aperture. At this stage it was necessary to pack behind the aluminium 'A' post strip for correct fit at the front of the window. The fit was perfect and passed over for the final inspection and test drive.
