MERCEDES-BENZ 190SL

A pictorial retrospective of the complete restoration

01 | BRIEF HISTORY

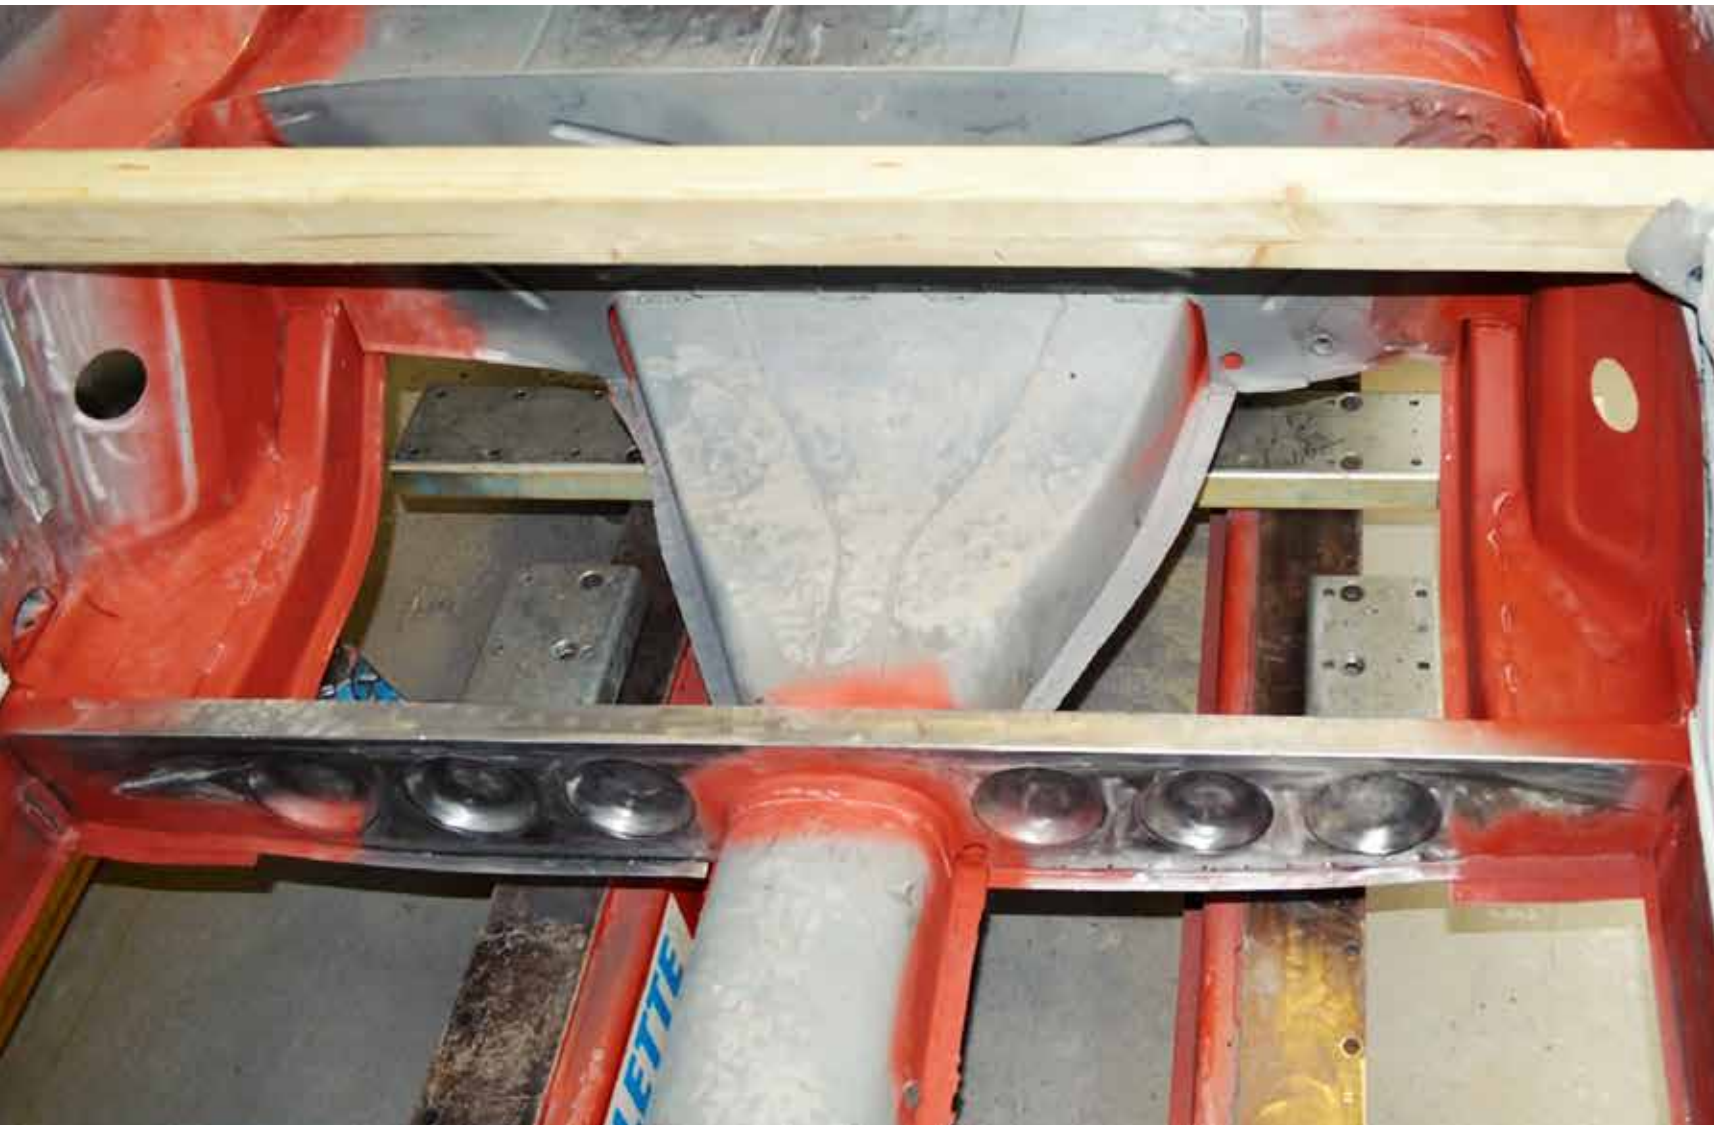
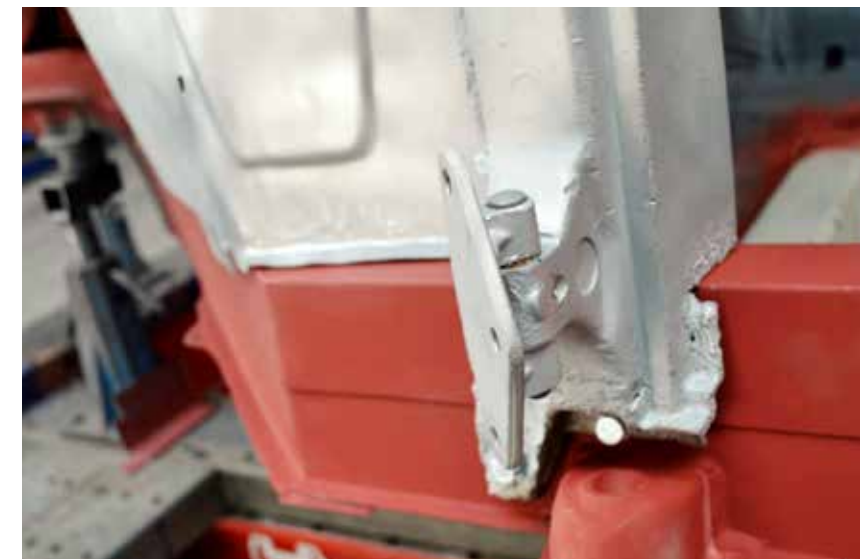
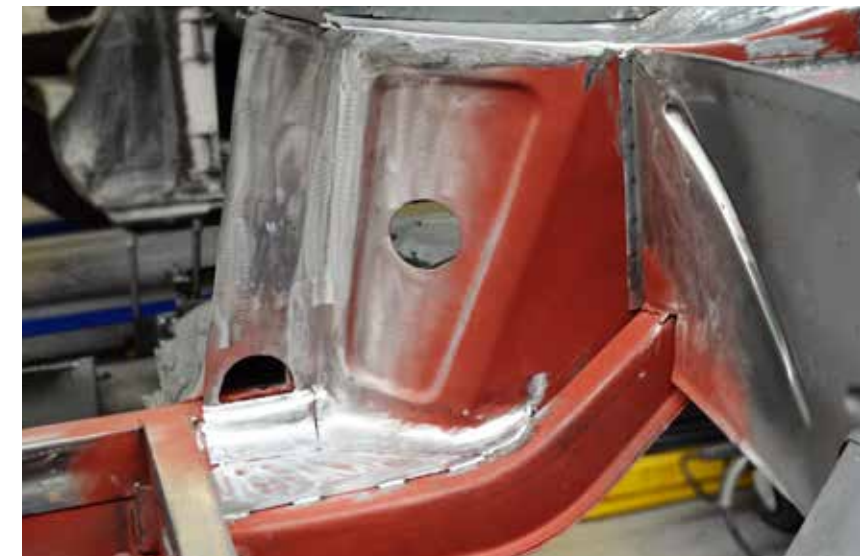
03 | CHASSIS AND BODY ASSESSMENT

The next and very important stage was to undertake a fully detailed and thorough assessment of the chassis (frame/floor assembly) structure. The U-section box reinforcements on the frame and side members received no primer or wax injection at Sindelfingen and generally rust from inside out. The shell was inspected internally with the aid of a Snap-on Video Inspection Scope™. Notes were made of any abnormal rust and chassis structures that need additional attention.

Stripping the many layers of paint and body filler from the outer shell followed, revealing even the slightest old panel damage. The windshield 'A' pillars were then removed together with the side sill panels joining the 'A' post to 'B' post at lower door openings.

Corrosion spots are generally found around the wheel arches, headlamp bowls, sills, rear wing stone guard area, boot and floor panels caused by damp and the effects of electrolytic induced corrosion of the steel panels in the proximity of its aluminium supporting frames.

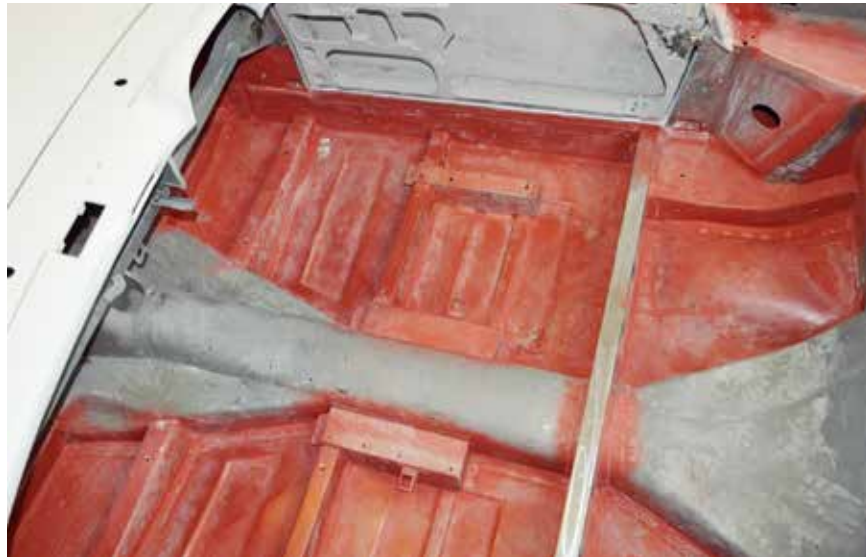
DIMENSIONAL CHECKING

On completion of the chassis reconstruction, another careful check was made to ensure that dimensional accuracy, particularly front and rear suspension mountings, sill alignment and 'A' and 'B' posts were still correct and that the alignment of doors, bonnet and boot was retained. In addition, a trial fit of the front and rear suspension was undertaken as a final check and to ensure easy assembly later.

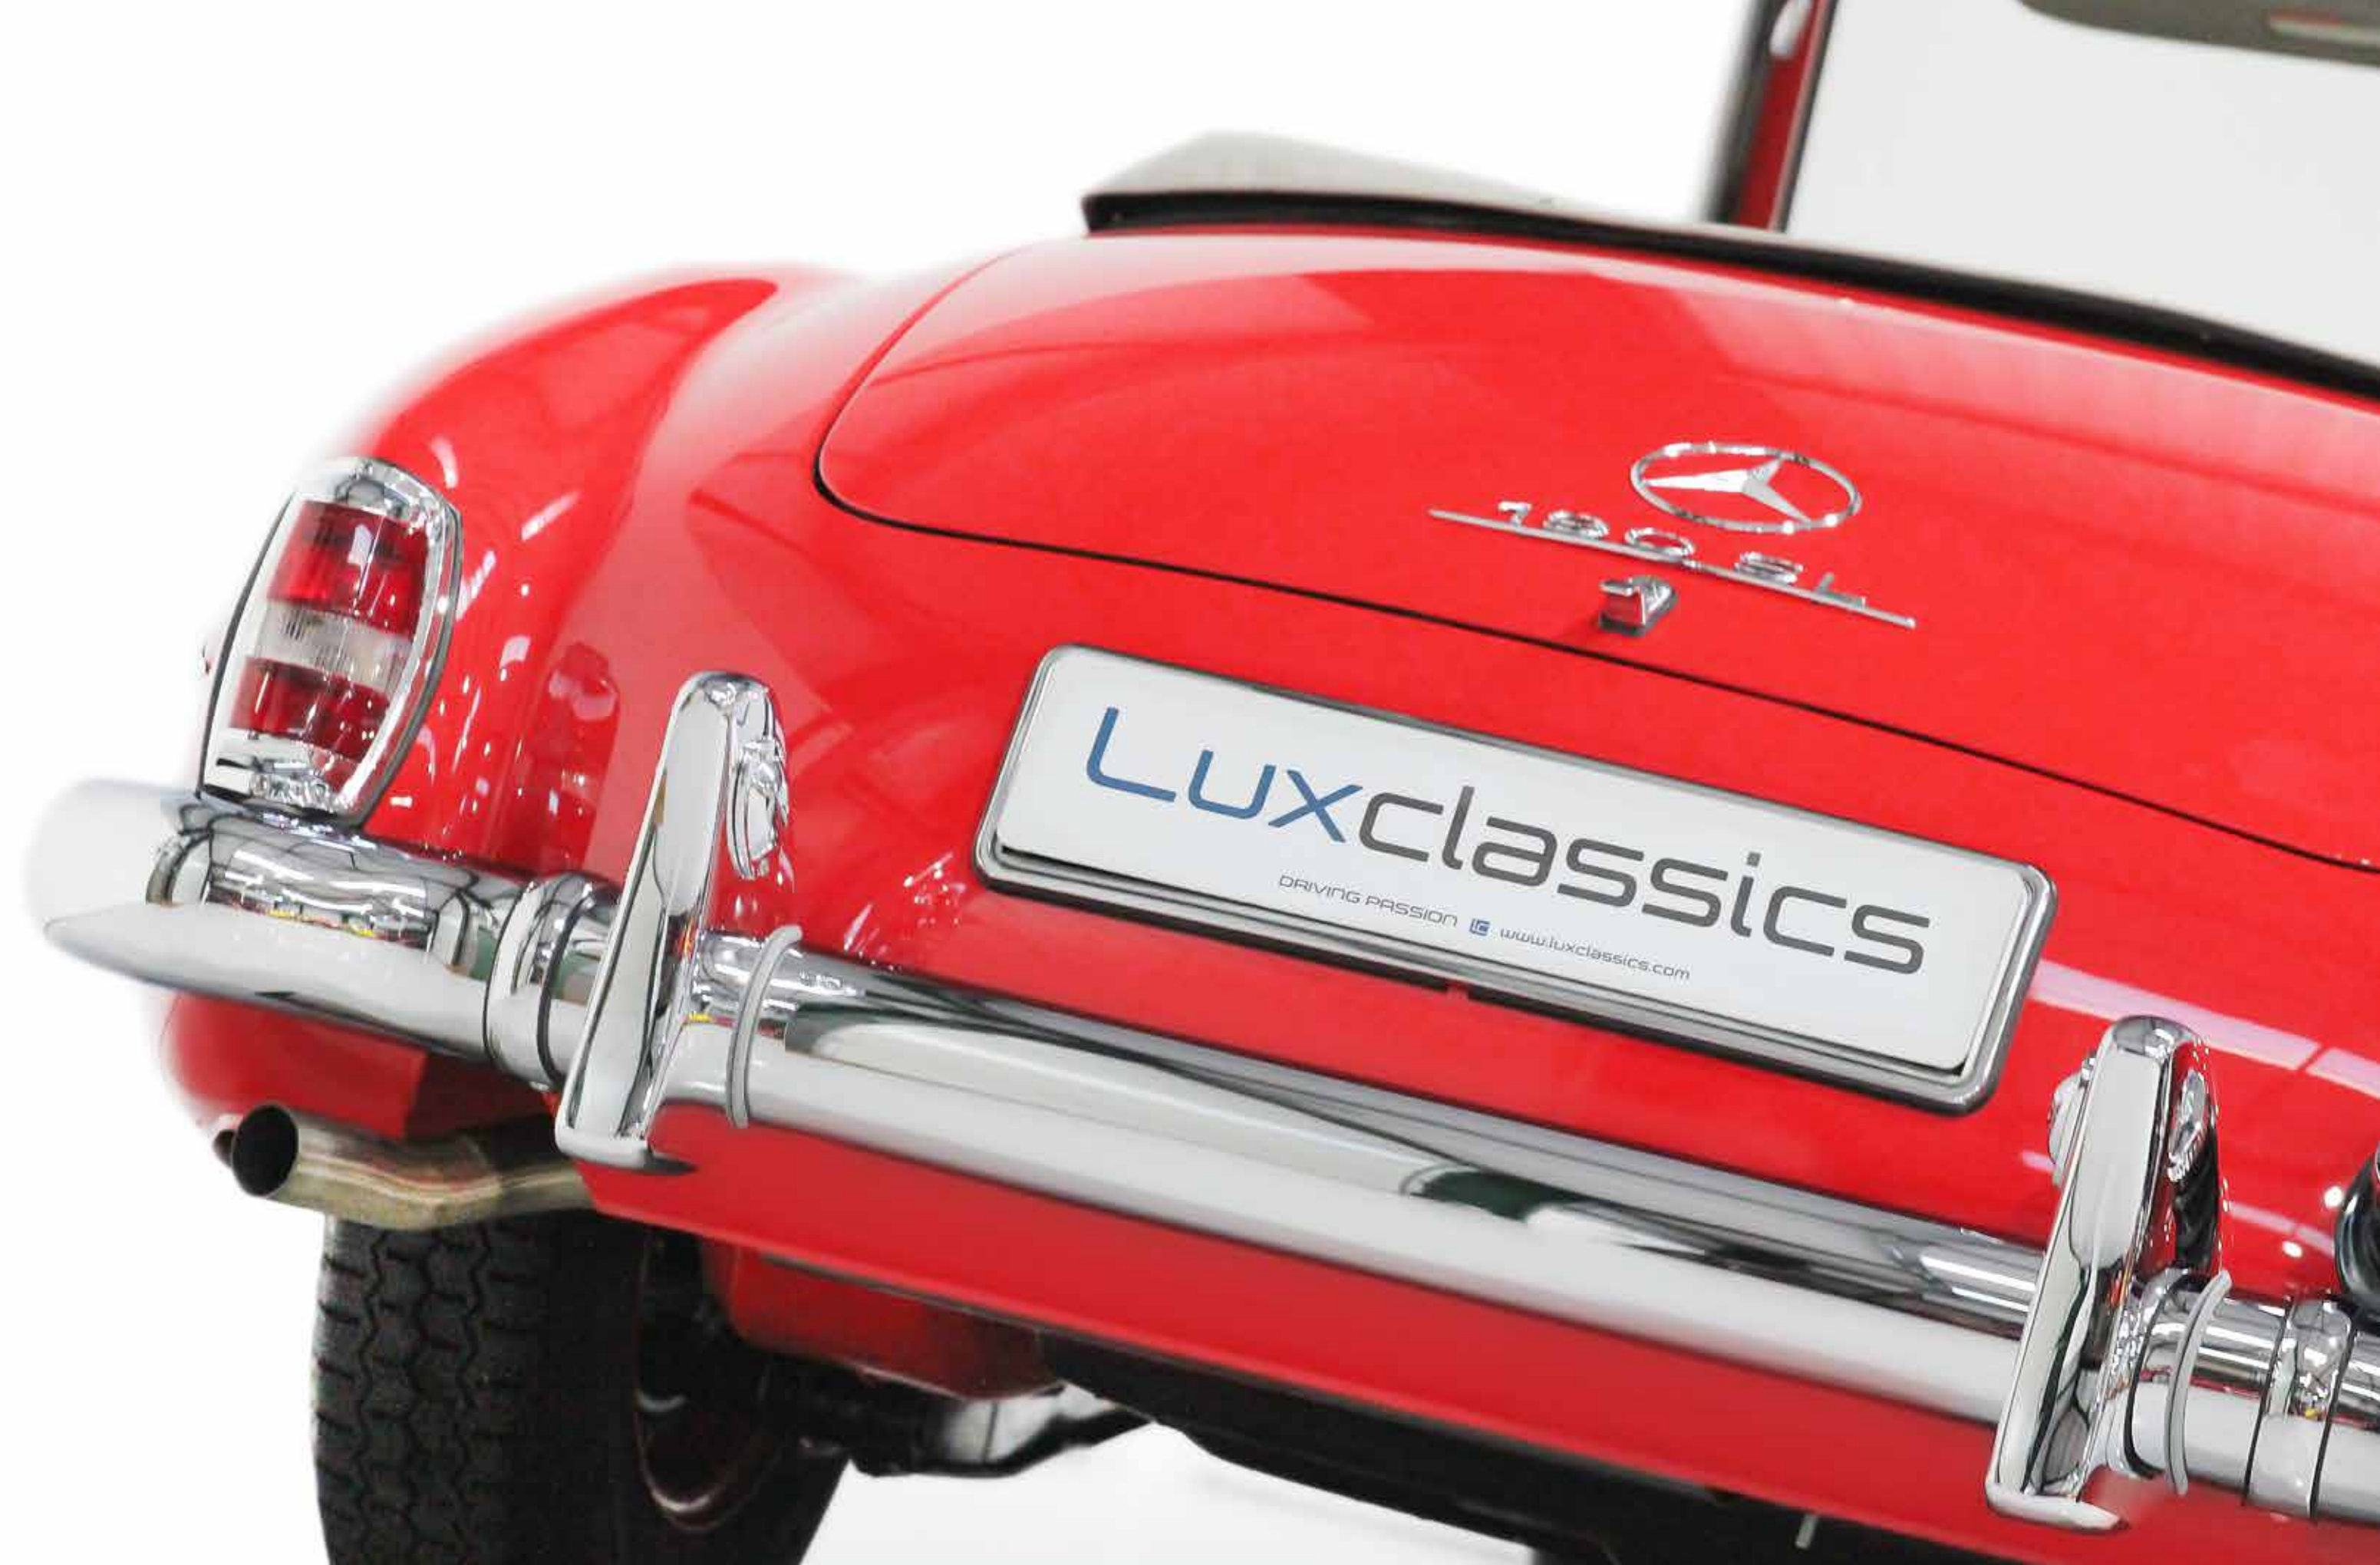
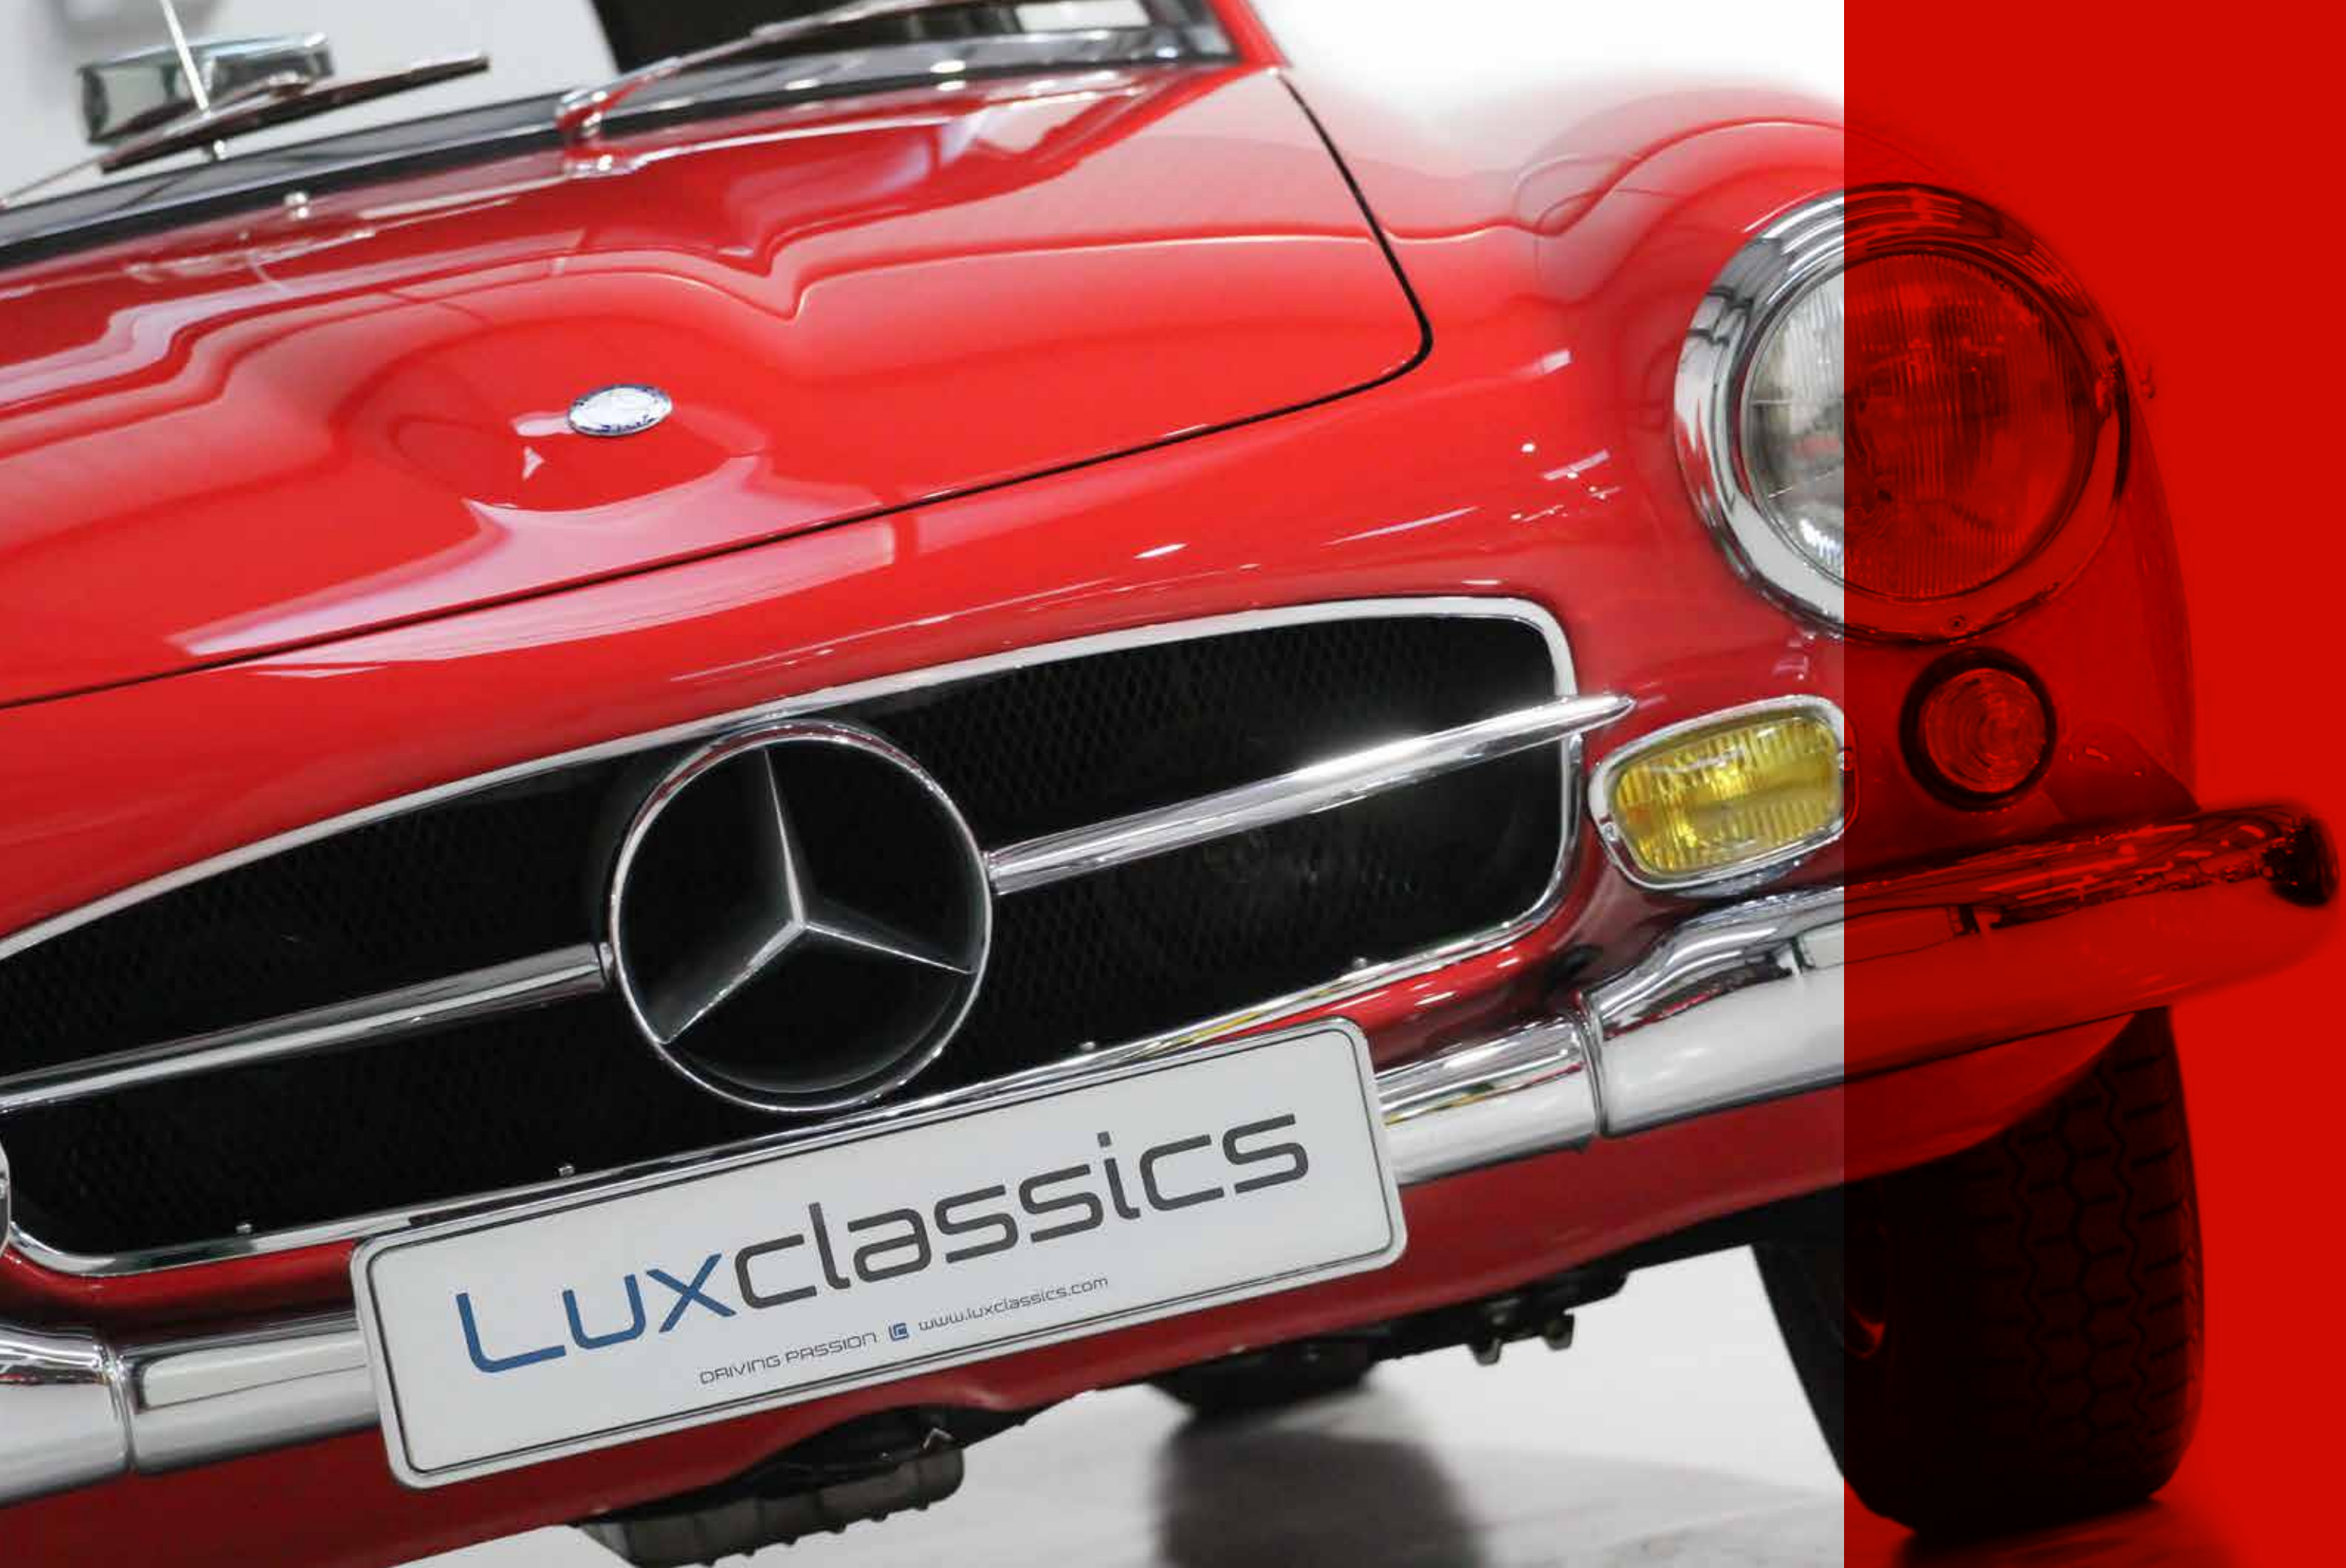
RUST PROOFING AND PROTECTION

An extensive level of reconstruction was required, and every new section had to be shaped to fit and carefully welded into place. All box sections were carefully epoxy primed and zinc coated with weld through primer on the welding contact sections prior to assembly.

Once the reconstruction was completed, the finished chassis was again grit blasted, acid washed and then epoxy primed after which it received two sprayed coats of smooth anti-chip coating. Any joints were seam sealed with Polyurethane sealing compounds. A sealer coat of epoxy primer was followed with three coats of PPG's DAR 4065 'Sandalwood' Semi-Gloss tan/grey underneath.

The inner boot floor, engine bay and inner floor sections were all sprayed with three coats of PPG Semi-Gloss black DB167 or RAL7167 (DB164 or DB167 Tiefdunkelgrau Matt). All internal sections were injected, providing a significantly enhanced level of corrosion protection and retained originality.

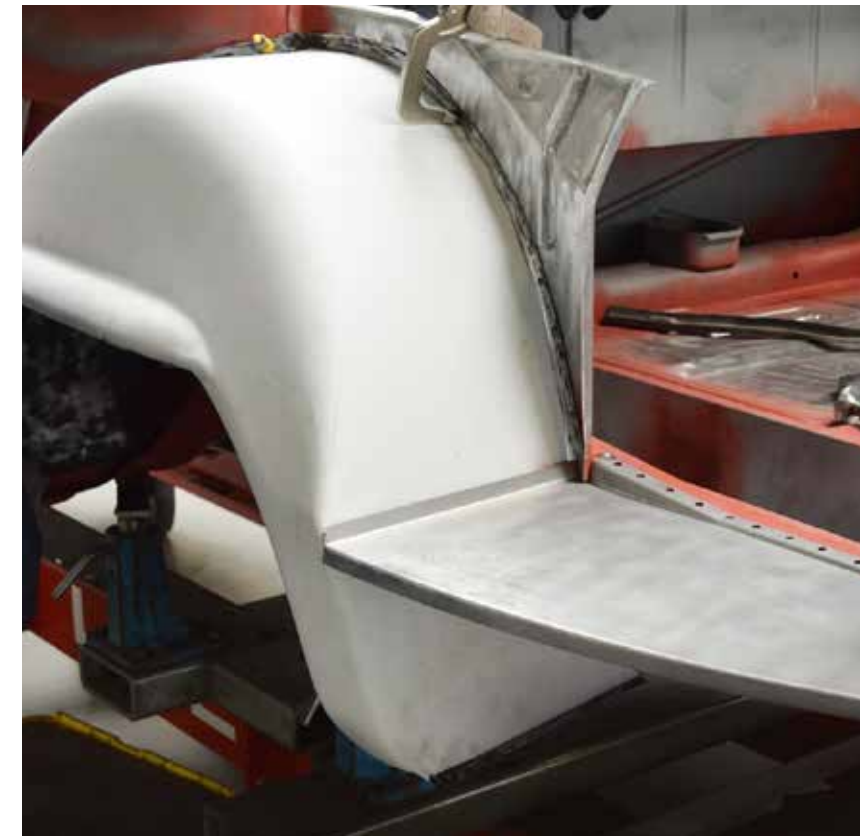
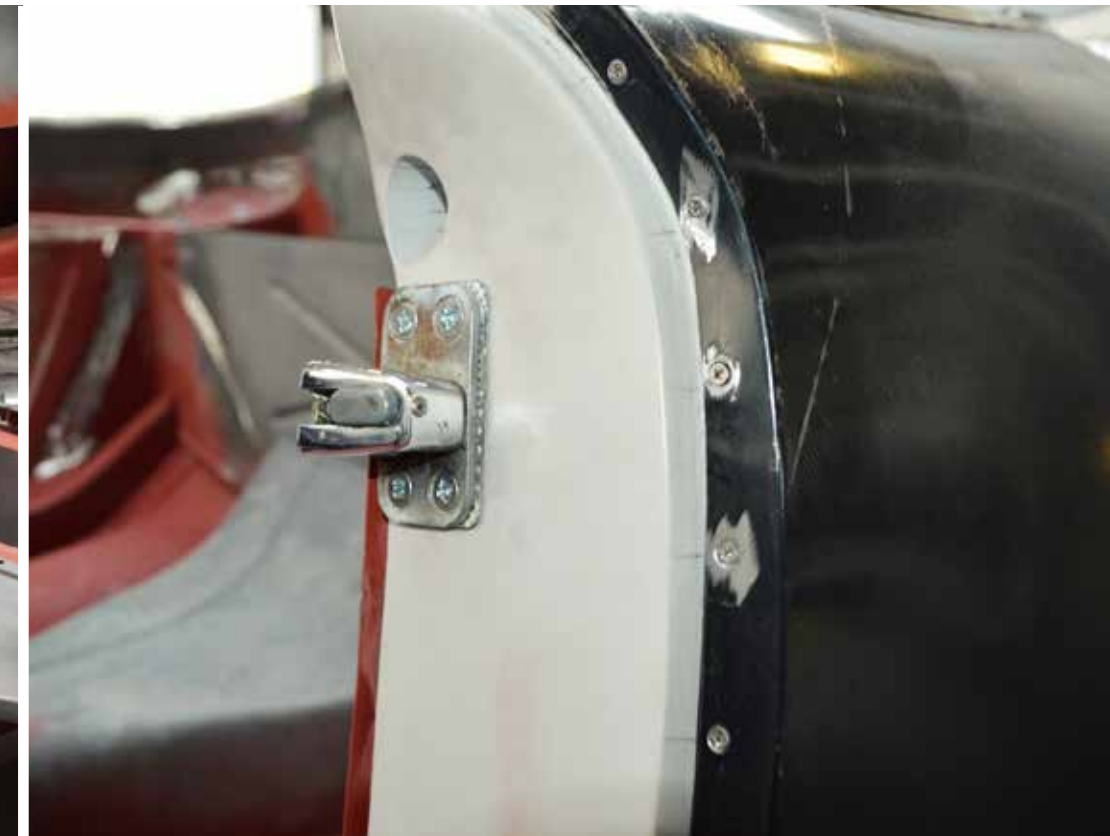
PANEL REPLACEMENT

All outer panels were replaced with original 'new old stock' items which are now virtually impossible to source. Every spot weld, seen or unseen was done with the latest welding equipment and to the highest of original factory standards. Any additional body parts, like chrome mouldings were prefitted at this stage to ensure perfect fit and adjusted accordingly.

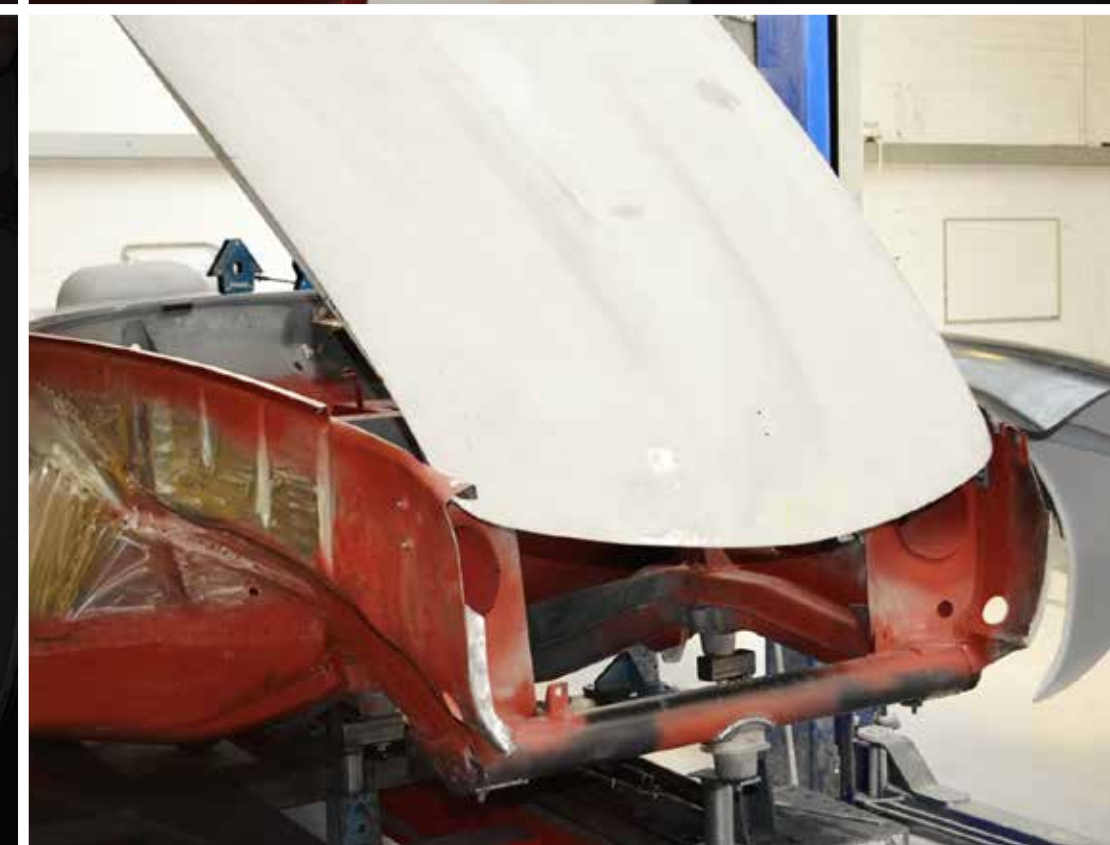
PANEL ASSEMBLY

With panels formed smooth by hand, the doors, bonnet and boot were mounted to check correct alignment. The front wing chassis struts were bolted on to ensure that the lower trailing edge matched with the door. The windshield frame was mounted so that the hard top fit could be checked. The dash panel was additionally checked for damage and assembled.

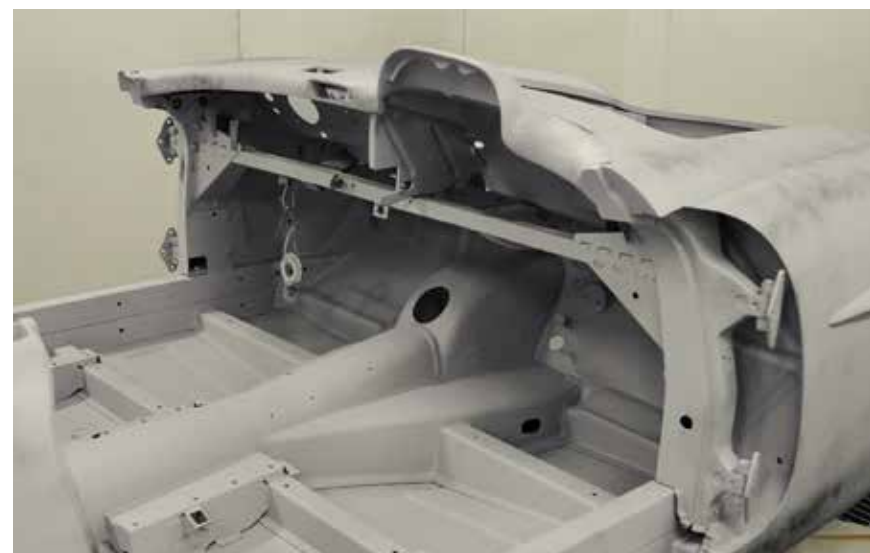
PREFIT, SHAPING AND GAPPING

Wear in the door hinges can cause the door to be out of alignment. A shortfall in maintenance means that the hinge pivot points on the 'A' post wear as the bush is made of brass and rubs against the harder steel hinge pin as it rotates. As expected the drivers door bushes required replacement. A special tool was fabricated to remove the old bush as space is restricted to drive these out with a pin punch.

The final stage of preparing the body for painting was to carry out a final shaping and prefit of the front windscreen chrome frames, bumpers, light fittings, door handles, front grill, rear wing stone guards, wing chrome eye brow mouldings, chrome sill mouldings and headlight glass chrome emblems. During the course of this stage the objective was to ensure a perfectly smooth shape so far as it was possible without use of filler. It was also to ensure that the gapping of the doors, bonnet and boot were perfect, all of the external bright trim, light fittings, front grille fit correctly, and gaps and apertures were adjusted as required.

Another aspect of this stage was to ensure that the aluminium surface was filed into a state that would allow the best possible adhesion of the epoxy primer in the initial stage of painting. The doors, bonnet and boot lid were then removed for later painting.

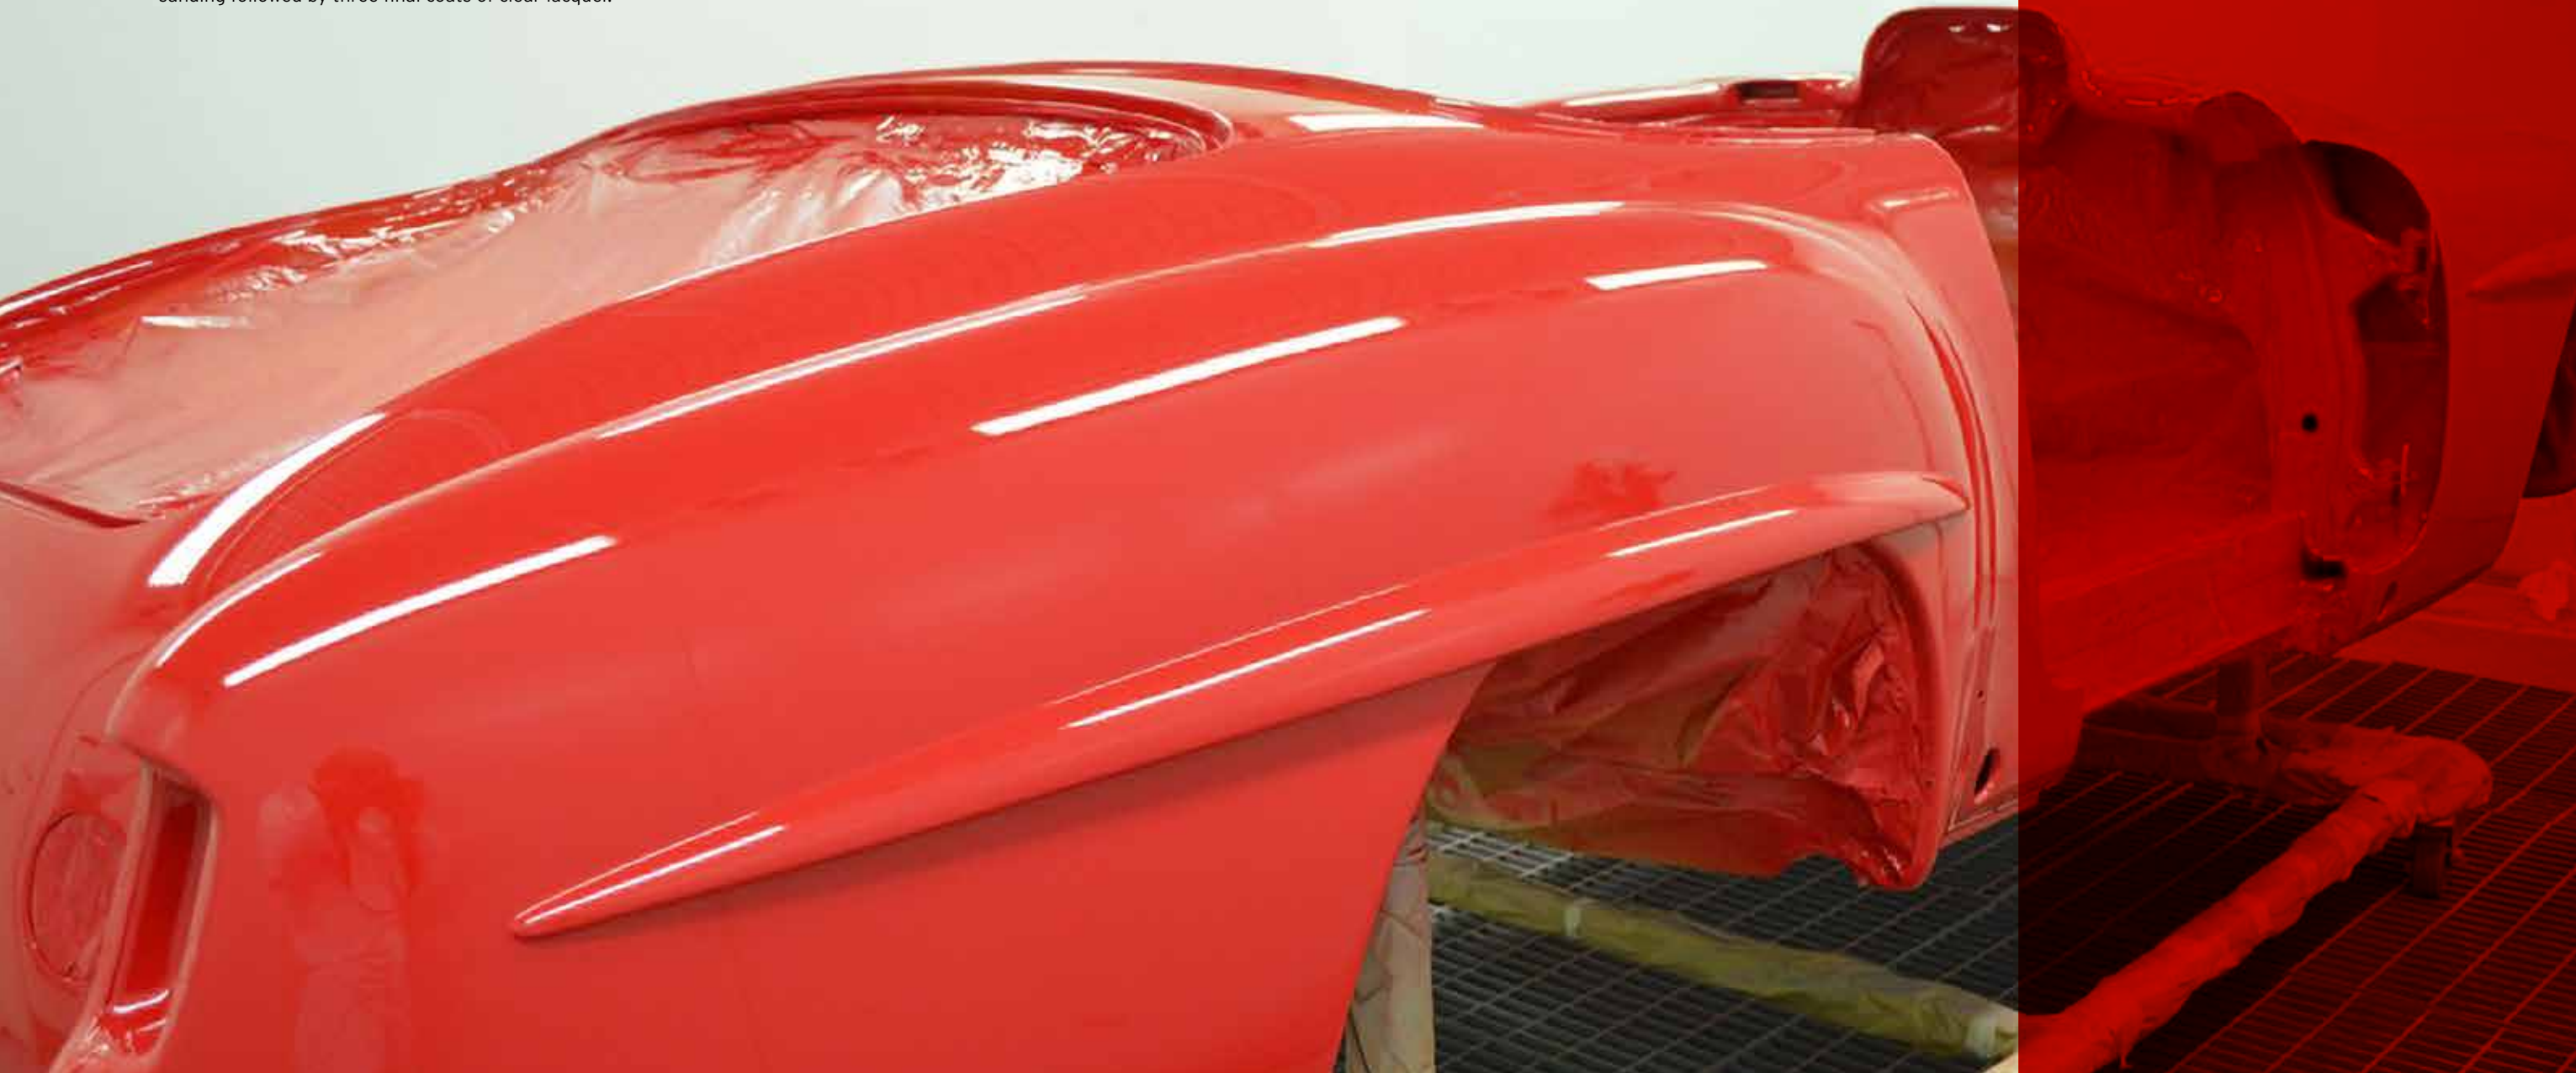
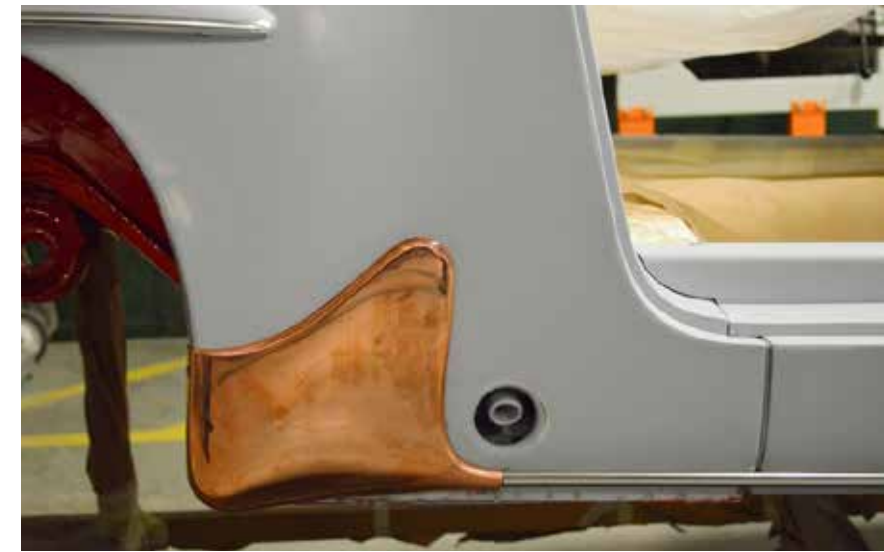
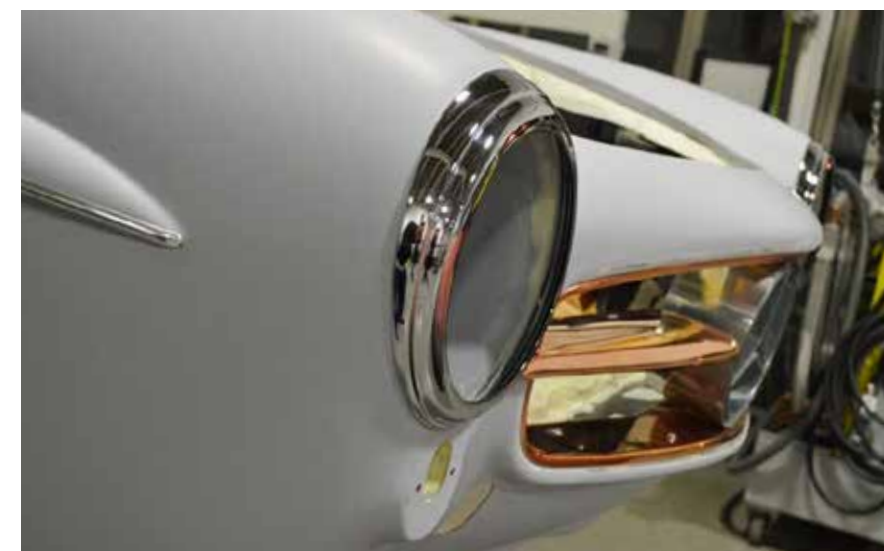
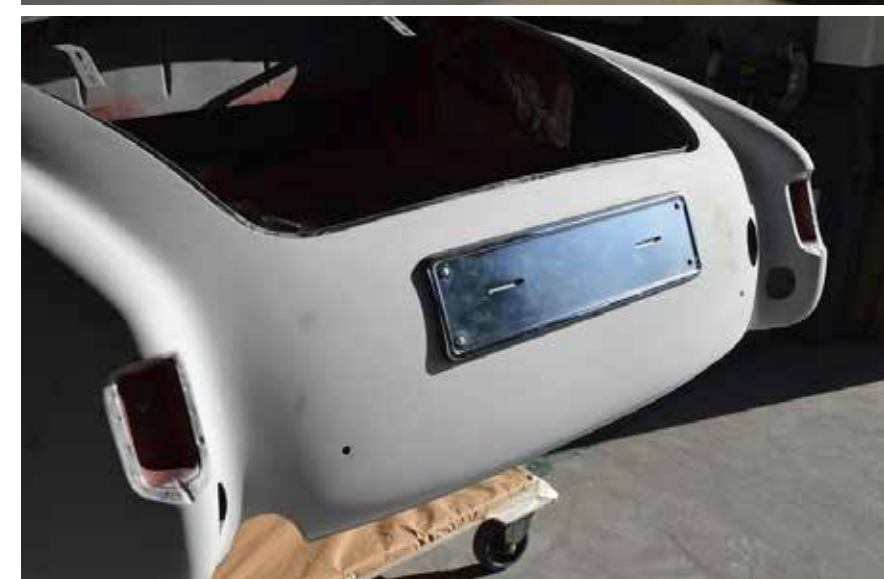
PAINTING

With the doors, bonnet and boot lid removed, the body was masked so that the weather strip channels and door jams could be sprayed. These were given three coats of DB180 base coat and three coats of clear lacquer. The edge of the doors too were given a similar coating to avoid dry spray when mounted. With the boot lid and bonnet removed, the inner surfaces were coated with PPG DB167 (Tiefdunkelgrau Matt). Factory standard black semi-gloss. Two coats of (Fire Engine Red DB534) base coats were sprayed. The doors, boot lid, bonnet and sills were all painted at the same time to ensure perfect continuity of colour. The paint was then allowed to harden and rubbed down with basecoat sanding pads. Three further coats of base coat, followed by three coats of clear lacquer were applied and allowed to fully harden prior to wet sanding followed by three final coats of clear lacquer.

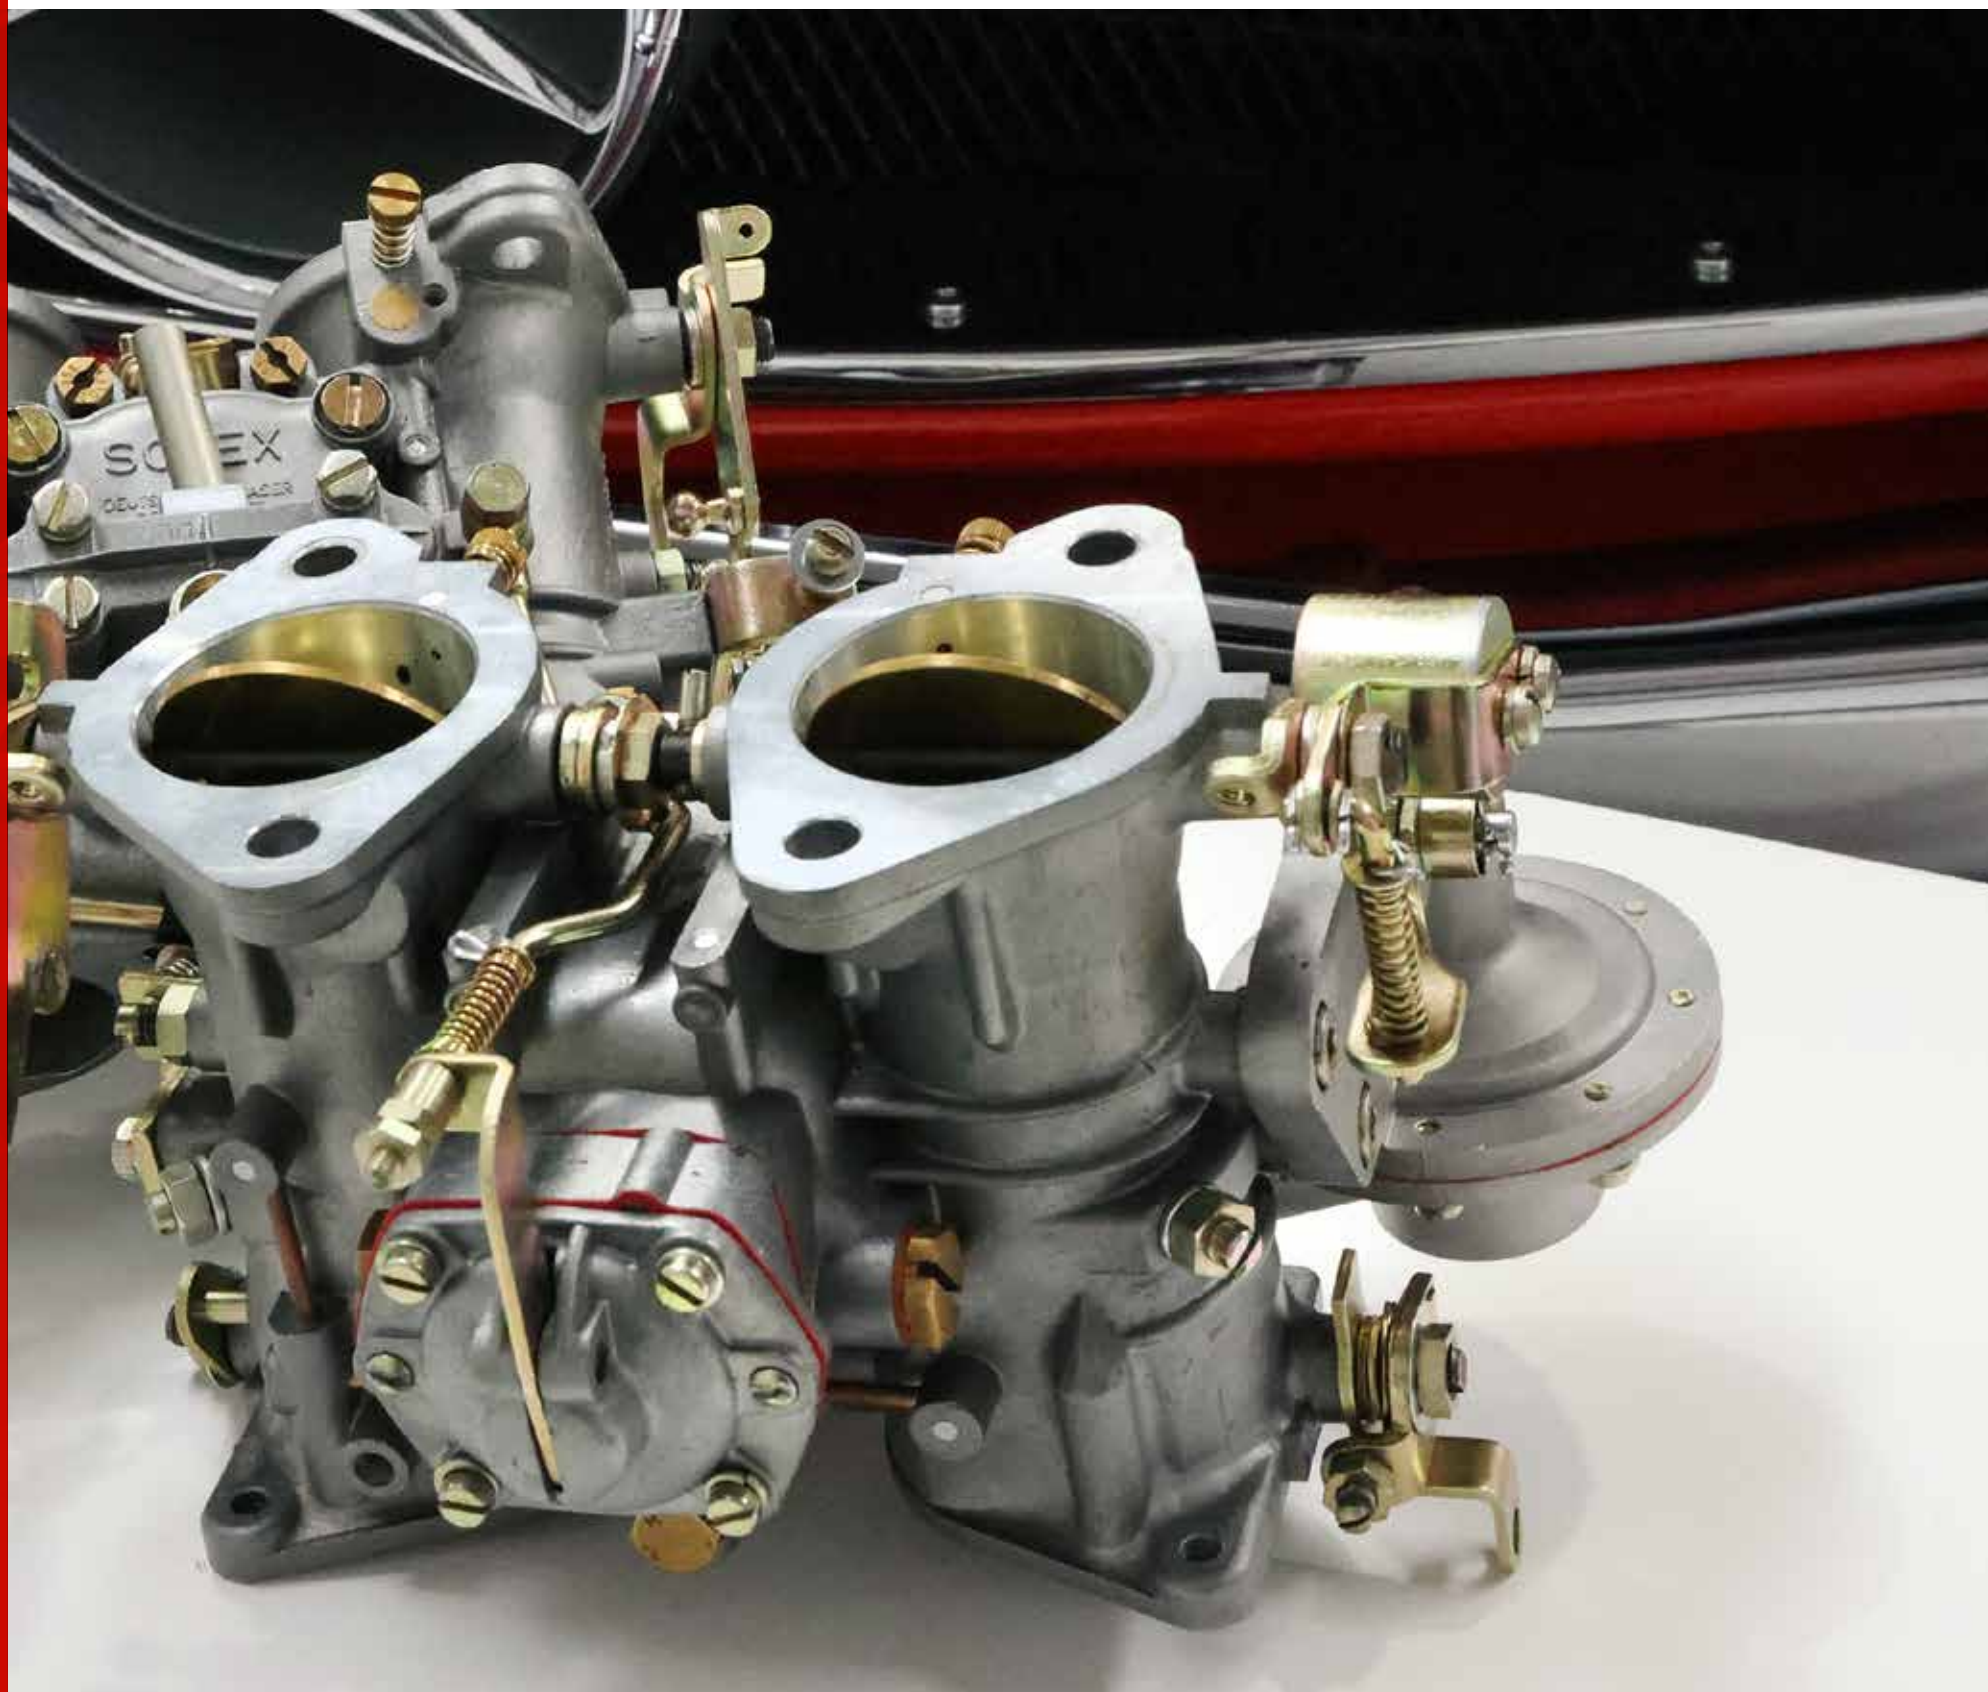
BENCH TESTING

The carburetor settings were checked against those suggested in the 190SL Supplement Workshop Manual and set up on the bench and flow tested with vacuum and an airflow Synchrometer. The secondaries indicated that no air was passing and the primaries idle adjustment set to 5kg/h on each carburetor. Final set up is performed with the carburetors mounted on the engine and with the engine running.
