MERCEDES-BENZ 190SL

A pictorial retrospective of the complete restoration

01 | BRIEF HISTORY

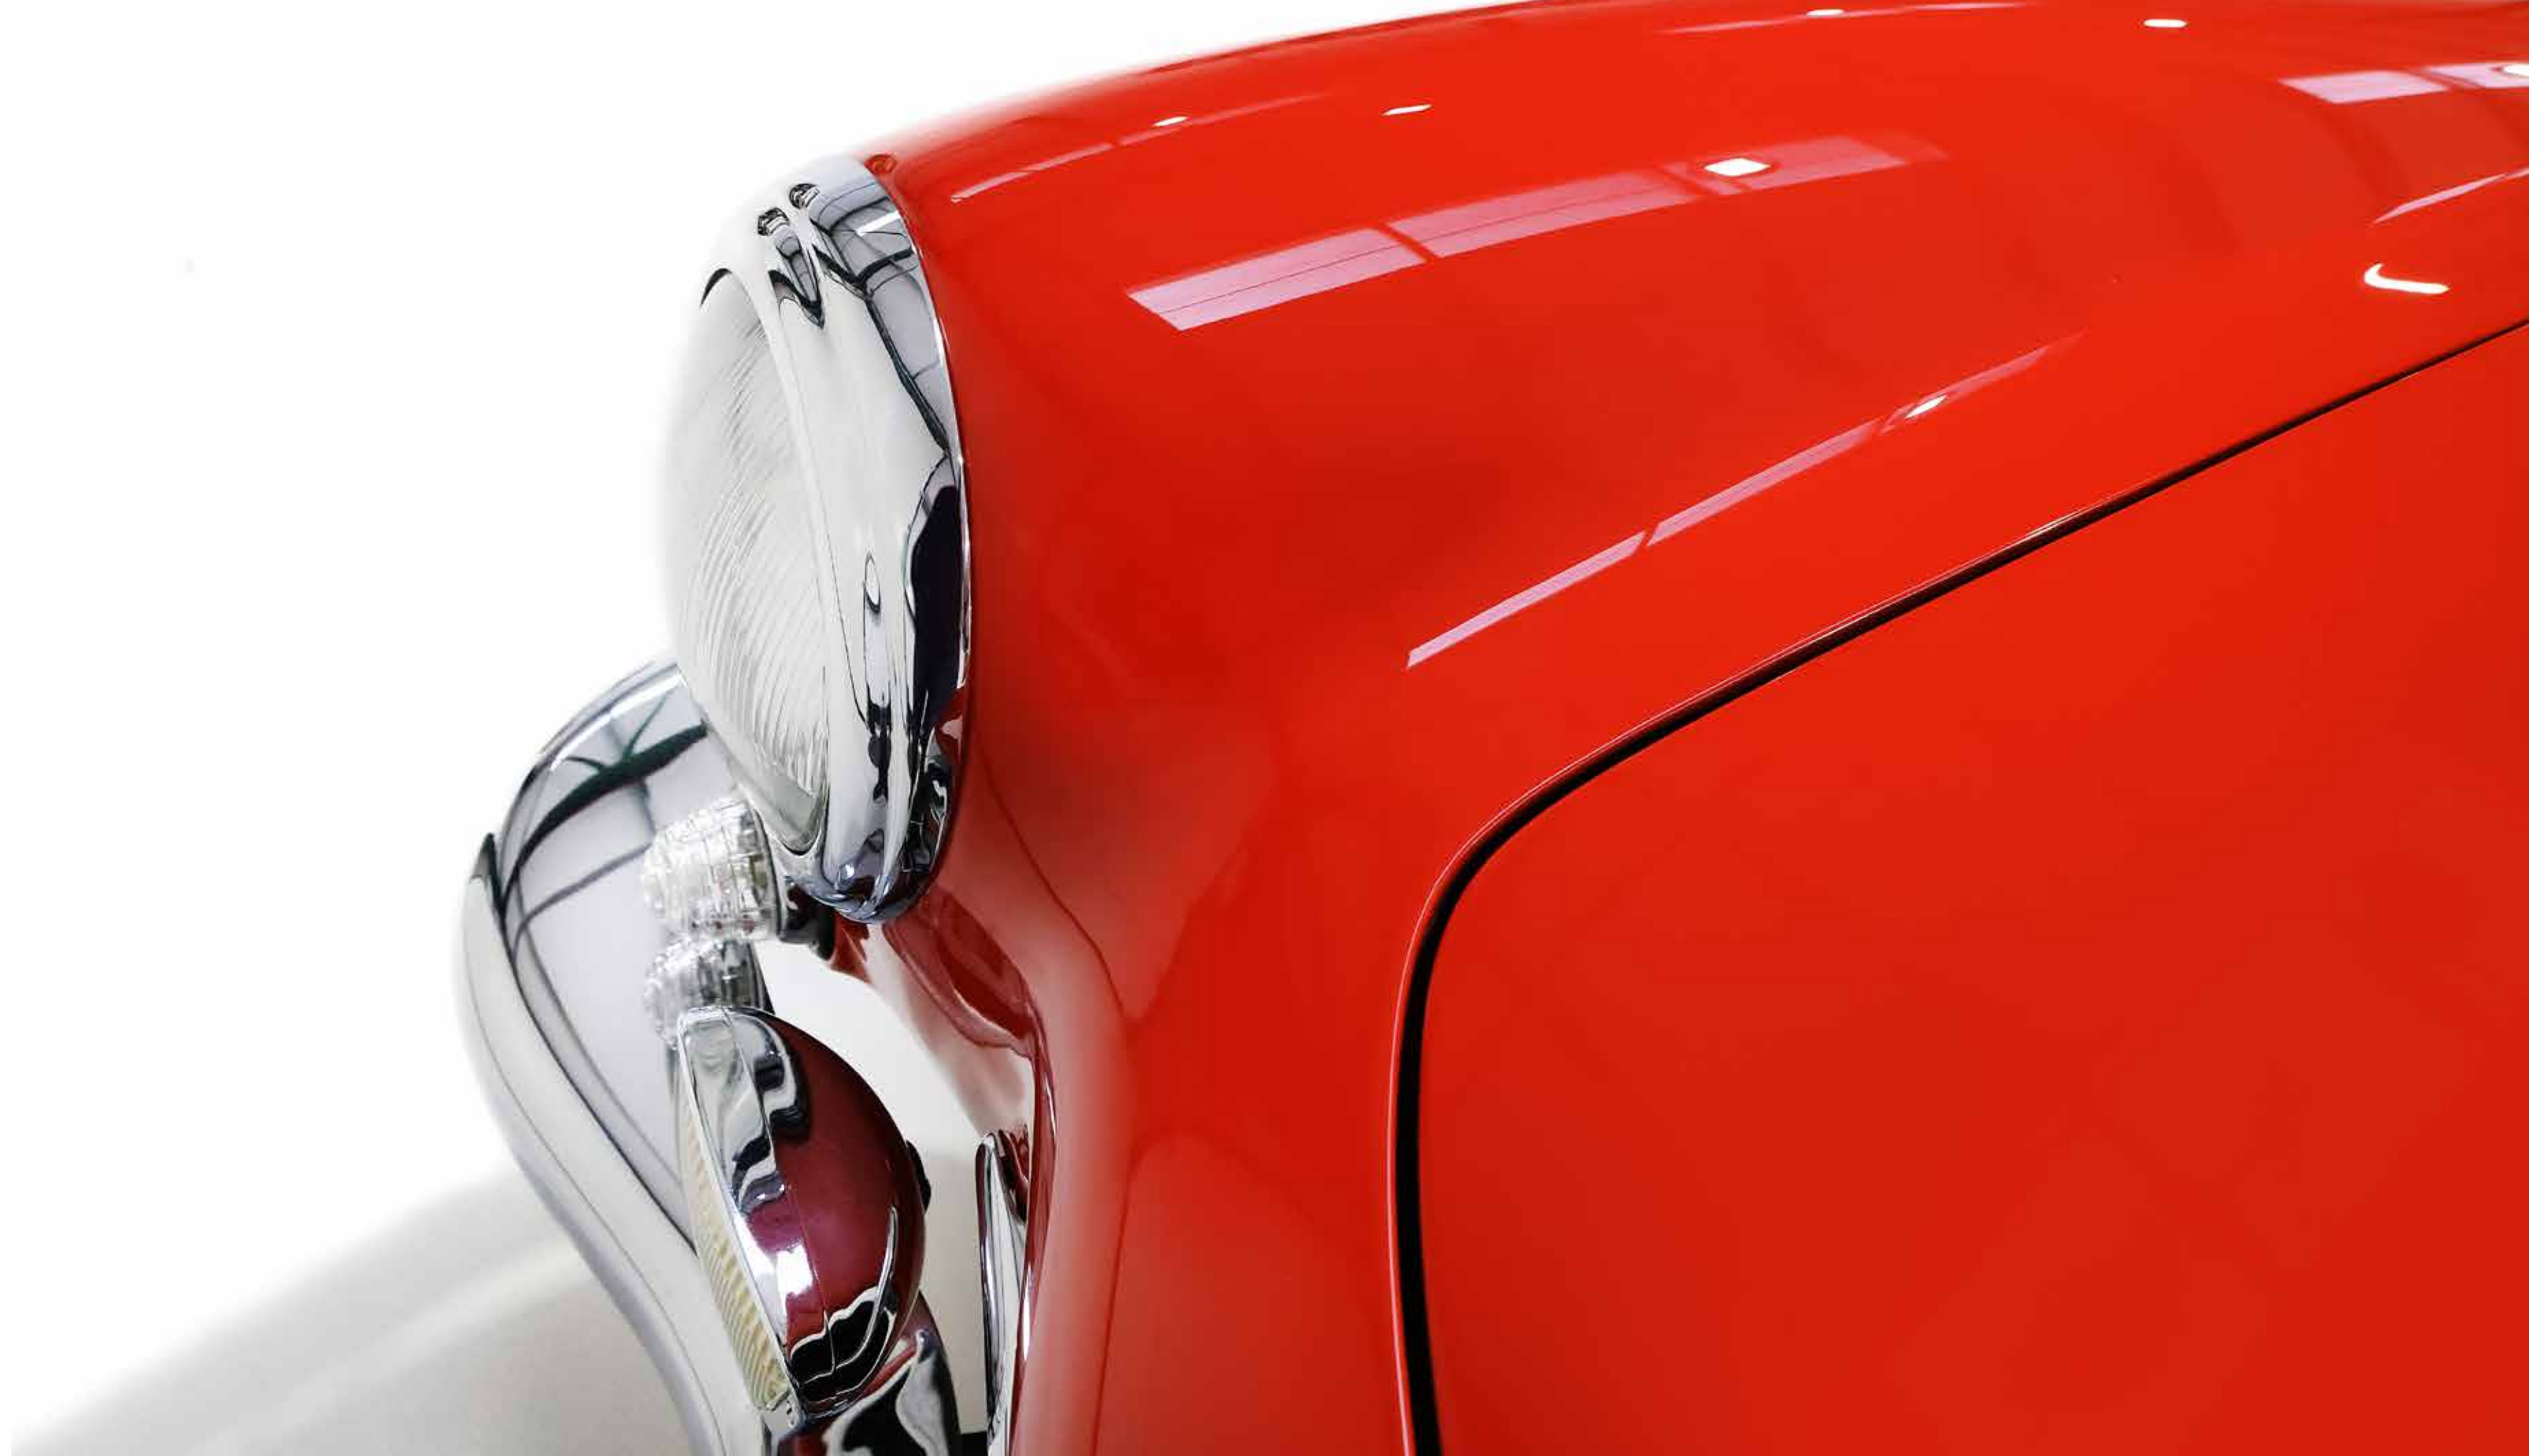
DOOR AND CHROME ASSEMBLY

The door top chrome strip was first to go on followed by the door latches and striker. The doors were built up with the window lifting and door opening mechanisms and the glass fitted. New door and boot rubbers were fitted. All chrome trim was re-plated and fitted carefully. This completed the remaining wiring on the head lights, tail lamps, indicator lights and number plate lights. Front and rear bumpers were fitted as well as a new chrome exhaust trim. The front grill, rear stone guard, sill / eye-brow mouldings and badges were fitted. Wiper motor, mechanism and linkages were rebuilt. Final assembly items like the wheels were attached and the car made ready for the interior trimming and soft top.

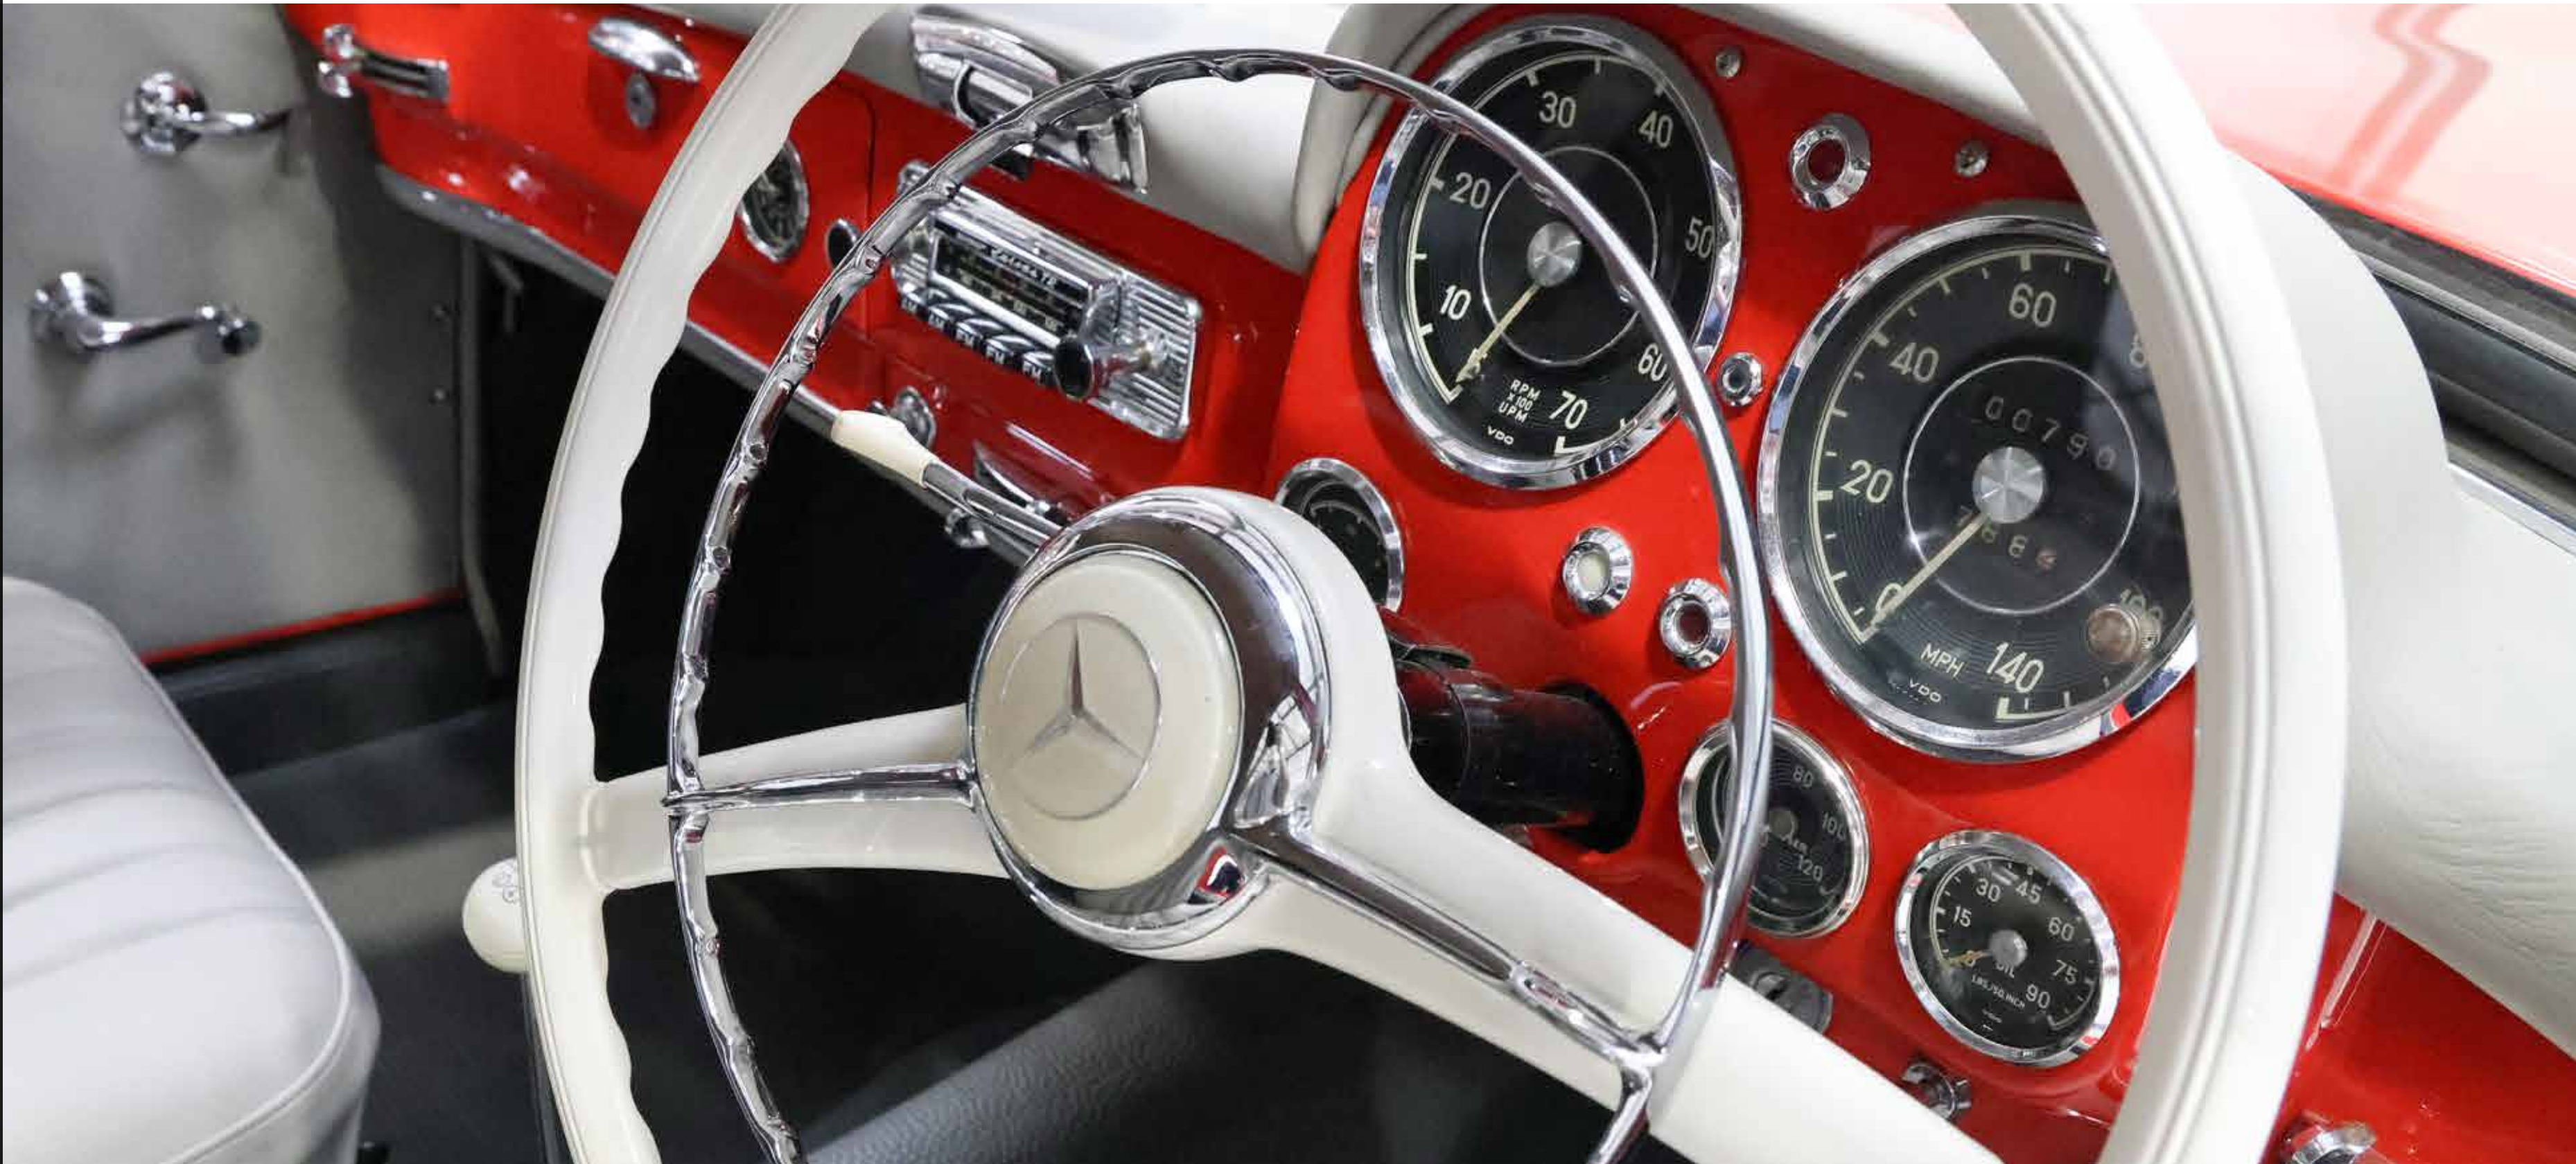
INSULATION, CARPETING AND RUBBER MATS

The interior floor pans were insulated with Dynamax™ sounding deadening material as an improvement to the original material. This was then covered with 'waffle' type felt. Carpeting was then undertaken with German fine weave 'Boucle' carpet material in the rear footwell and storage compartment. The front foot wells, centre tunnel, side sills and boot area was covered with rubber mats similar to when the car was new. The correct fasteners were used to hold the mats in place at the correct points.

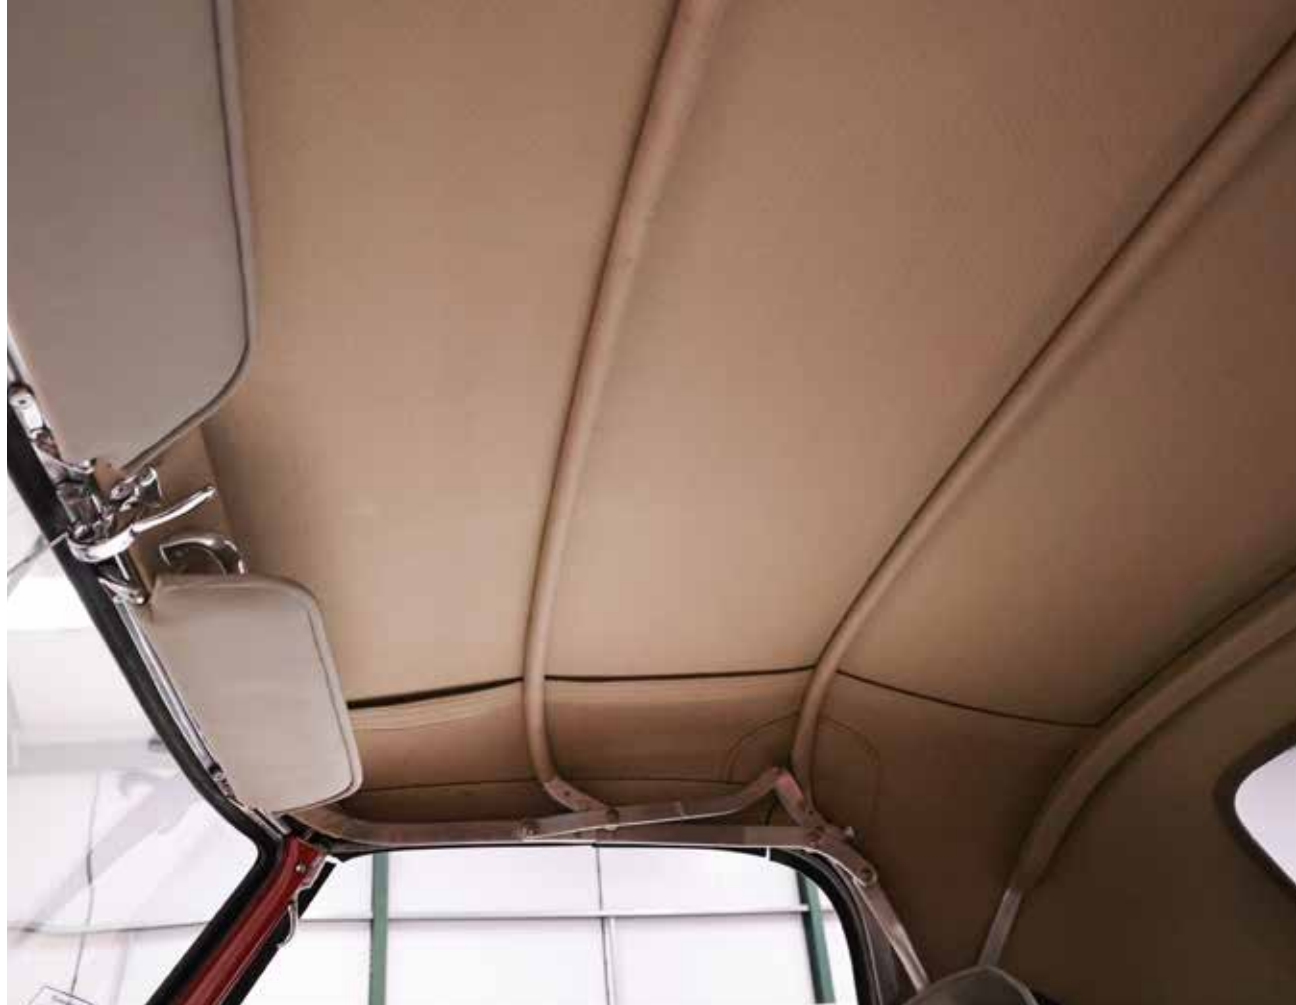
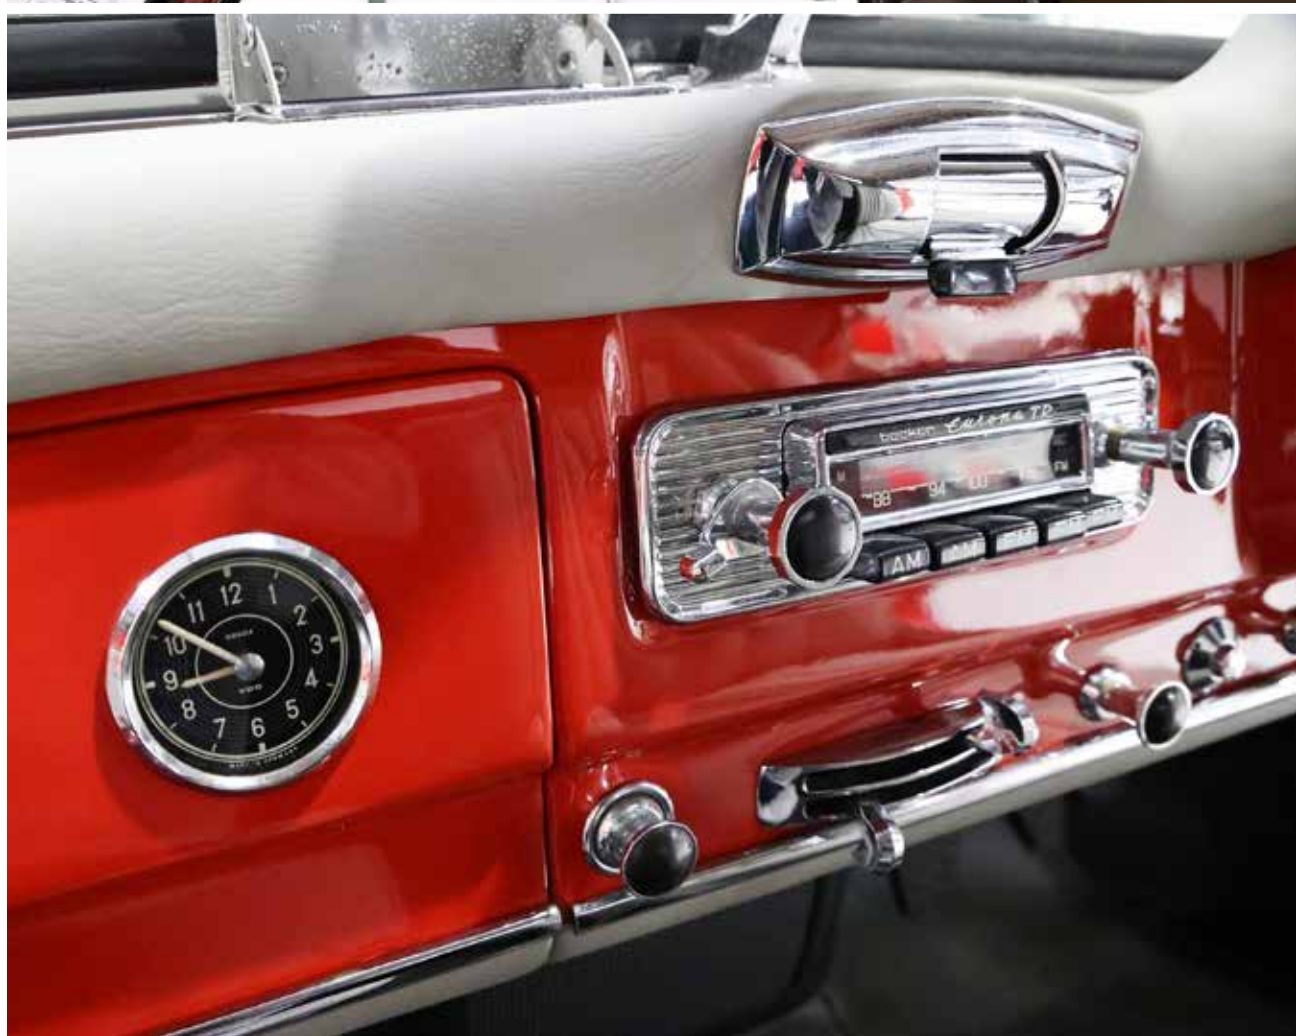
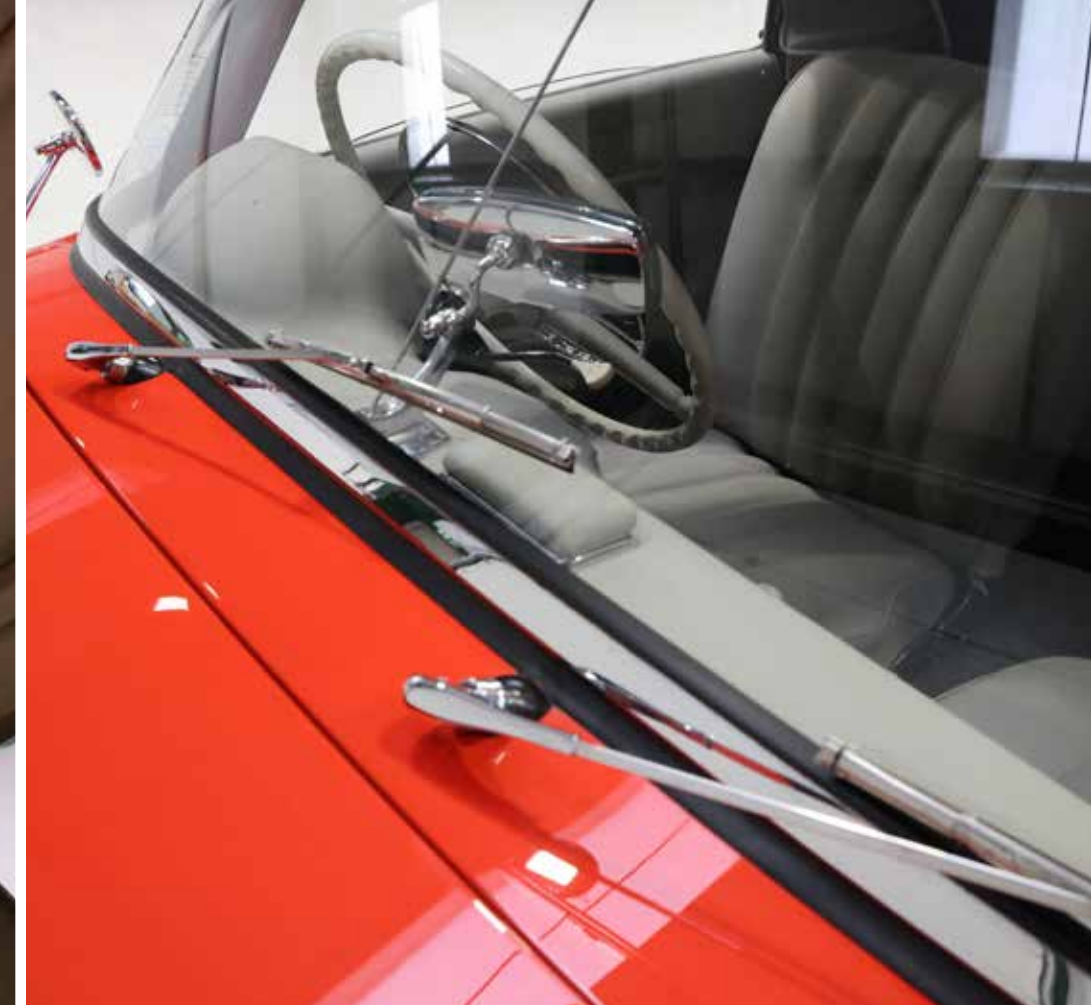
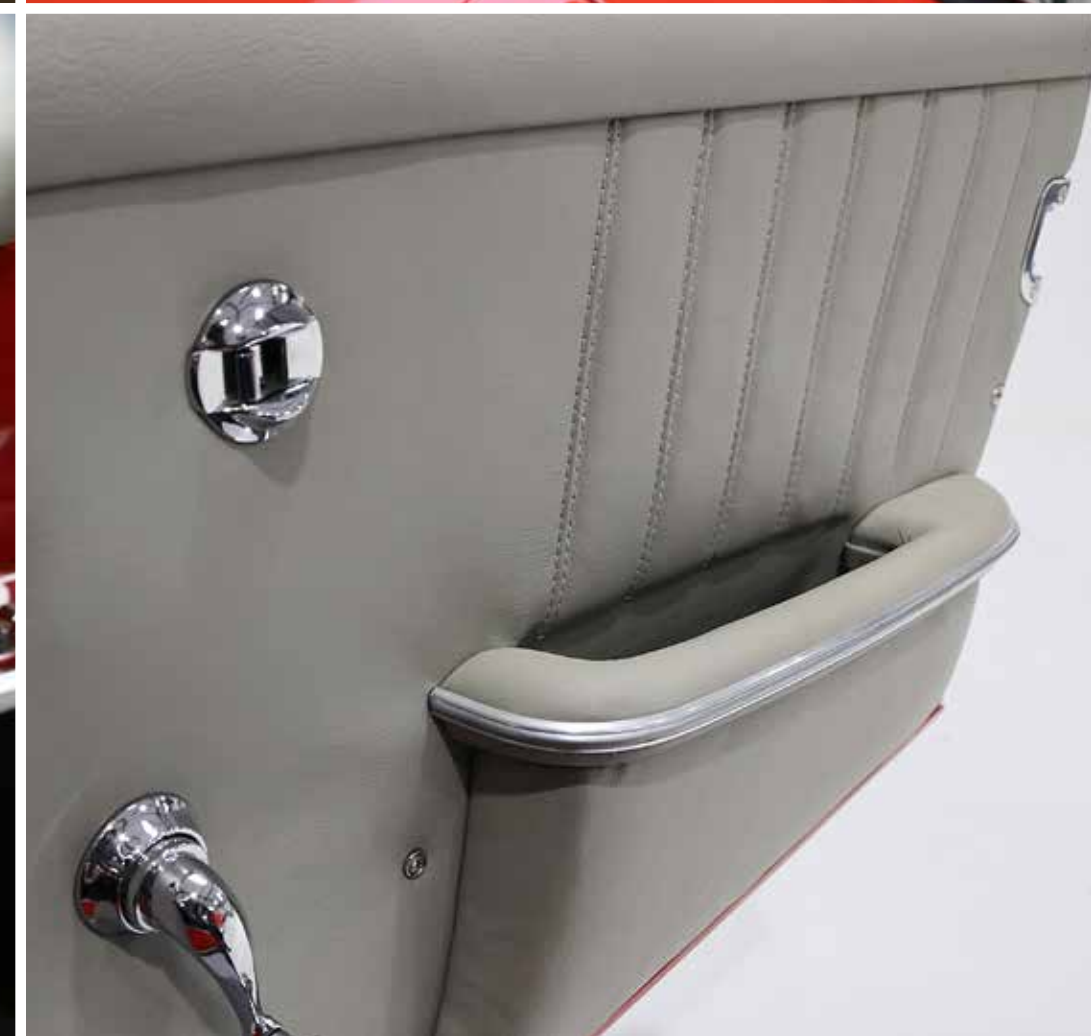
LEATHER TRIMMING AND INSTRUMENT PANEL ASSEMBLY

Trimming the car requires not only patience but also passion for the detail and workmanship that makes the Mercedes-Benz 190SL what it is. Re-covering the dashboard with leather is the most challenging single task in restoring a 190SL interior. The dash was carefully covered with German fine grain supple light grey leather. As the leather was skived (thinned to half its thickness) it was possible to cover the contours of the dash. The dash is first fitted, stretched and shrunk around the instrument hump, then stretched to fit the rest of the dashboard.

Welting strips were made to fit around the instrument hump and door 'A' and 'B' posts. The rear soft top compartment was additionally covered with the same leather. The seats and door panels were made up, using traditional materials to fill the seats. Next the instrument panel was covered using felt under the leather at knee curves and instruments and switches fitted to the panel. The glove compartment was covered in leather and the glove box lid was trimmed. The windscreen pillars were fitted. The chrome vent strips and vent levers were fitted before the front windscreen and chrome surround was fitted and the dash trimmed to fit. The instrument panel was fitted as were the remaining switches and gauges. The interior wiring was completed together with final fit of dash chrome and glove box lid. The door panels will be fitted once the soft top has been trimmed and final window adjustments.
