MERCEDES-BENZ 190SL

A pictorial retrospective of the complete restoration

Parry Chana - LuxClassics

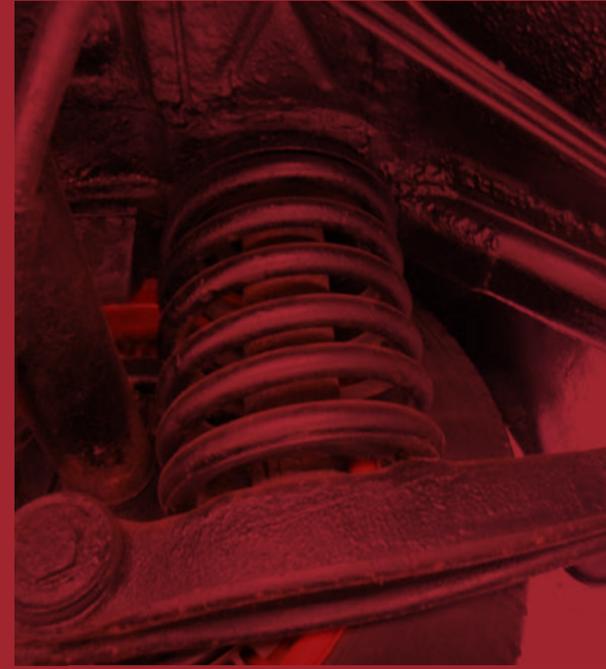
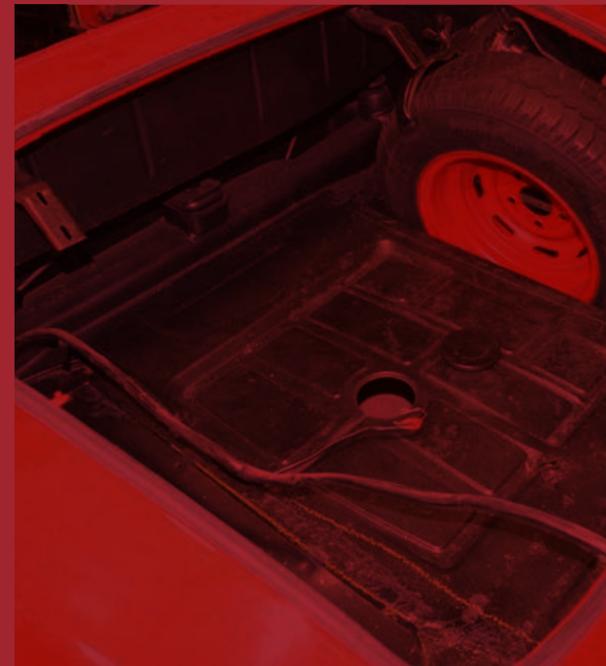
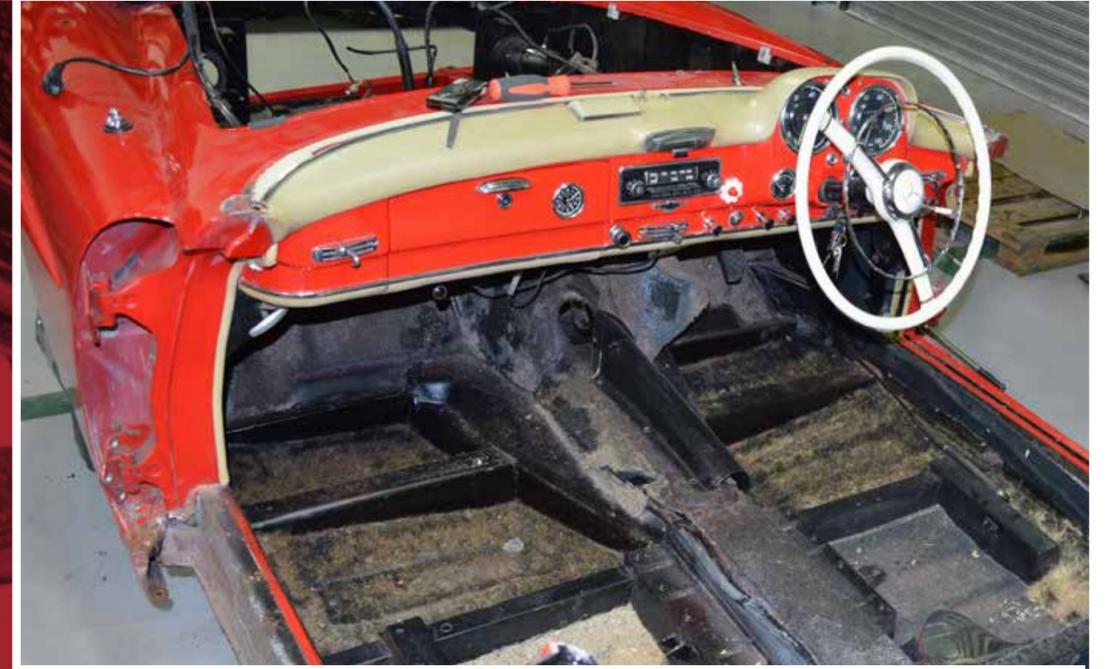
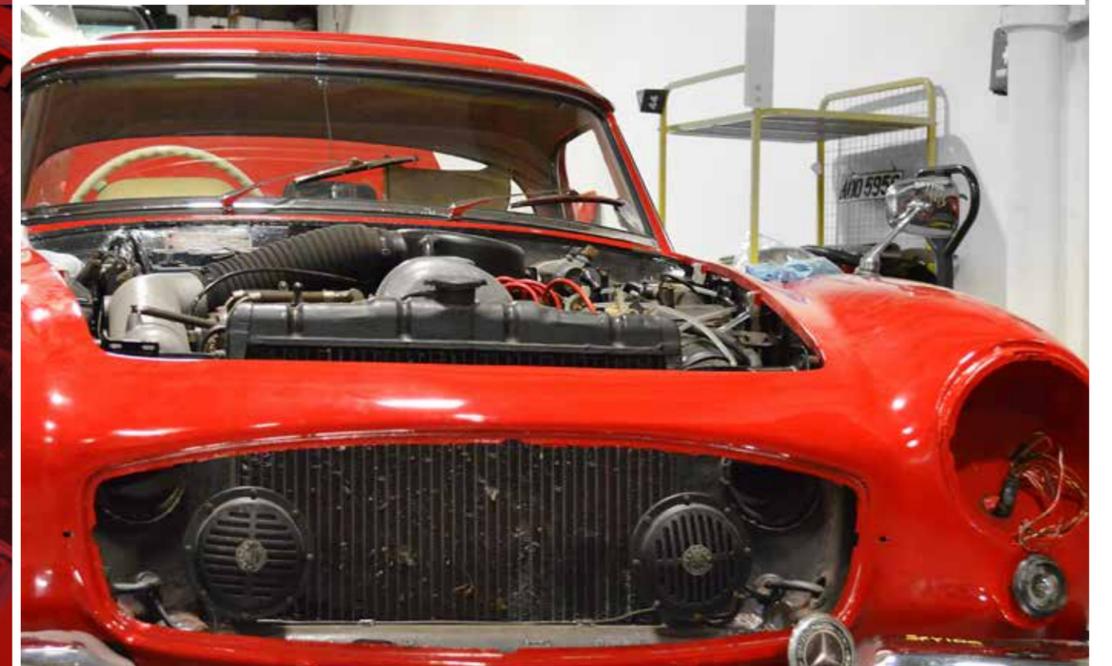
02 | STRIP AND INITIAL ASSESSMENT

The 190SL is one of the earliest cars to be built in the 'monocoque' or 'unit body' design. With the exception of the rocker panels, which are screw on, the steel body panels, frame and floors are welded and nailed with special twist nails and held together to form a very strong single unit. The doors, bonnet and boot are aluminium together with the 'A' and 'B' posts and dash cowl and dash. The aluminium parts will generally not need to be replaced but all of the outer body panels are made of steel and may need to be repaired or replaced.

The first thing to do is to carefully evaluate the car for signs of wear and tear, serious or hidden damage, non originality, etc. As any issues arise, they are documented and photographed. At the same time research begins to determine what items were original to that particular model and year, what replacement parts are readily available, and what sorts of materials will be required.

All removed components are stored for later assessment. It is also worth noting that all screws, bolts, fasteners and clamps removed with these were retained and will be reused where usable. These will be later bead blasted and correctly plated. Reference to these processes and in aid of assembly we follow the Mercedes-Benz manual for standard parts or DIN book (Deutsches Institut fuer Normung), spare parts manual (Edition 'D' for this particular year) and the Mercedes Service manuals (Model 190 Passenger Cars and 190SL Supplement).

During the disassembly process, we note any irregular fits in the body panels or trim pieces. The stripped body is mounted onto a wheeled trolley and transferred to our body shop.

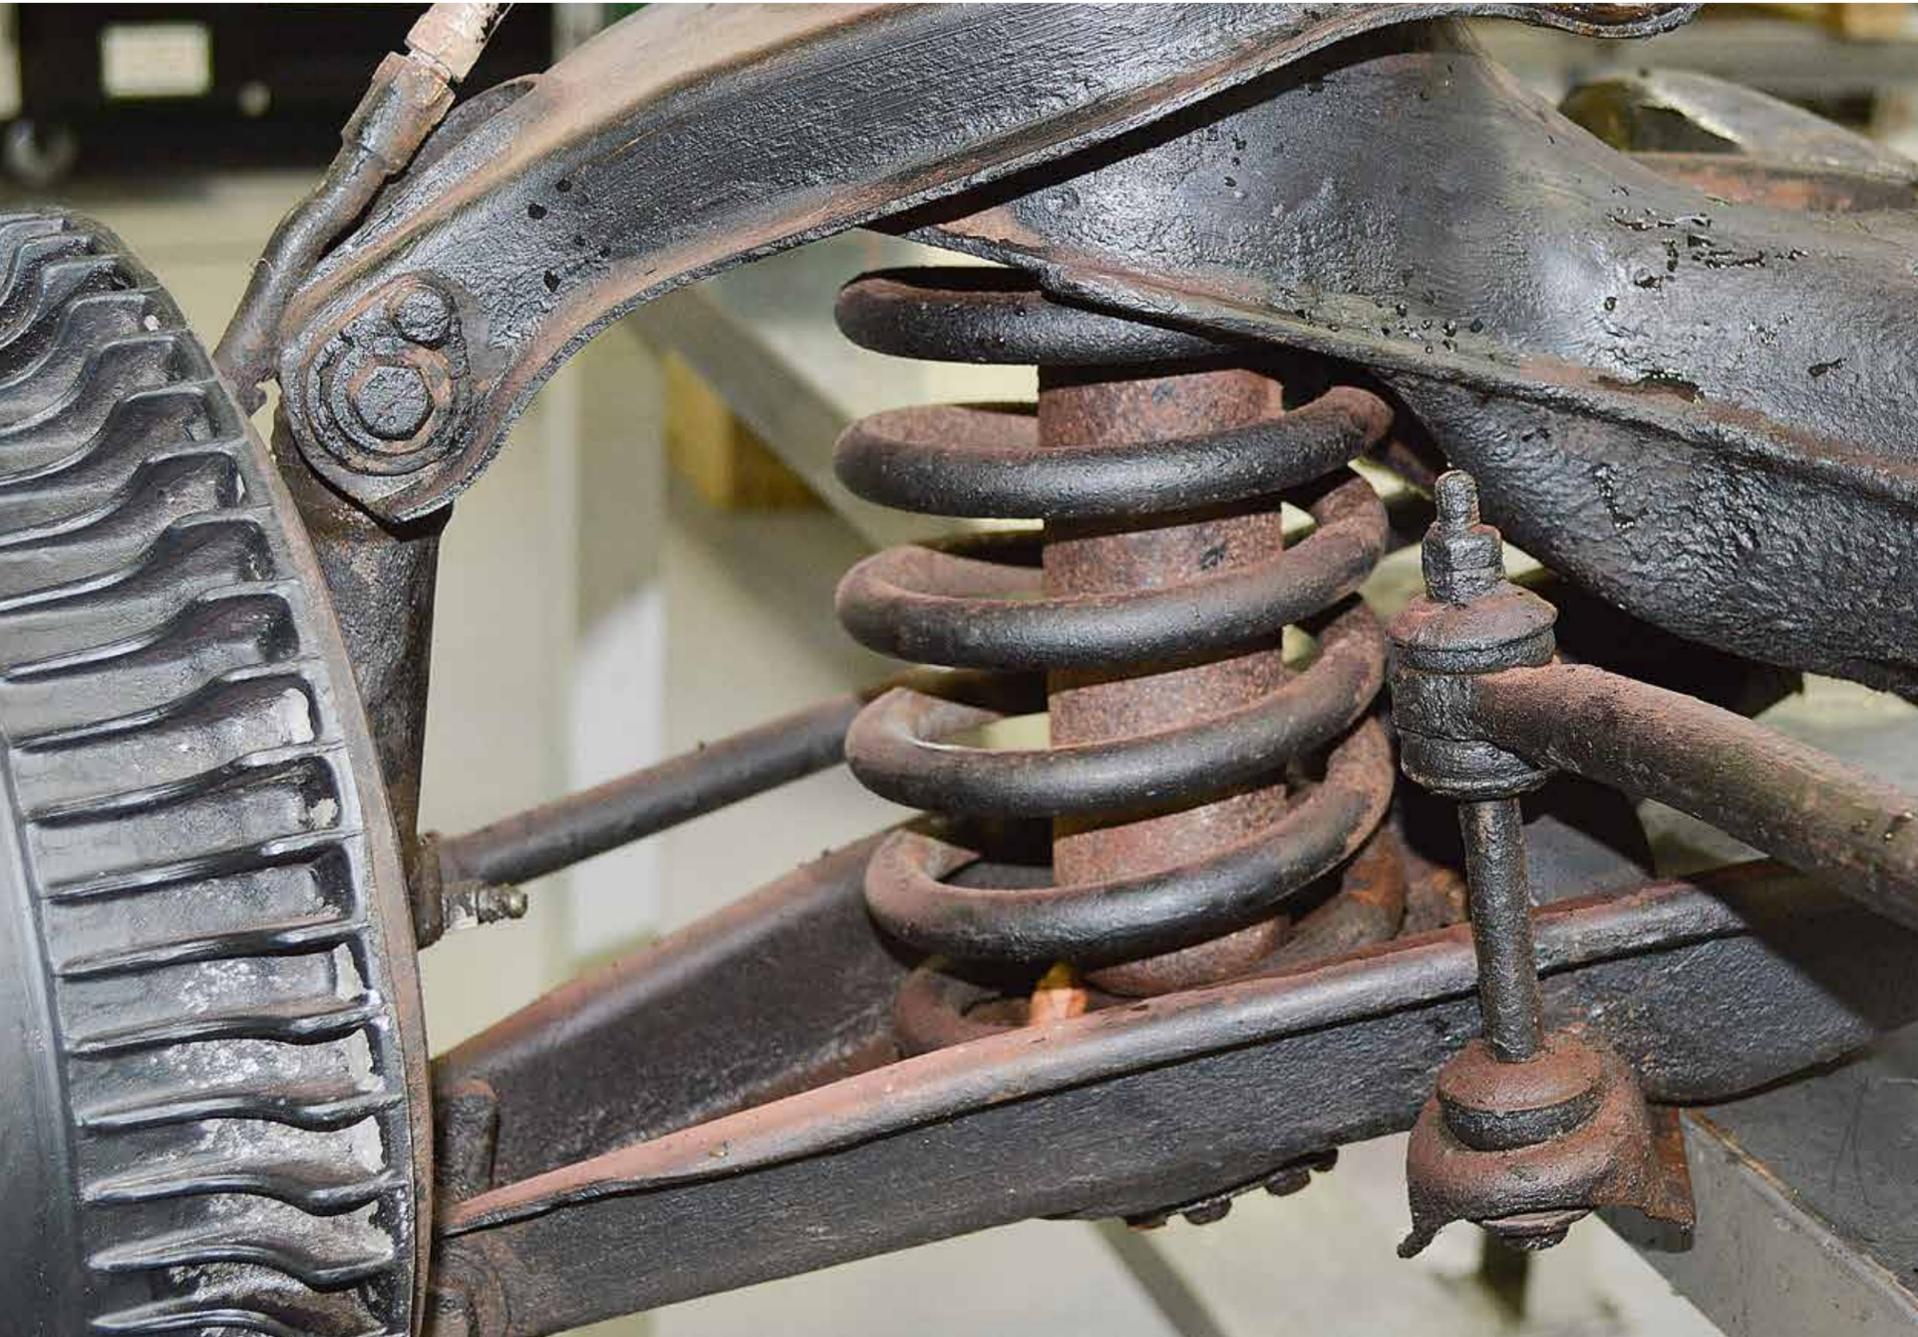
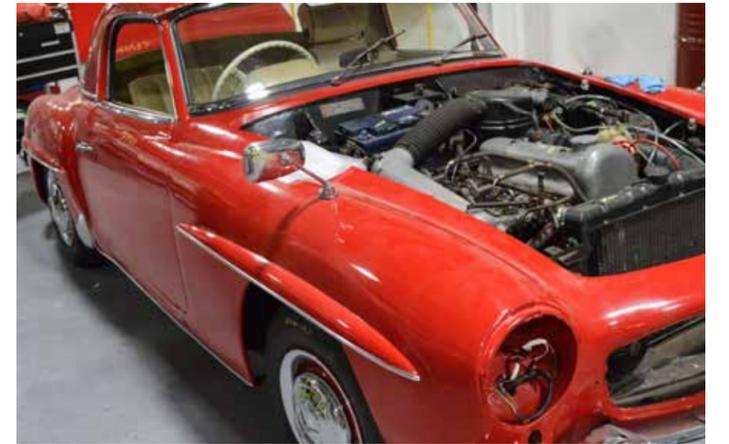
03 | CHASSIS AND BODY ASSESSMENT

The next and very important stage was to undertake a fully detailed and thorough assessment of the chassis (frame/floor assembly) structure. The U-section box reinforcements on the frame and side members received no primer or wax injection at Sindelfingen and generally rust from inside out. The shell was inspected internally with the aid of a Snap-on Video Inspection Scope™. Notes were made of any abnormal rust and chassis structures that need additional attention.

The chassis was then cleaned back to remove all of the residual oil, grease and general muck that had accumulated over the years. This was a filthy job, but vital if the soda blast of the structure that followed was to be fully effective in removing all of the surface rust.

Stripping the many layers of paint and body filler from the outer shell followed, revealing even the slightest old panel damage. The windshield 'A' pillars were then removed together with the side sill panels joining the 'A' post to 'B' post at lower door openings.

Corrosion spots are generally found around the wheel arches, headlamp bowls, sills, rear wing stone guard area, boot and floor panels caused by damp and the effects of electrolytic induced corrosion of the steel panels in the proximity of its aluminium supporting frames.

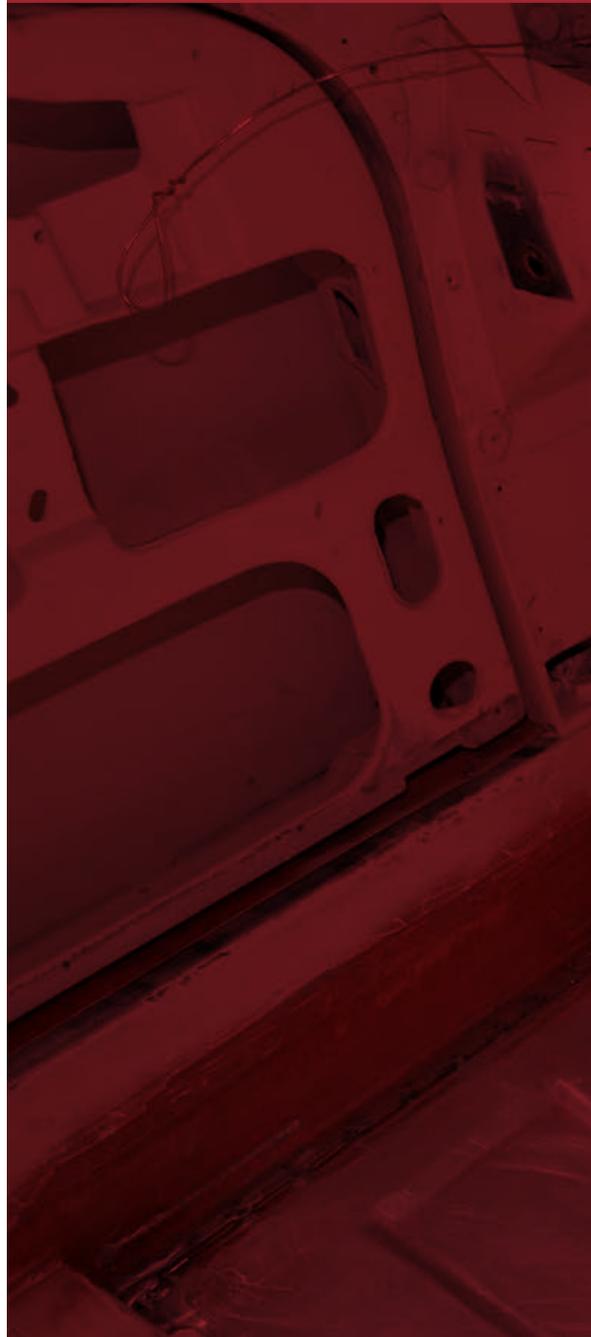
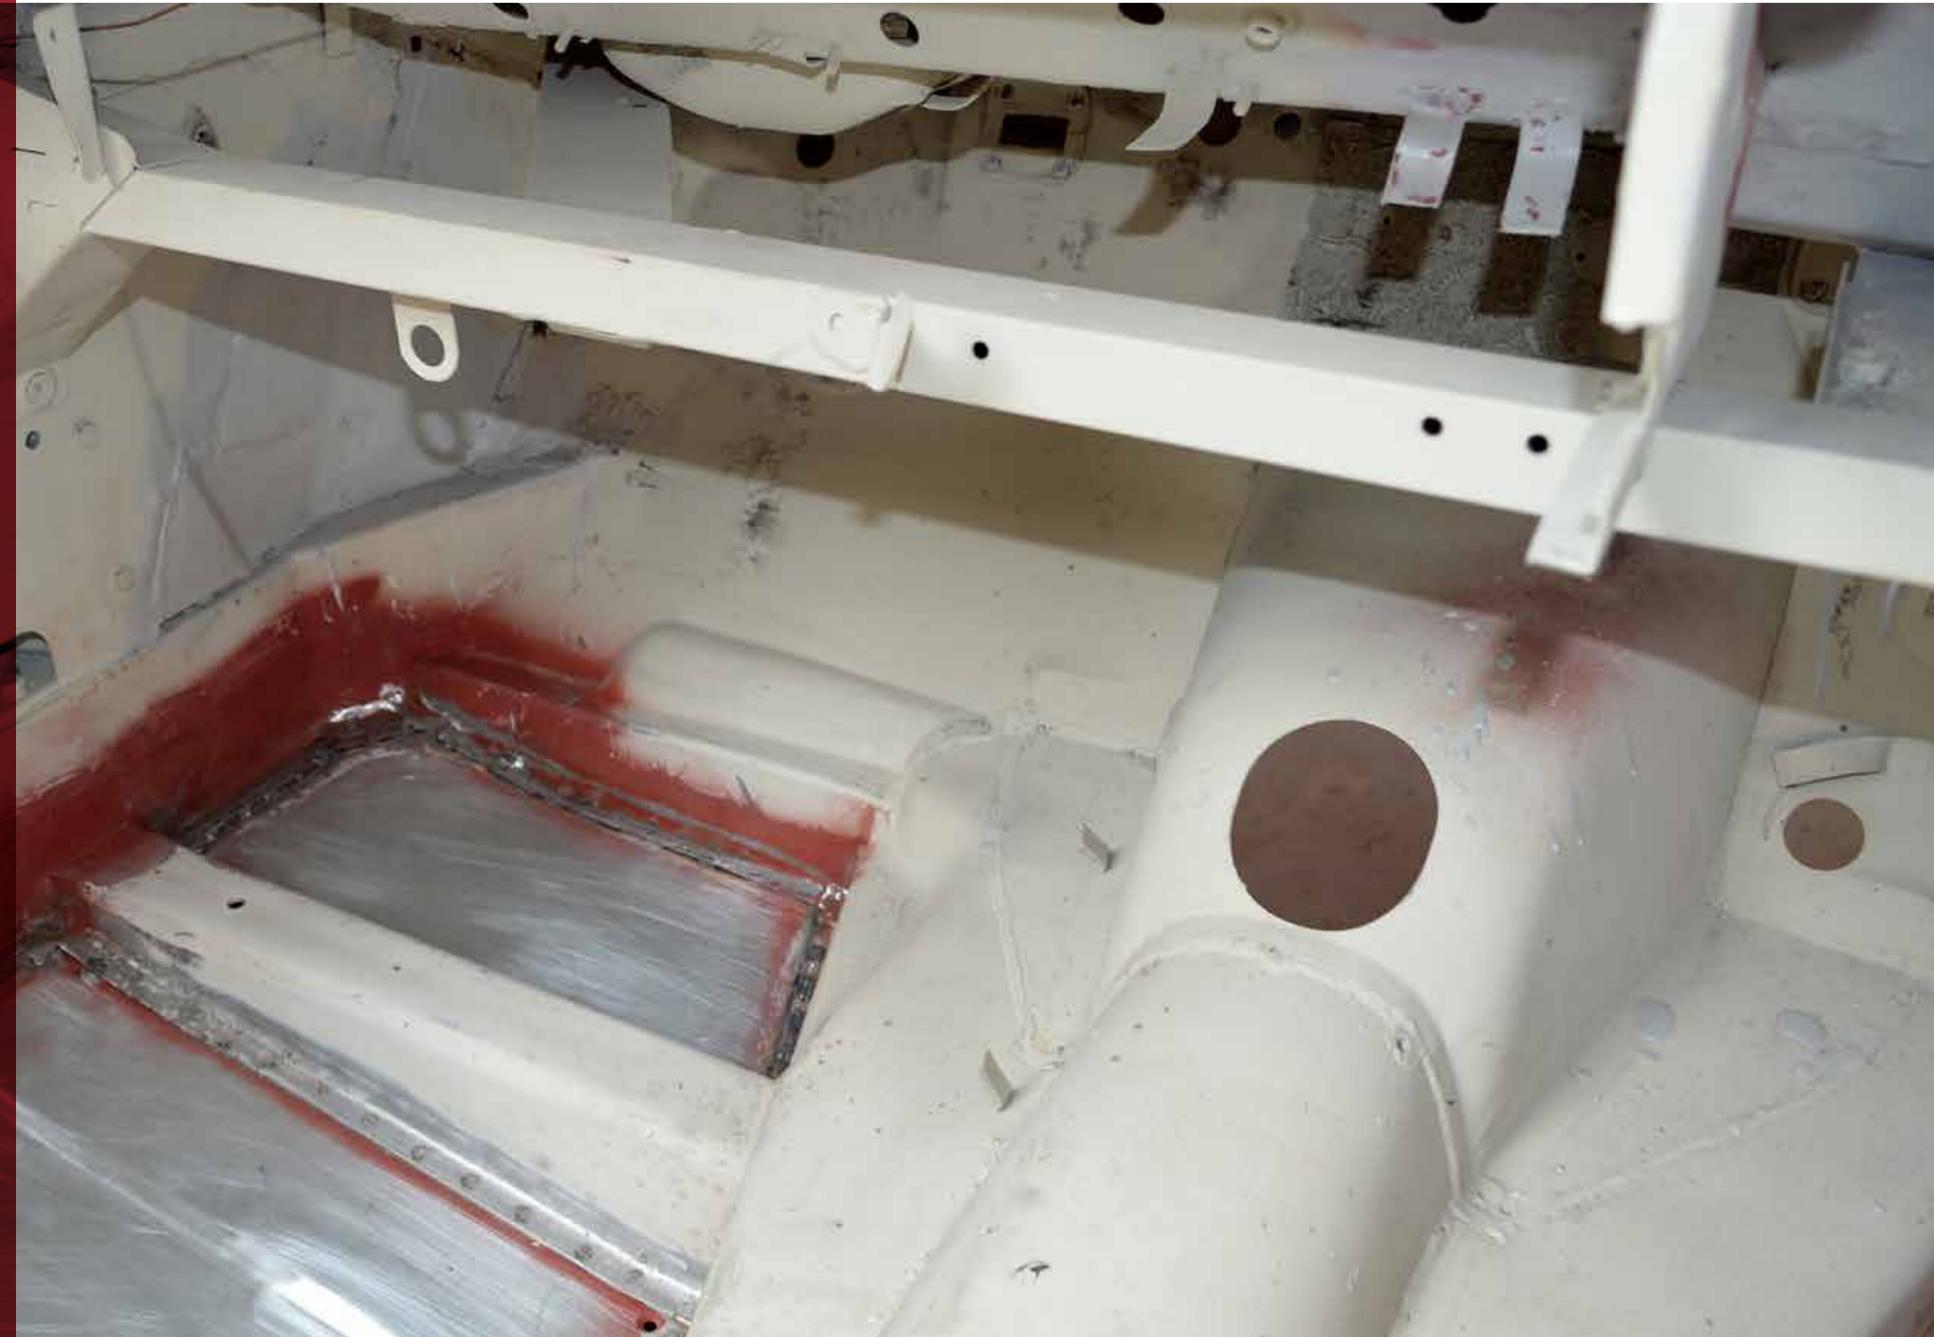
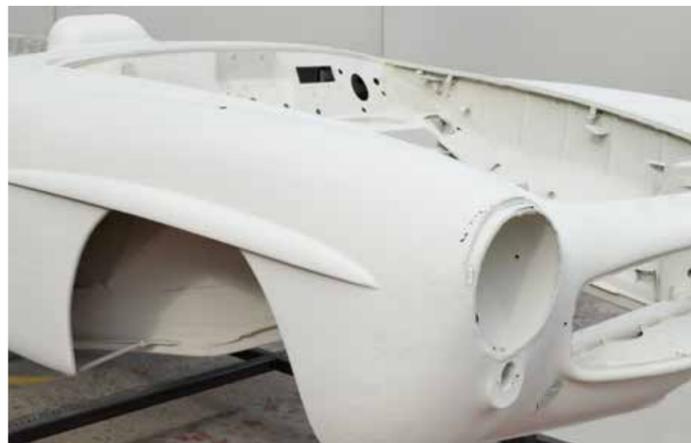
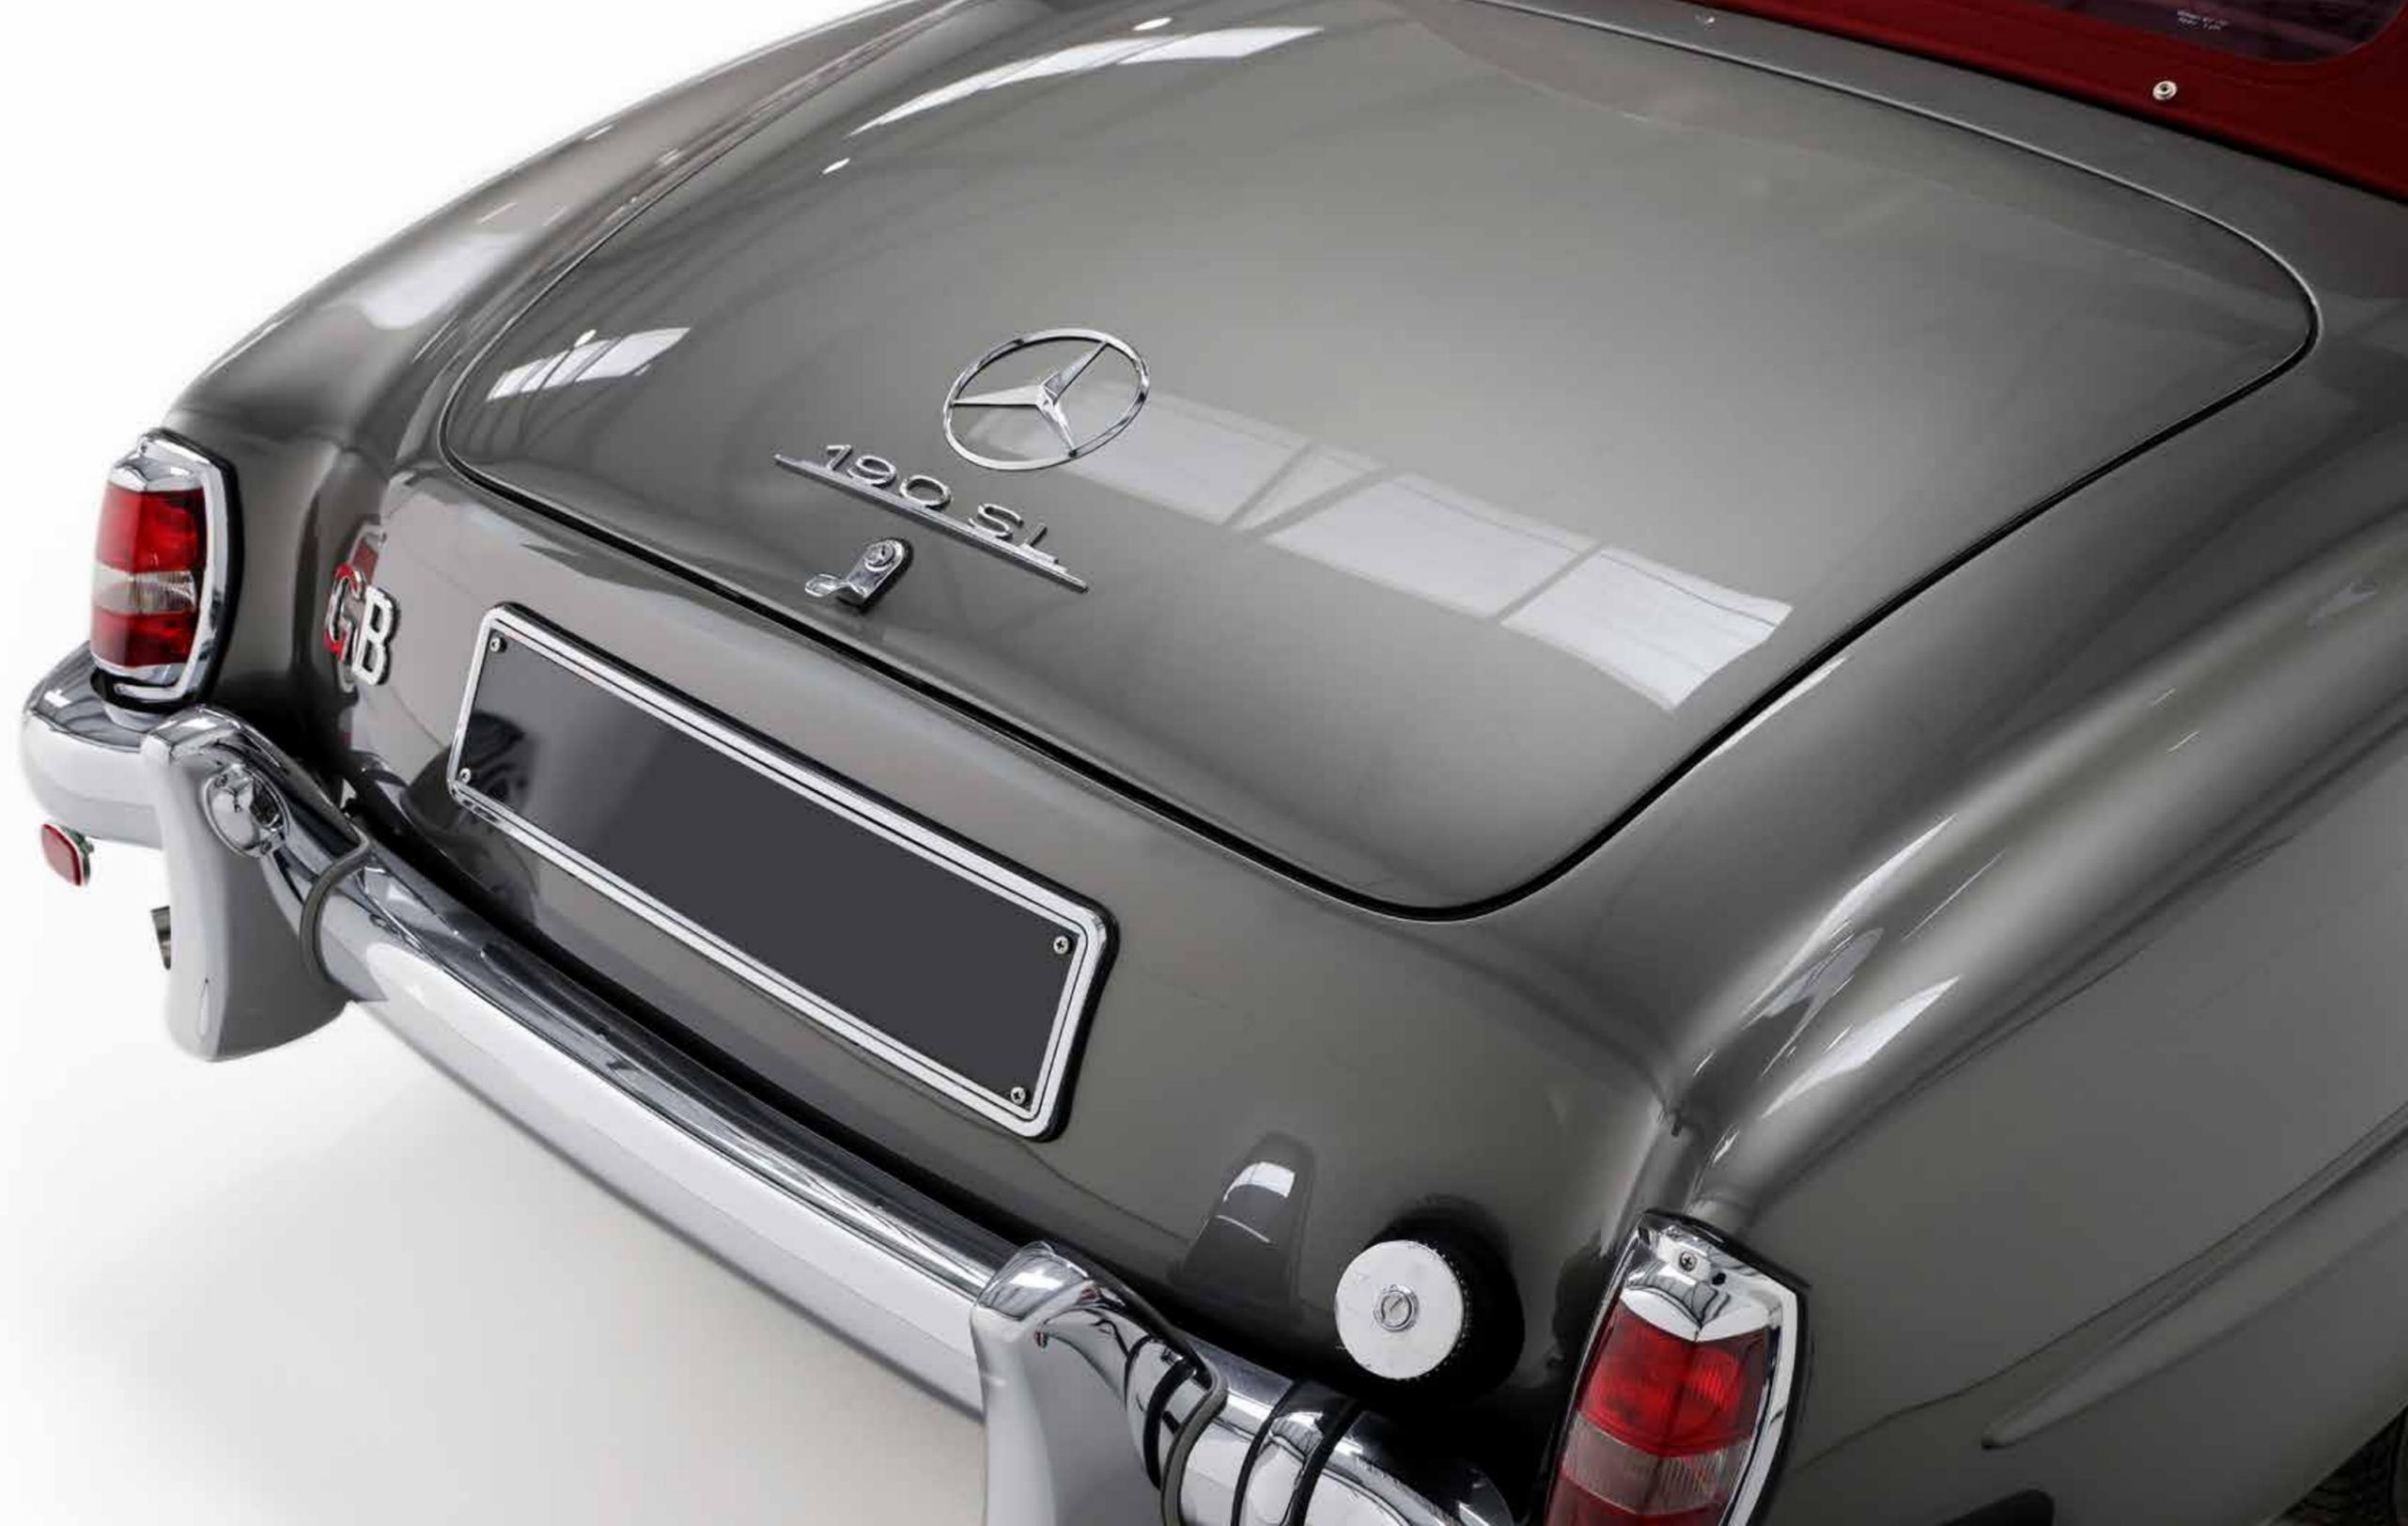
04 | CHASSIS RECONSTRUCTION

Following the stripping of the chassis, the first step taken in the reconstruction is to mount the chassis on a jig. Additional support to the frame was provided by the use of clamp struts in the door opening between the 'A' and 'B' post frames. This not only ensured that front and rear suspension alignment was always correct but also served to support the chassis during its reconstruction to avoid twist and sag.

Chassis measurements were compared to those in the Mercedes-Benz Data Book for Passenger Cars. It also provided a means whereby past damage could be detected and eliminated.

The chassis reconstruction started with repairs to rusted sections which were cut, bead blasted, acid washed with repair panels fabricated and welded, keeping originality. The four seat box sections together with the four floor pans and two front lower firewall repair panels were cut out for replacement, de-rusting as we went along. The replacement floor pans are thicker than the original and zinc coated steel. The zinc coating creates a barrier against rust and can be painted over once prepared well. All chassis members were checked carefully by tapping with a pick hammer to ensure that they are not weak, especially the trailing arm supports which could become critical if they were to break loose. All new replacement Mercedes-Benz panels were either spot welded or plug welded in place before spraying with weld through primer. The lower firewall panel and chassis repair panel were butt welded and ground flat.

On completion of the chassis reconstruction, another careful check was made to ensure that dimensional accuracy, particularly front and rear suspension mountings, sill alignment and 'A' and 'B' posts were still correct and that the alignment of doors, bonnet and boot was retained. In addition, a trial fit of the front and rear suspension was undertaken as a final check and to ensure easy assembly later.

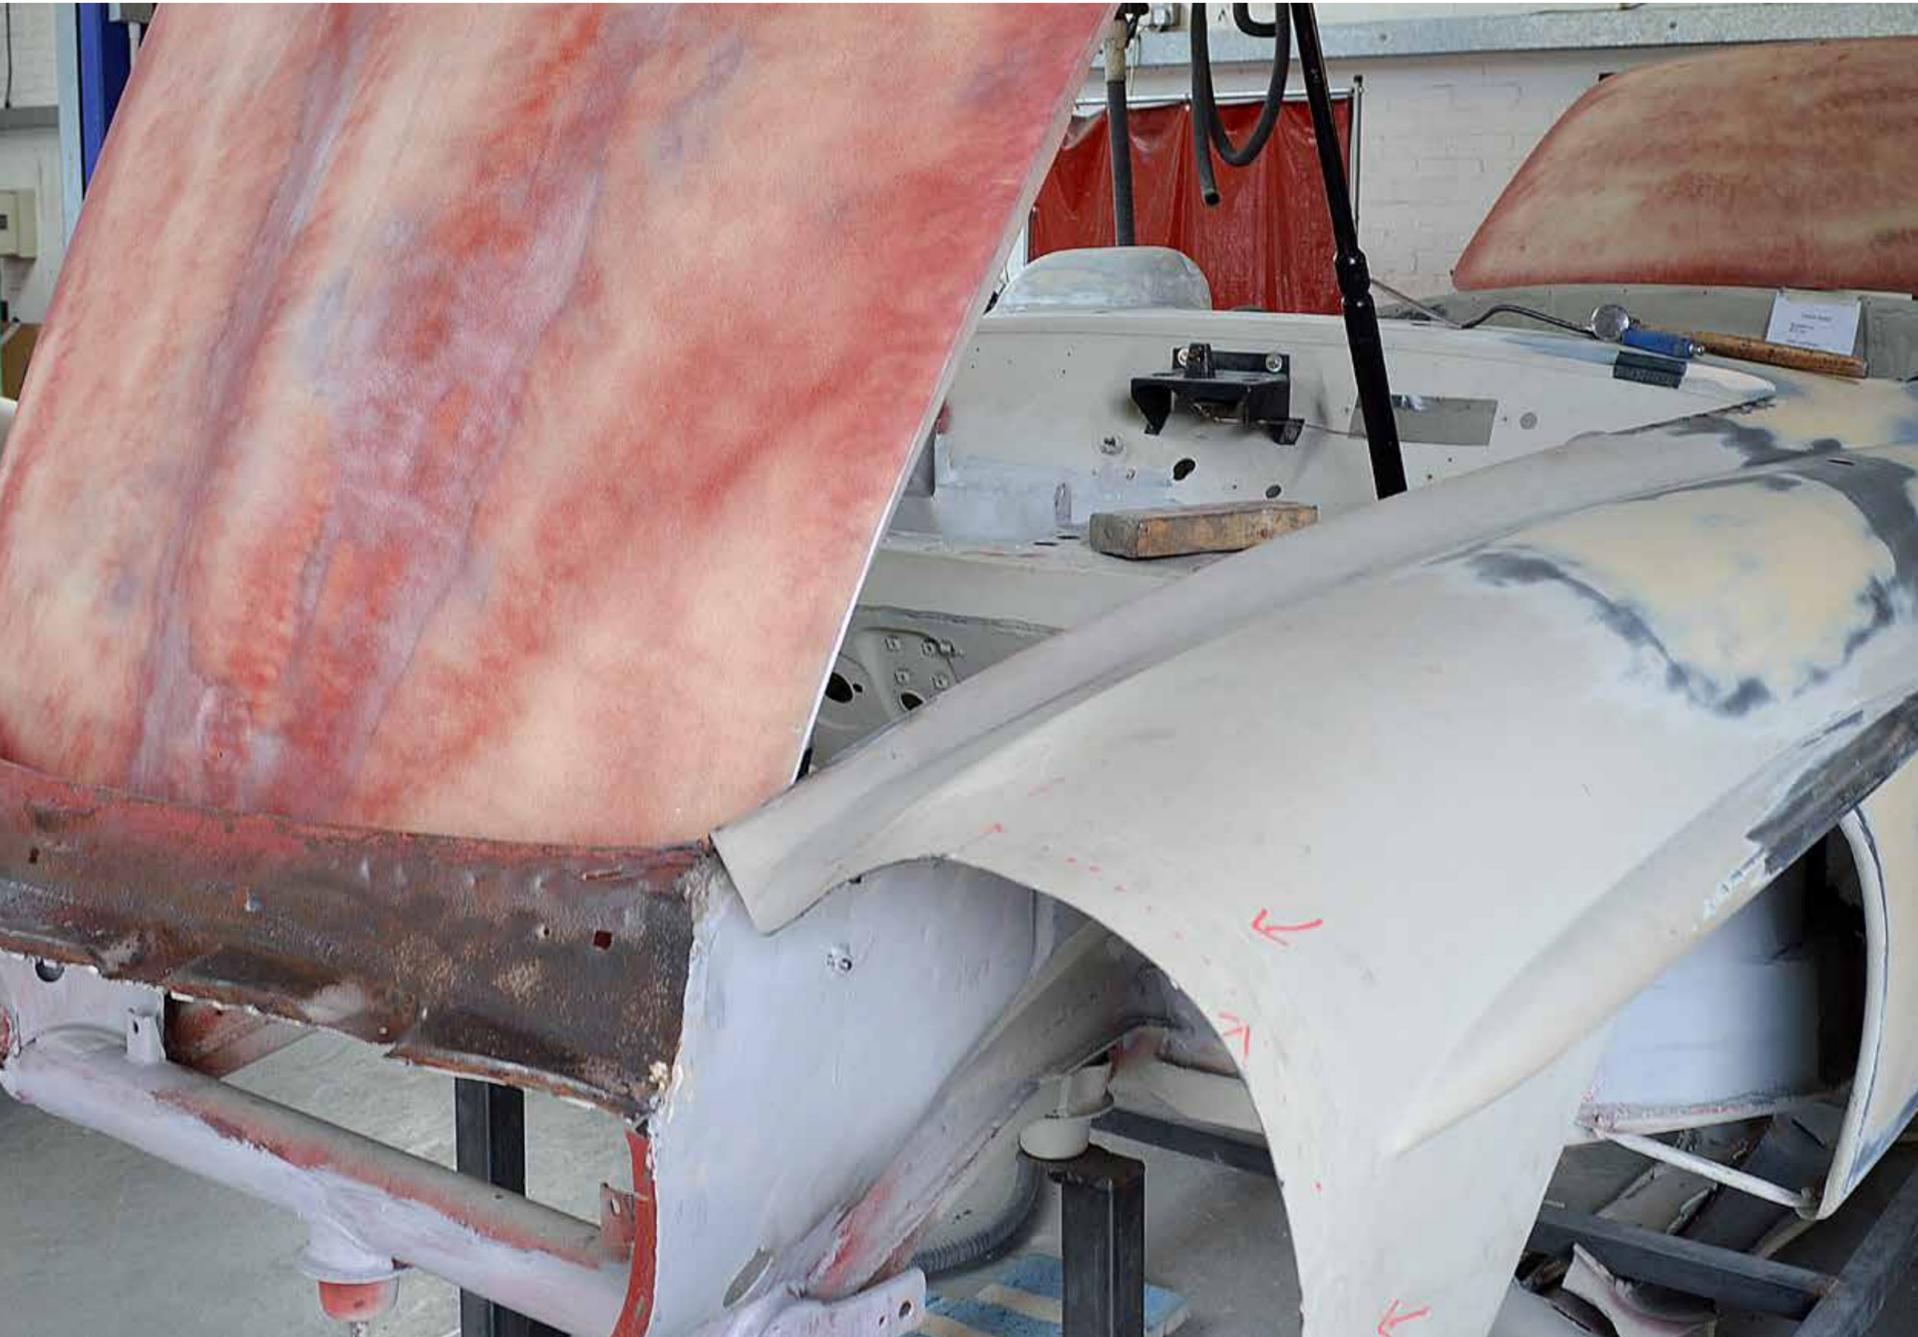
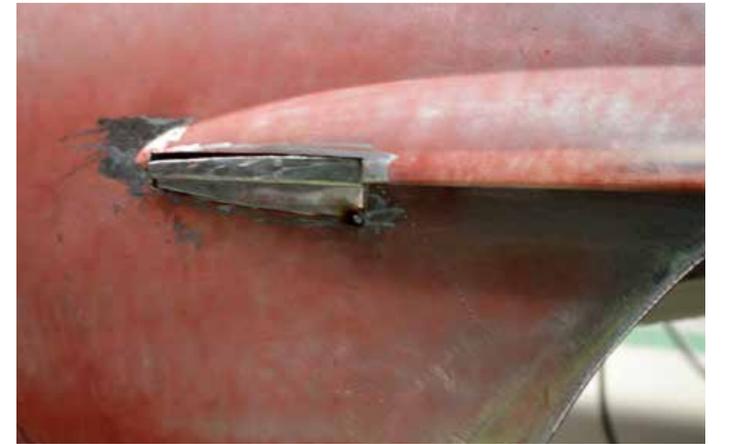
RUST PROOFING AND PROTECTION

An extensive level of reconstruction was required, and every new section had to be shaped to fit and carefully welded into place. All box sections were carefully epoxy primed and zinc coated with weld through primer on the welding contact sections prior to assembly.

Once the reconstruction was completed, the finished chassis was again grit blasted, acid washed and then epoxy primed after which it received two sprayed coats of smooth anti-chip coating. Any joints were seam sealed with Polyurethane sealing compounds. A sealer coat of epoxy primer was followed with three coats of anthracite basecoat.

The inner boot floor, engine bay and inner floor sections were all sprayed with three coats of PPG Semi-Gloss black DB167 or RAL7167 (DB164 or DB167 Tiefdunkelgrau Matt). All internal sections were injected, providing a significantly enhanced level of corrosion protection and retained originality.

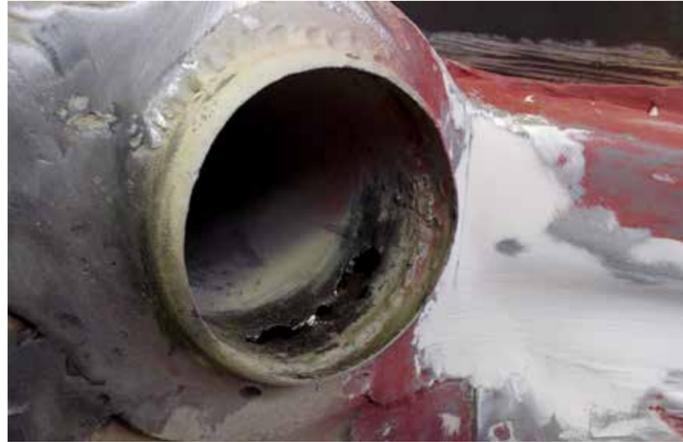
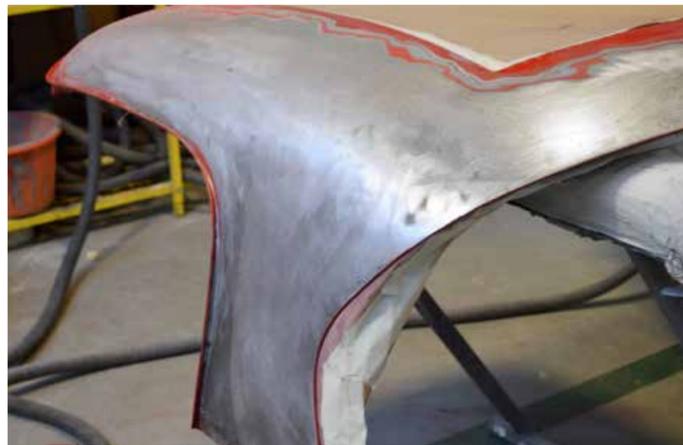
CORROSION REMOVAL

Steel panels were stripped to bare metal by hand and finished off using a mini air hand sander with 3M™ 2" Roloc Bristle discs. No grit blasting was necessary as there was only surface rust that could be taken care of by hand and chemical de-rusting. Once any hammer work, and or lead loading was done, the cleaned panels were acid washed before a sealer coat of epoxy primer was applied preventing further rust due to moisture in the air.

Concurrent to this work the aluminium removable dash panel and glove box lid were chemically stripped and prepared with epoxy primer for later painting. The front wing splash panels were blasted of all paint and primer to their bare aluminium state, and sealed for later painting with semi-gloss black paint.

Most outer panels were replaced with new Mercedes-Benz panels. Every spot weld, seen or unseen was done with the latest welding equipment and to the highest of original factory standards. Any additional body parts, like chrome mouldings were prefitted at this stage to ensure perfect fit and adjusted accordingly.
