MERCEDES-BENZ 190SL

A pictorial retrospective of the complete restoration

Parry Chana - LuxClassics

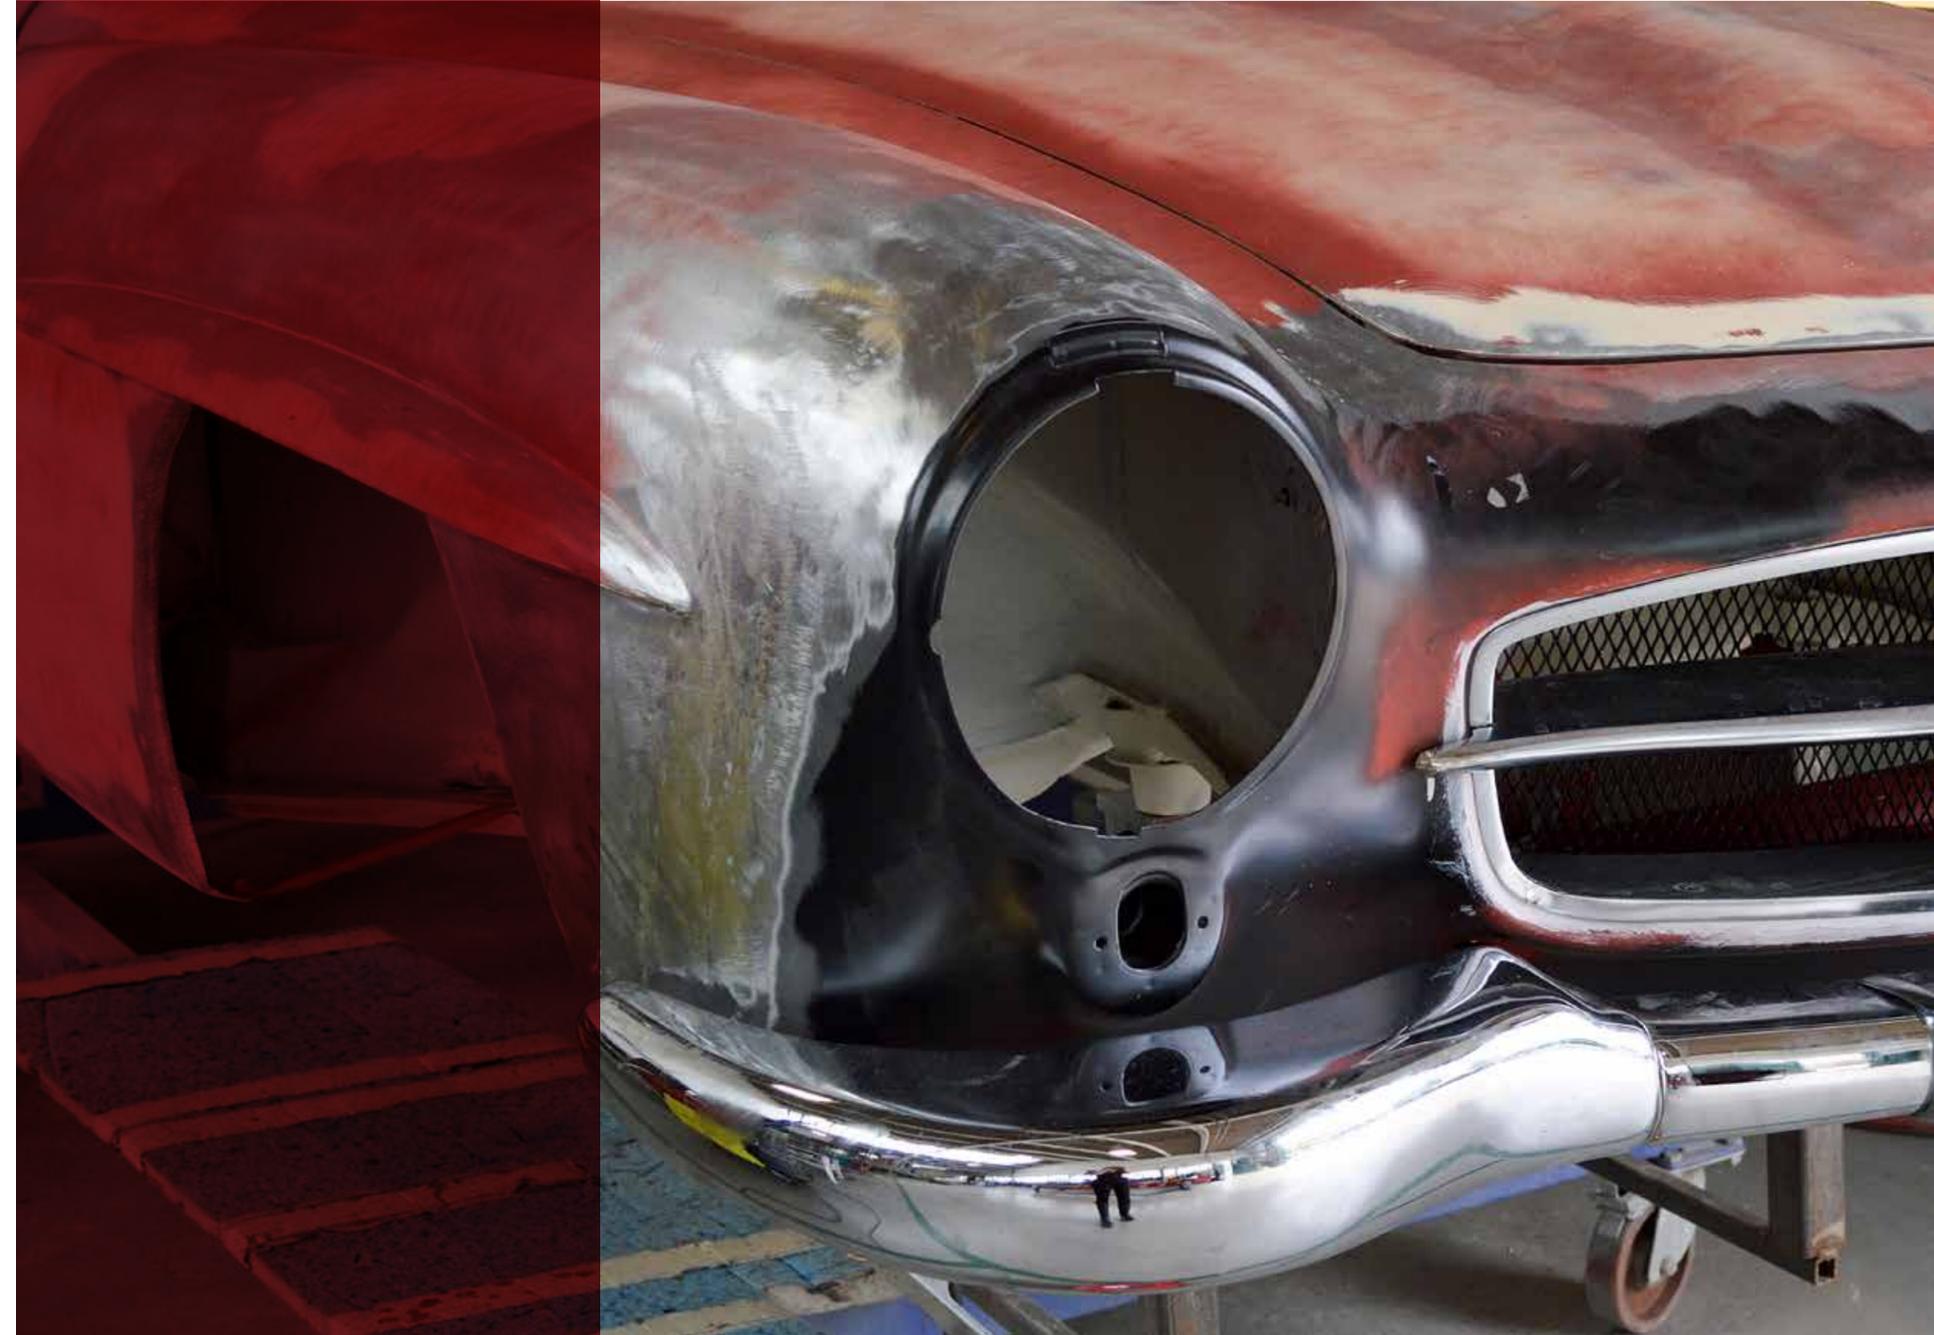
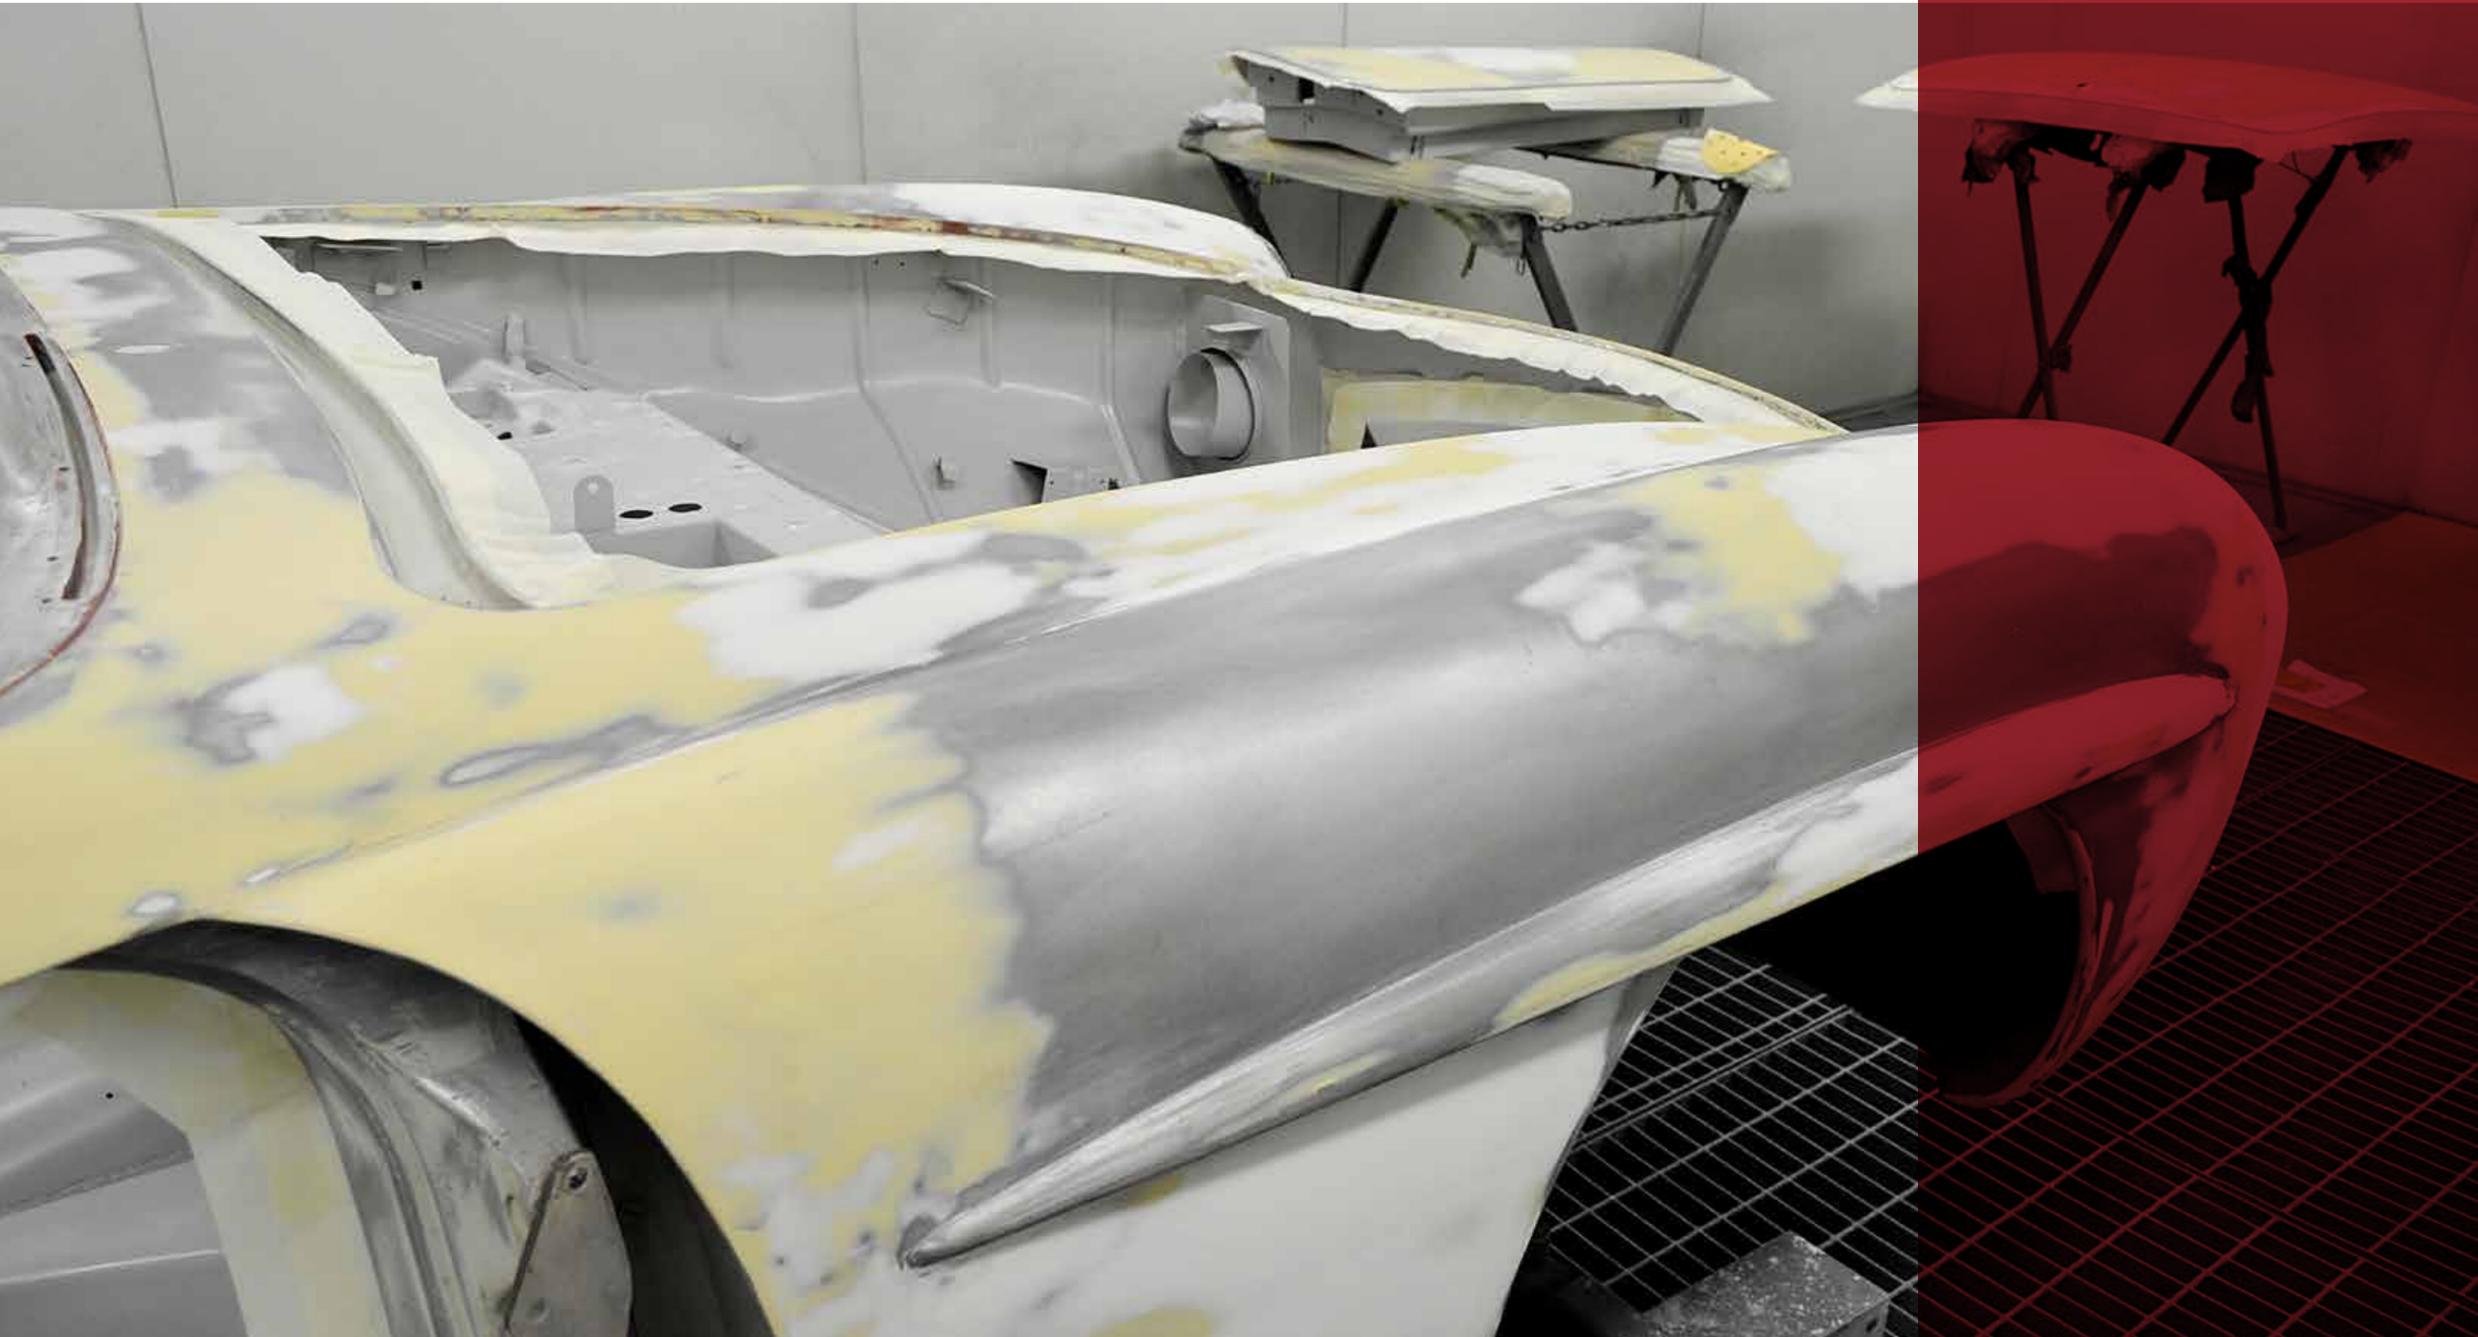
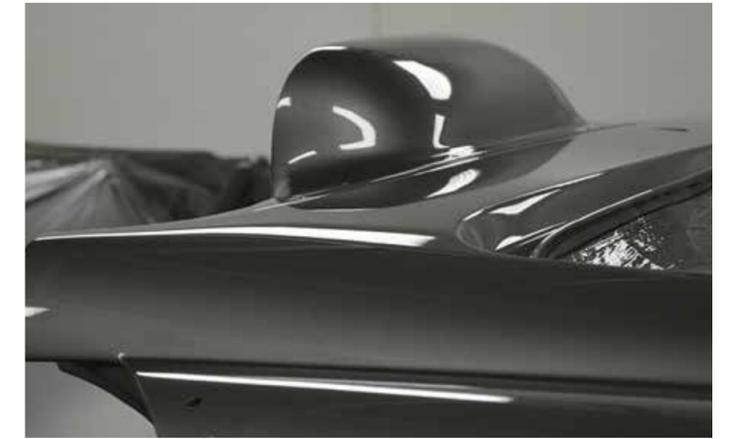
PANEL ASSEMBLY

With panels formed smooth by hand, the doors, bonnet and boot were mounted to check correct alignment. The front wing chassis struts were bolted on to ensure that the lower trailing edge matched with the door. The windshield frame was mounted so that the hard top fit could be checked. The dash panel was additionally checked for damage and assembled.

Wear in the door hinges can cause the door to be out of alignment. A shortfall in maintenance means that the hinge pivot points on the 'A' post wear as the bush is made of brass and rubs against the harder steel hinge pin as it rotates. As expected the drivers door bushes required replacement. A special tool was fabricated to remove the old bush as space is restricted to drive these out with a pin punch.

The final stage of preparing the body for painting was to carry out a final shaping and prefit of the front windscreen chrome frames, bumpers, light fittings, door handles, front grill, rear wing stone guards, wing chrome eye brow mouldings, chrome sill mouldings and headlight glass chrome emblems. During the course of this stage the objective was to ensure a perfectly smooth shape so far as it was possible without use of filler. It was also to ensure that the gapping of the doors, bonnet and boot were perfect, all of the external bright trim, light fittings, front grille fit correctly, and gaps and apertures were adjusted as required.

Another aspect of this stage was to ensure that the aluminium surface was filed into a state that would allow the best possible adhesion of the epoxy primer in the initial stage of painting. The doors, bonnet and boot lid were then removed for later painting.

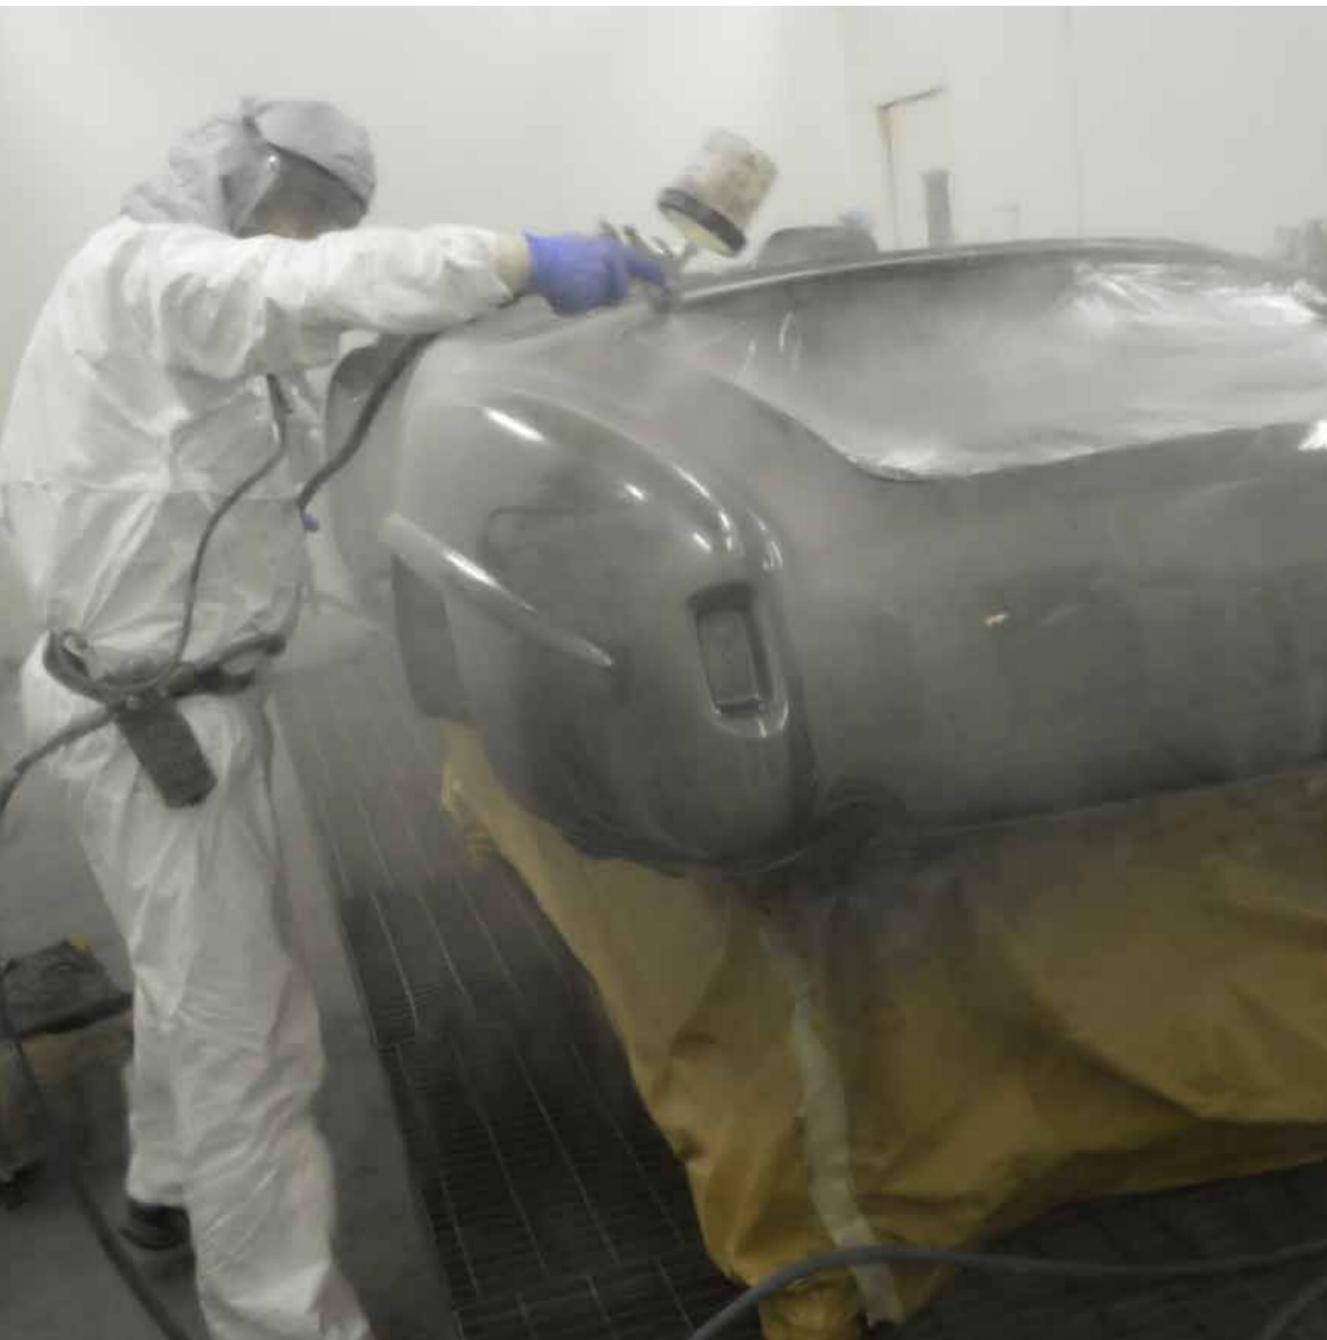
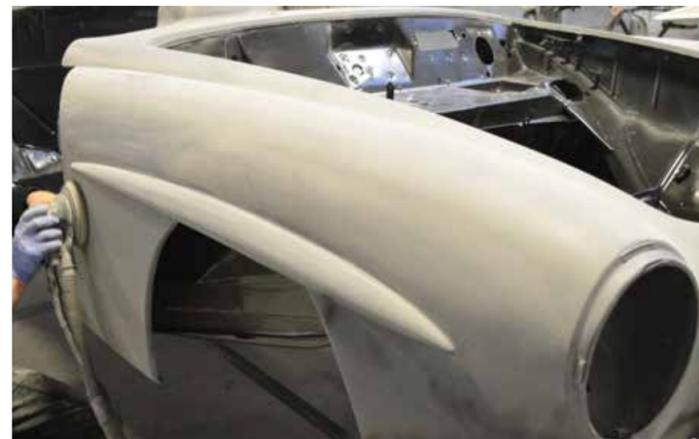
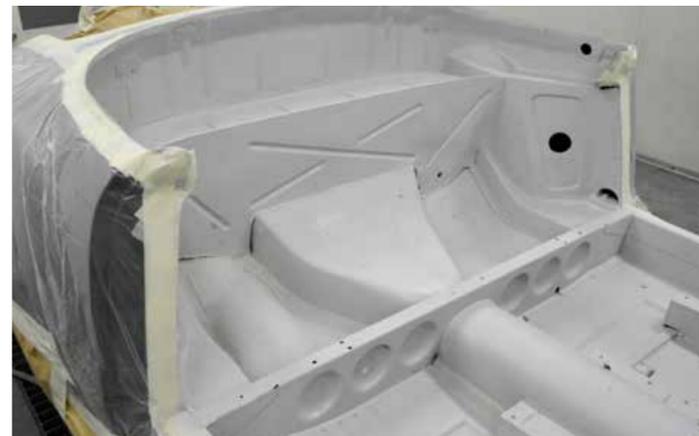
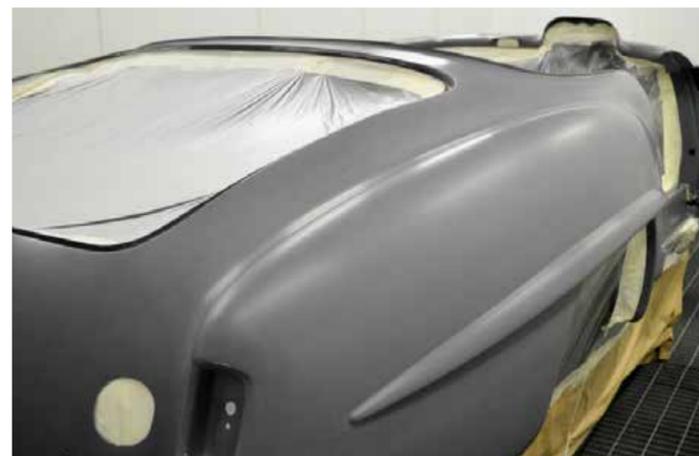
EPOXY PRIMING AND FINAL SHAPING

The first stage of painting was to epoxy prime the body shell. The objective of the epoxy primer is to provide an impermeable barrier to any moisture and to provide the best possible adhesion to the steel and aluminium surfaces and of subsequent primer coats.

This followed with the application of two coats of polyester primer filler followed by 3M™ dry guide coat with primer allowed to fully cure and harden. A long process of dry sanding followed to ensure that a perfectly smooth and flat surface was produced. A second round of sprayable polyester filler and blocking proceeded. Any final shaping of panels was then undertaken to ensure the best possible standard of finish and to ensure the barest minimum of filler was used. A small skim of filler was used where necessary to compensate for any minor deviation of the panel from the perfect shape.

The body shell was then given three coats of high build primer, followed by a light guide coat and this was allowed to fully harden. A long process of wet sanding followed to ensure a perfectly smooth and flat surface. This followed with two more rounds of high build primer and wet sanding in between each of the three coats with progressively finer sand paper. Only when an even guide coat finish was achieved and the surface perfectly smooth was the body shell sealed and passed as fit to move to the final painting stage.

The same process was used for the doors, bonnet, boot lid, and dash panel. Although the polyester spray filler was not coated on the edge and inner surfaces of these panels, but rather a wet-on-wet primer finish for smoothness. The final stage was to refit the doors and other opening panels and to make any final adjustment in the gapping, ensure that adequate clearance was provided and a perfect match of the front and rear body panels with the doors, boot lid and bonnet was achieved.

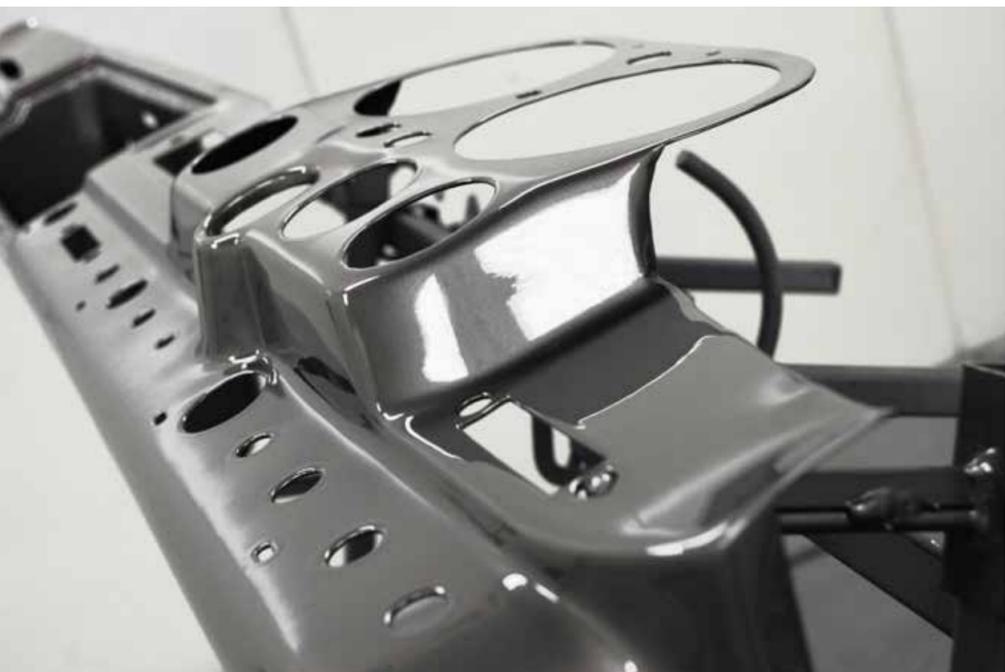
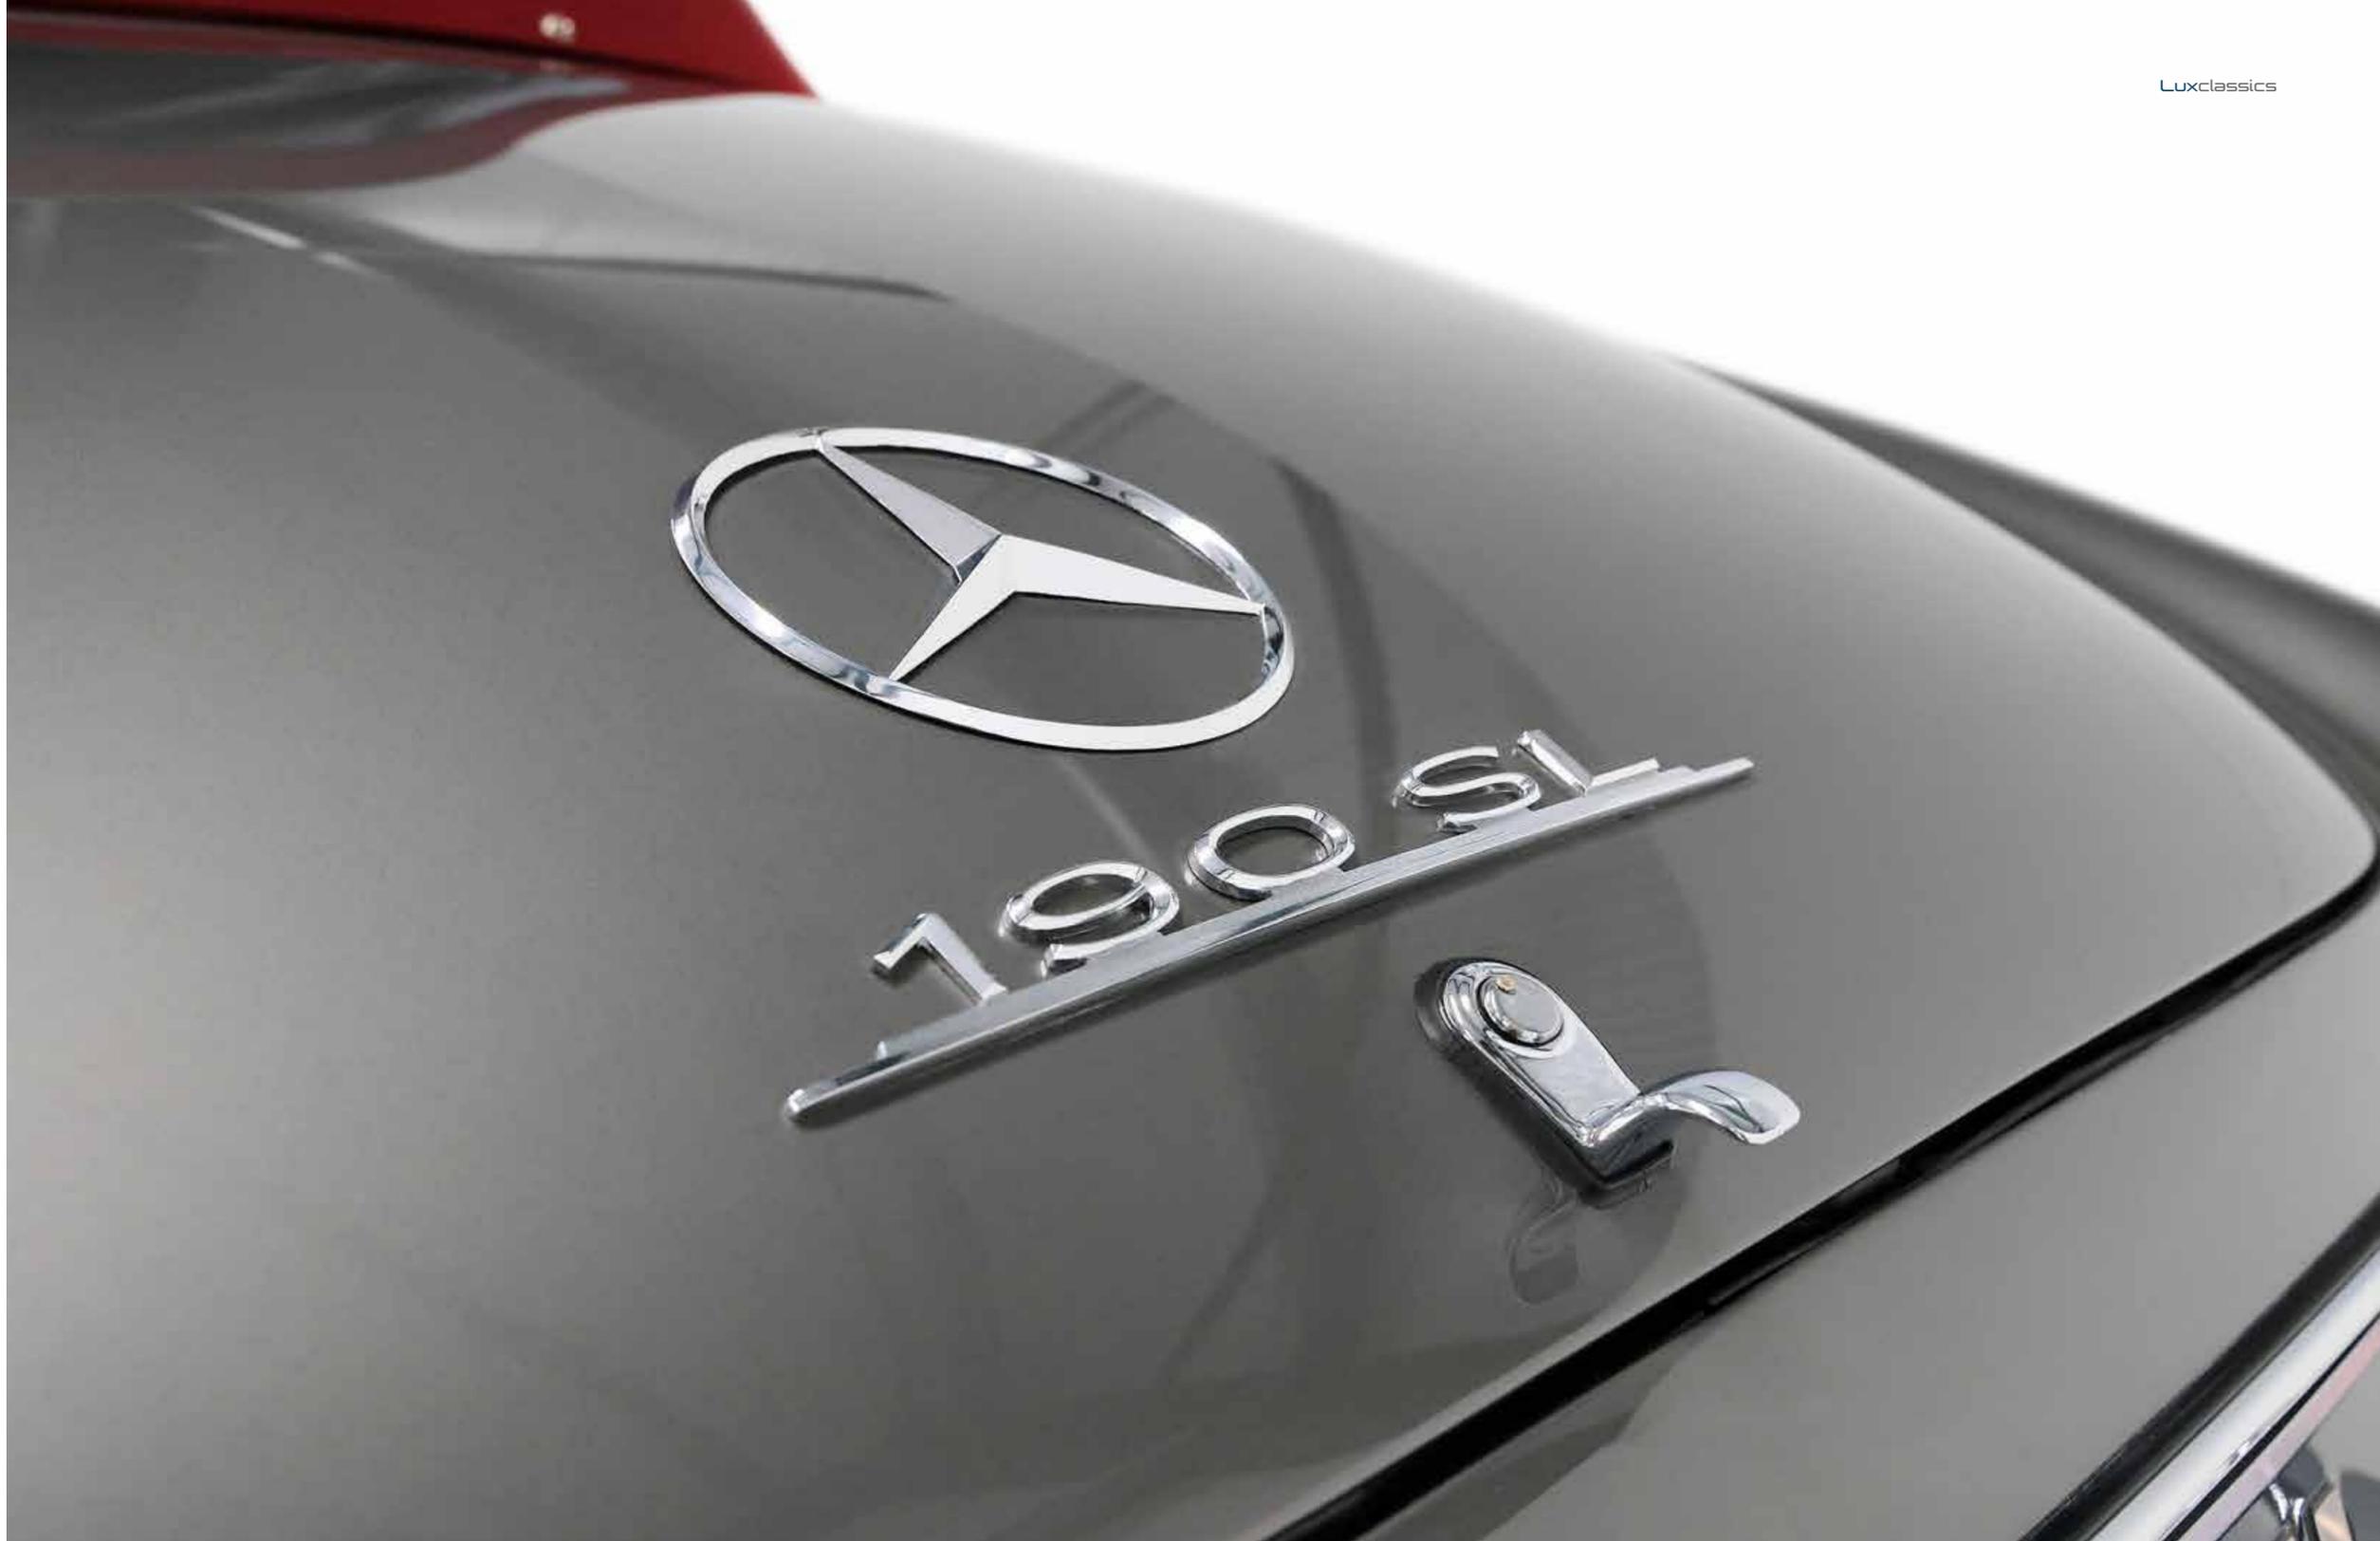
PAINTING

With the doors, bonnet and boot lid removed, the body was masked so that the weather strip channels and door jambs could be sprayed. These were given three coats of base coat and three coats of clear lacquer. The edge of the doors too were given a similar coating to avoid dry spray when mounted. The doors, boot lid, bonnet and sills were all painted at the same time in Anthracite Grey DB172 to ensure perfect continuity of colour. The paint was then allowed to harden and rubbed down with basecoat sanding pads. Three further coats of base coat, followed by three coats of clear lacquer were applied and allowed to fully harden prior to wet sanding followed by three final coats of clear lacquer.

The fully hardened lacquer coat was then lightly wet sanded using four grades of wet n dry paper to achieve a flat 'orange peel' free surface. The body had to be masked again fully to prevent the semi-gloss black from becoming marked. This process left the surface matt and the next three stages of compound and polish brought back the shine.

What we have achieved is a paint job that has depth and is flat as well. The secret is in the preparation work, priming and final shaping. This stage is where the time has been spent to create the base for the colour coats. The next and final stage was to fit and align the doors, bonnet and boot lid panels before the painted and polished shell was set aside for assembly.
