MERCEDES-BENZ 190SL

A pictorial retrospective of the complete restoration

Parry Chana - LuxClassics

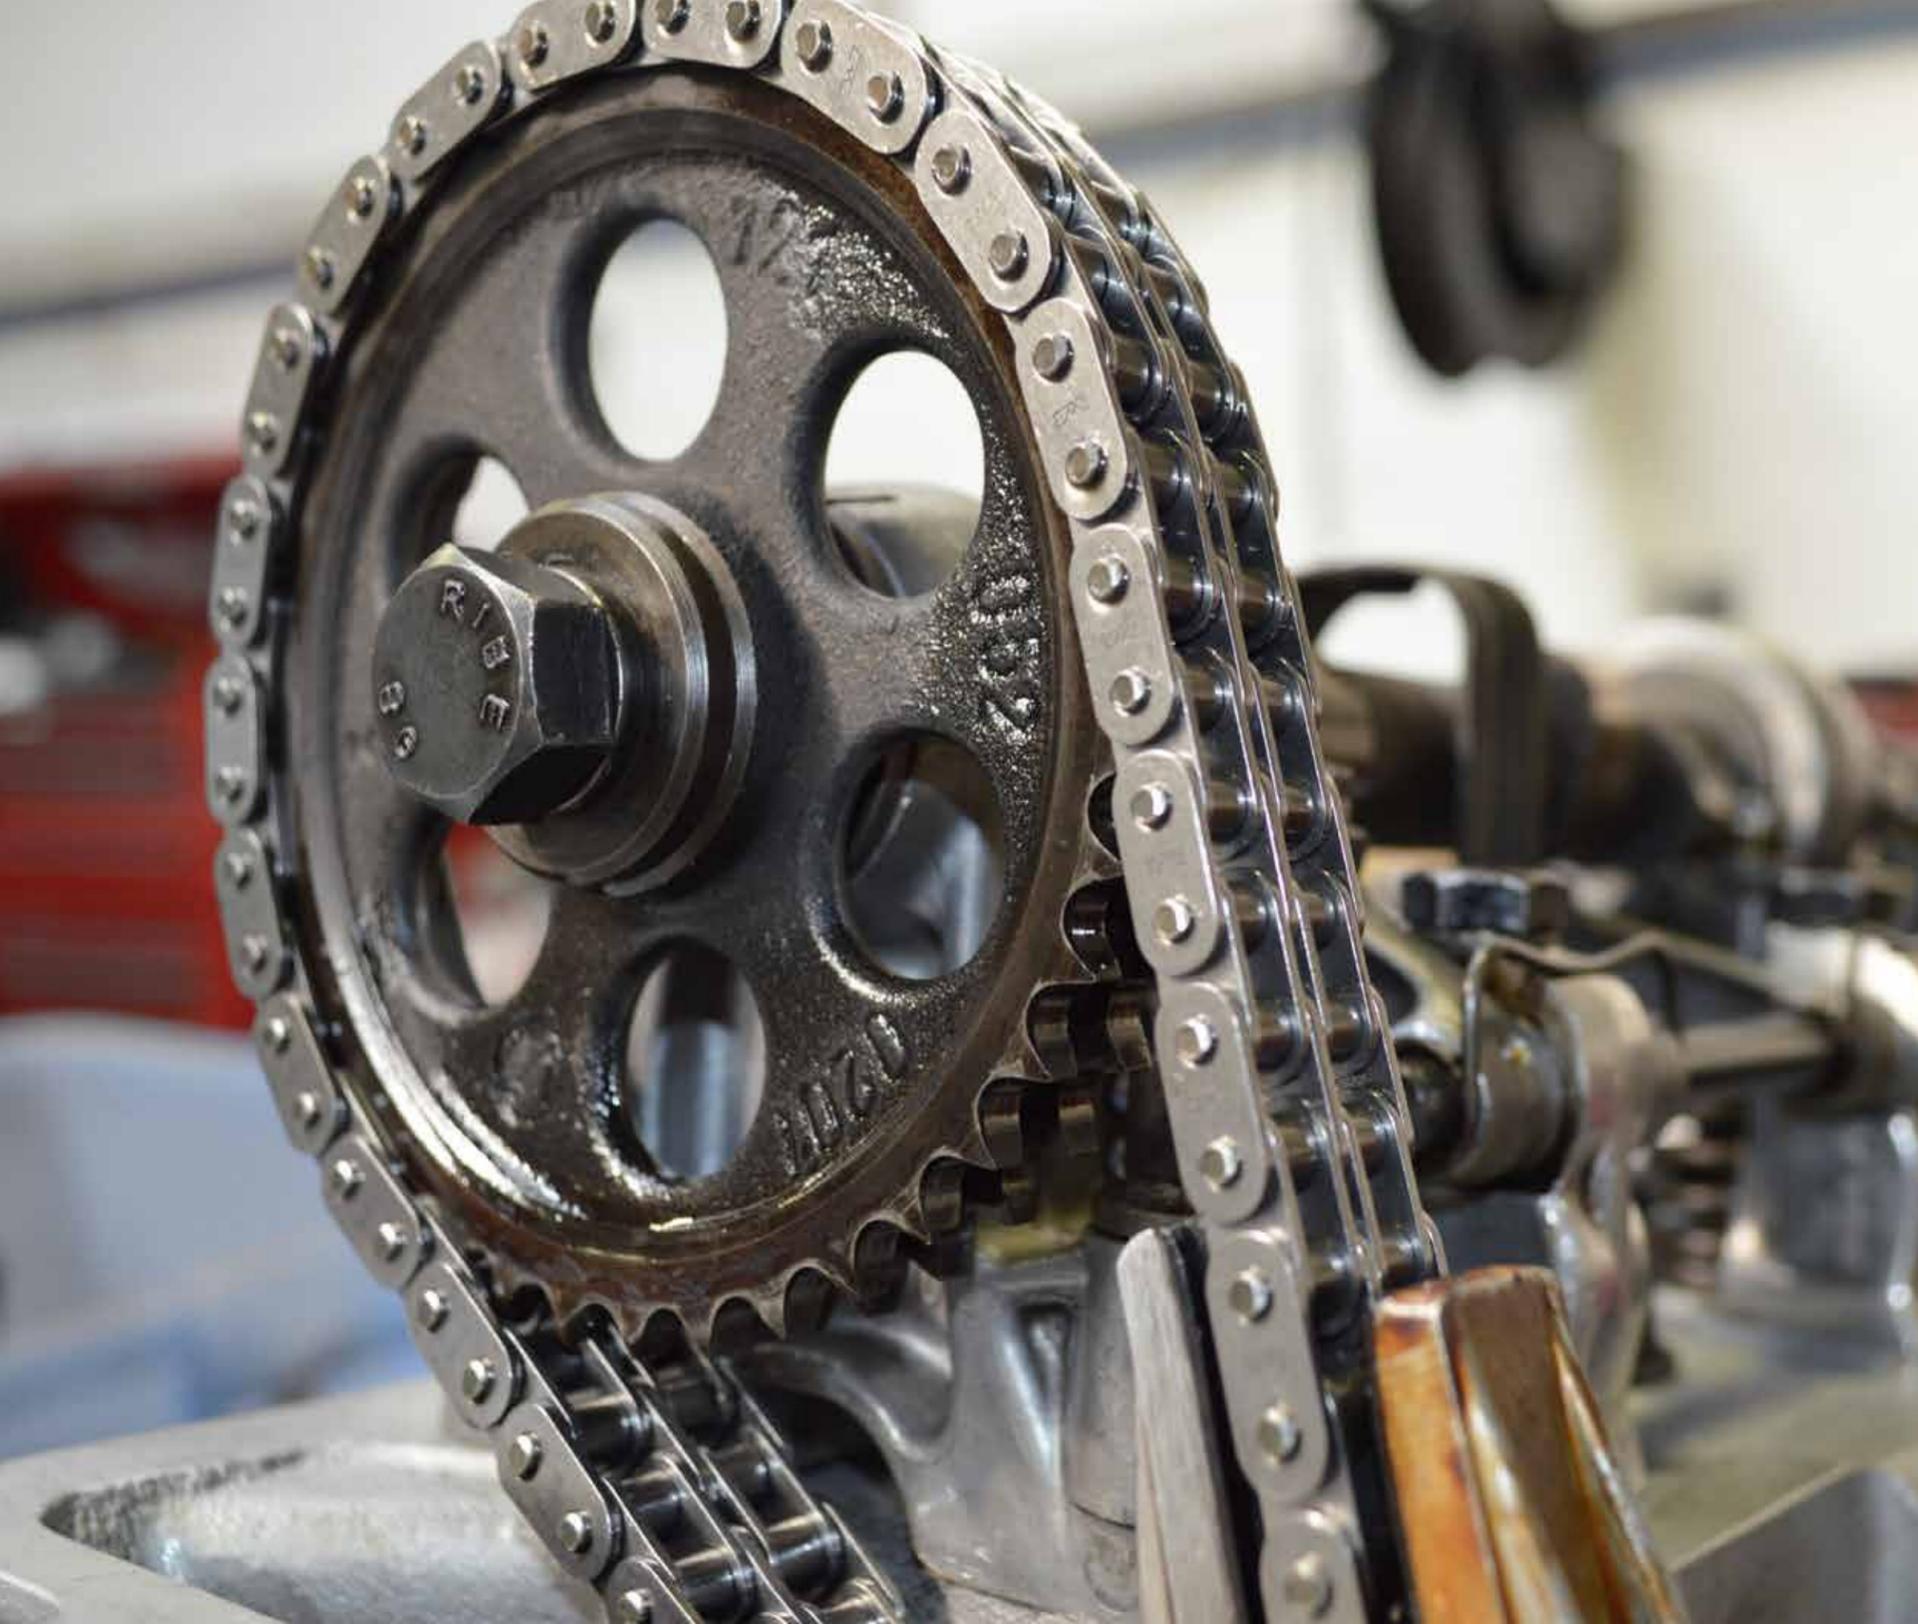
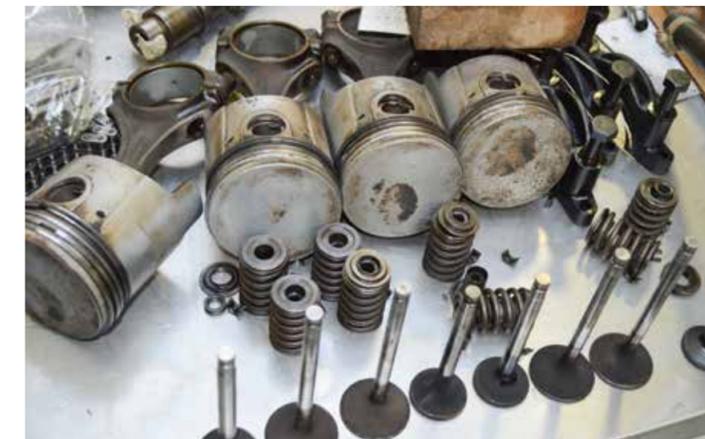
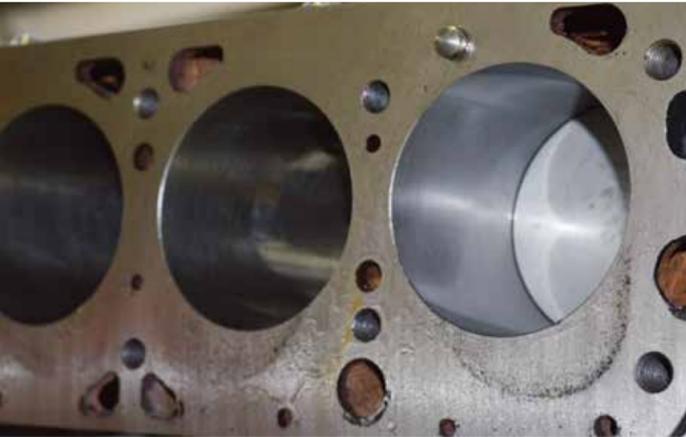
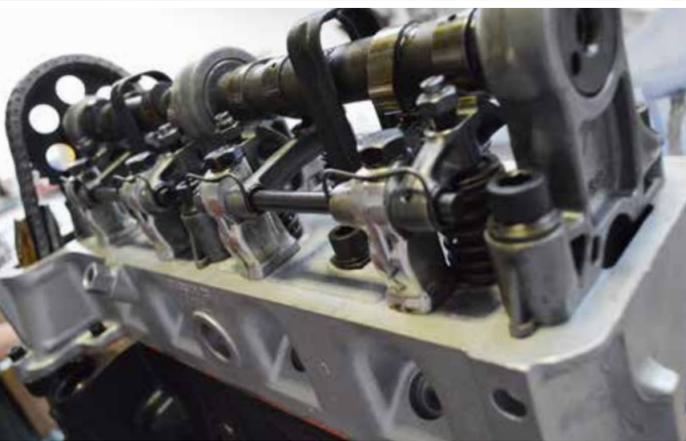
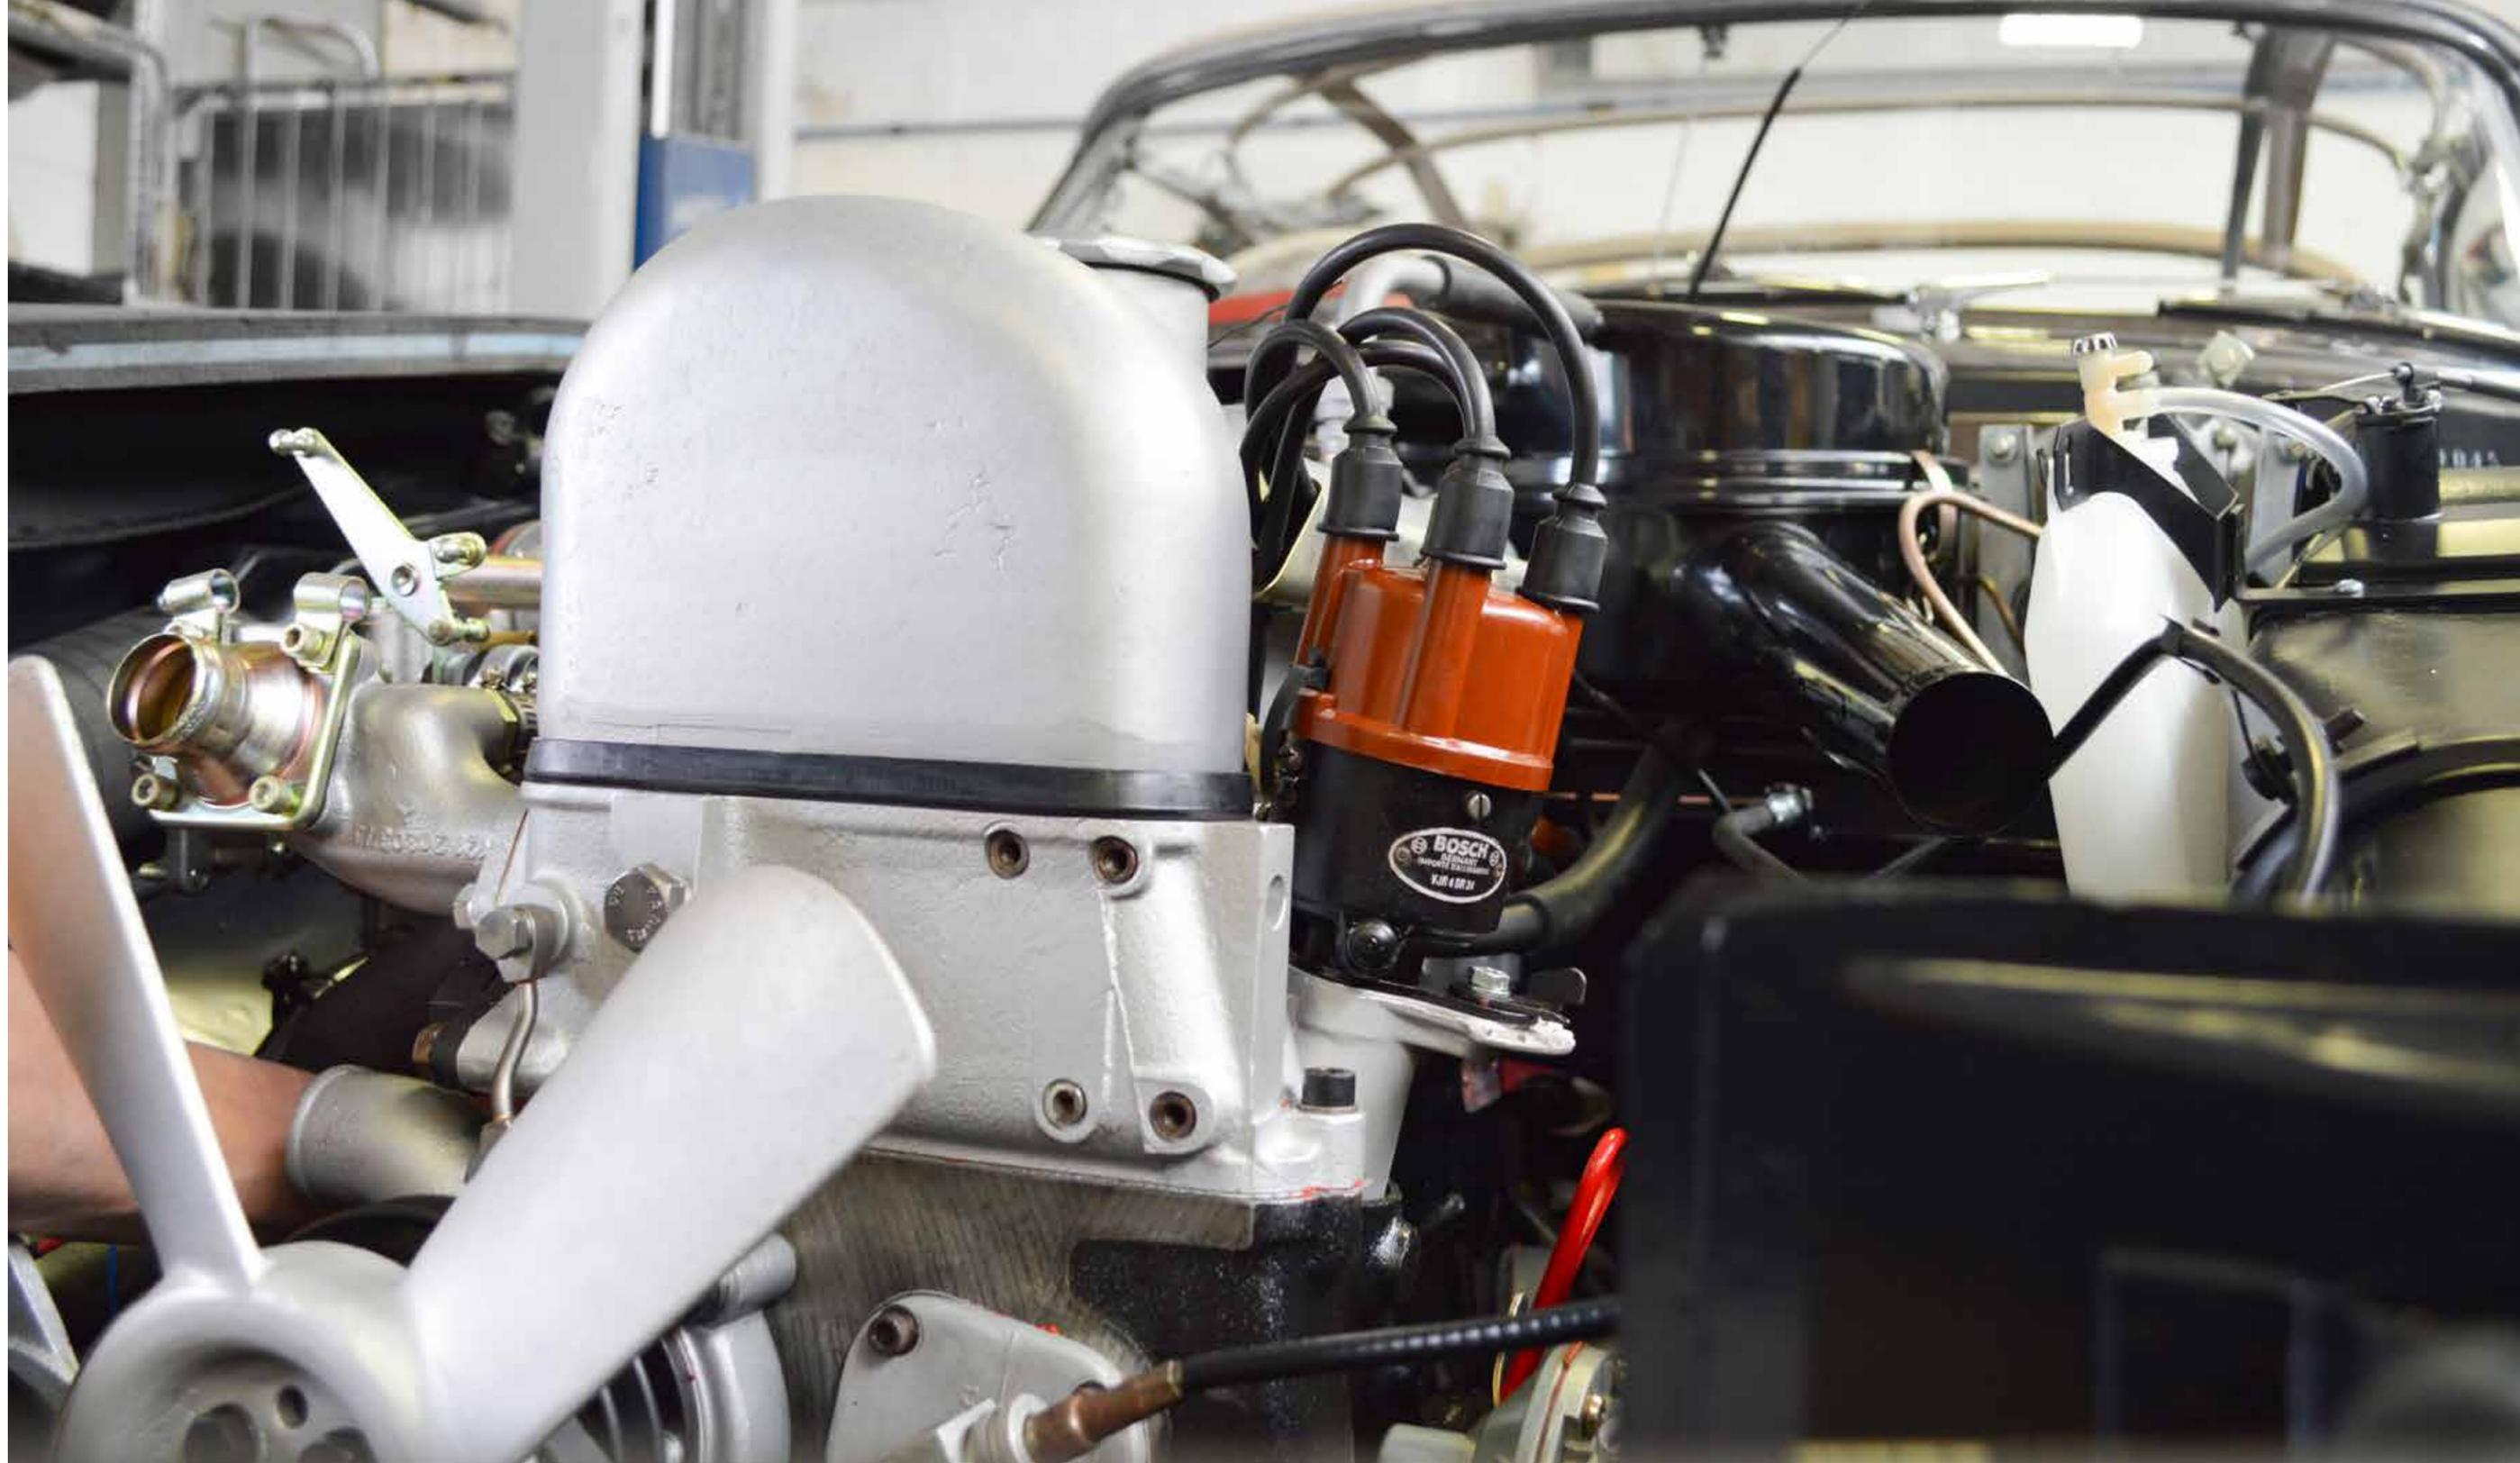
07 | ENGINE STRIP AND REBUILD

With the engine and gearbox now separated from the car, these were cleaned off and the engine was dismantled, with the first task being to remove all intake and exhaust manifolds, regulator, water pump, fan, fuel pump and distributor. This was followed by the separation of the bell housing and gearbox. The next operation was the removal of the cylinder head. The sump was then removed, followed by the removal of the timing chain and camshaft sprocket. The camshaft and camshaft followers were removed. The separation of the cylinder head followed, revealing for the first time the inner state of the cylinders and pistons.

The next stage was to remove pistons and connecting rods, followed by the crankshaft, oil pump and all of the external fittings. The freeze or core plugs in the cylinder block were removed and the block inspected and set aside for later use.

The crankshaft was carefully measured across all main bearing and connecting rod journals, and though a small amount of wear was noted, this was well within acceptable tolerances and therefore indicated that the crankshaft could be safely reground, polished and refitted with oversize bearing shells. The cylinder head was also dismantled at this stage. Waterways were flushed out and all external fittings were removed as a matter of course and set aside for later examination.

The cylinder bore dimensions were checked against the Mercedes-Benz workshop data and compared with the wear on the pistons. Having assessed the block, it was fit to reuse, with the first stage of the restoration being to thoroughly flush out and ensure all waterway scale was removed.

The machining of the cylinder head and block was entrusted to an experienced machine shop. The cylinder head and block mating surfaces were lightly skimmed to ensure tight fit of the mating surface between the head gasket and block.

As a matter of course all cylinder head valves, guides and valve seatings were removed for scrap. All waterways were then subject to a thorough alkaline wash to remove any water jacket lime scale and the casting checked for any incipient cracking, particularly across valve seatings. Once passed by the machine shop as serviceable the cylinder head facing was lightly machined to obtain a truly flat surface. New seatings were then pressed into position and machined to shape in accordance with the data in the Mercedes-Benz Technical Data Manual. Similarly, new phosphor bronze valve guides were carefully pressed into position, taking care to achieve the best possible seal. Valves were then inserted and bedded in. The cylinder head was then pressure tested to ensure no leaks were present.

Dependent on their condition, the camshaft bearing housings may be line bored, though in most cases this is not required. The camshaft was polished and within tolerances so was reused. Valve followers were then assembled and set aside for later assembly with the cylinder head. The cylinder head was then washed down and valves and valve springs etc, fitted as the final stage of preparing the cylinder head for final assembly.

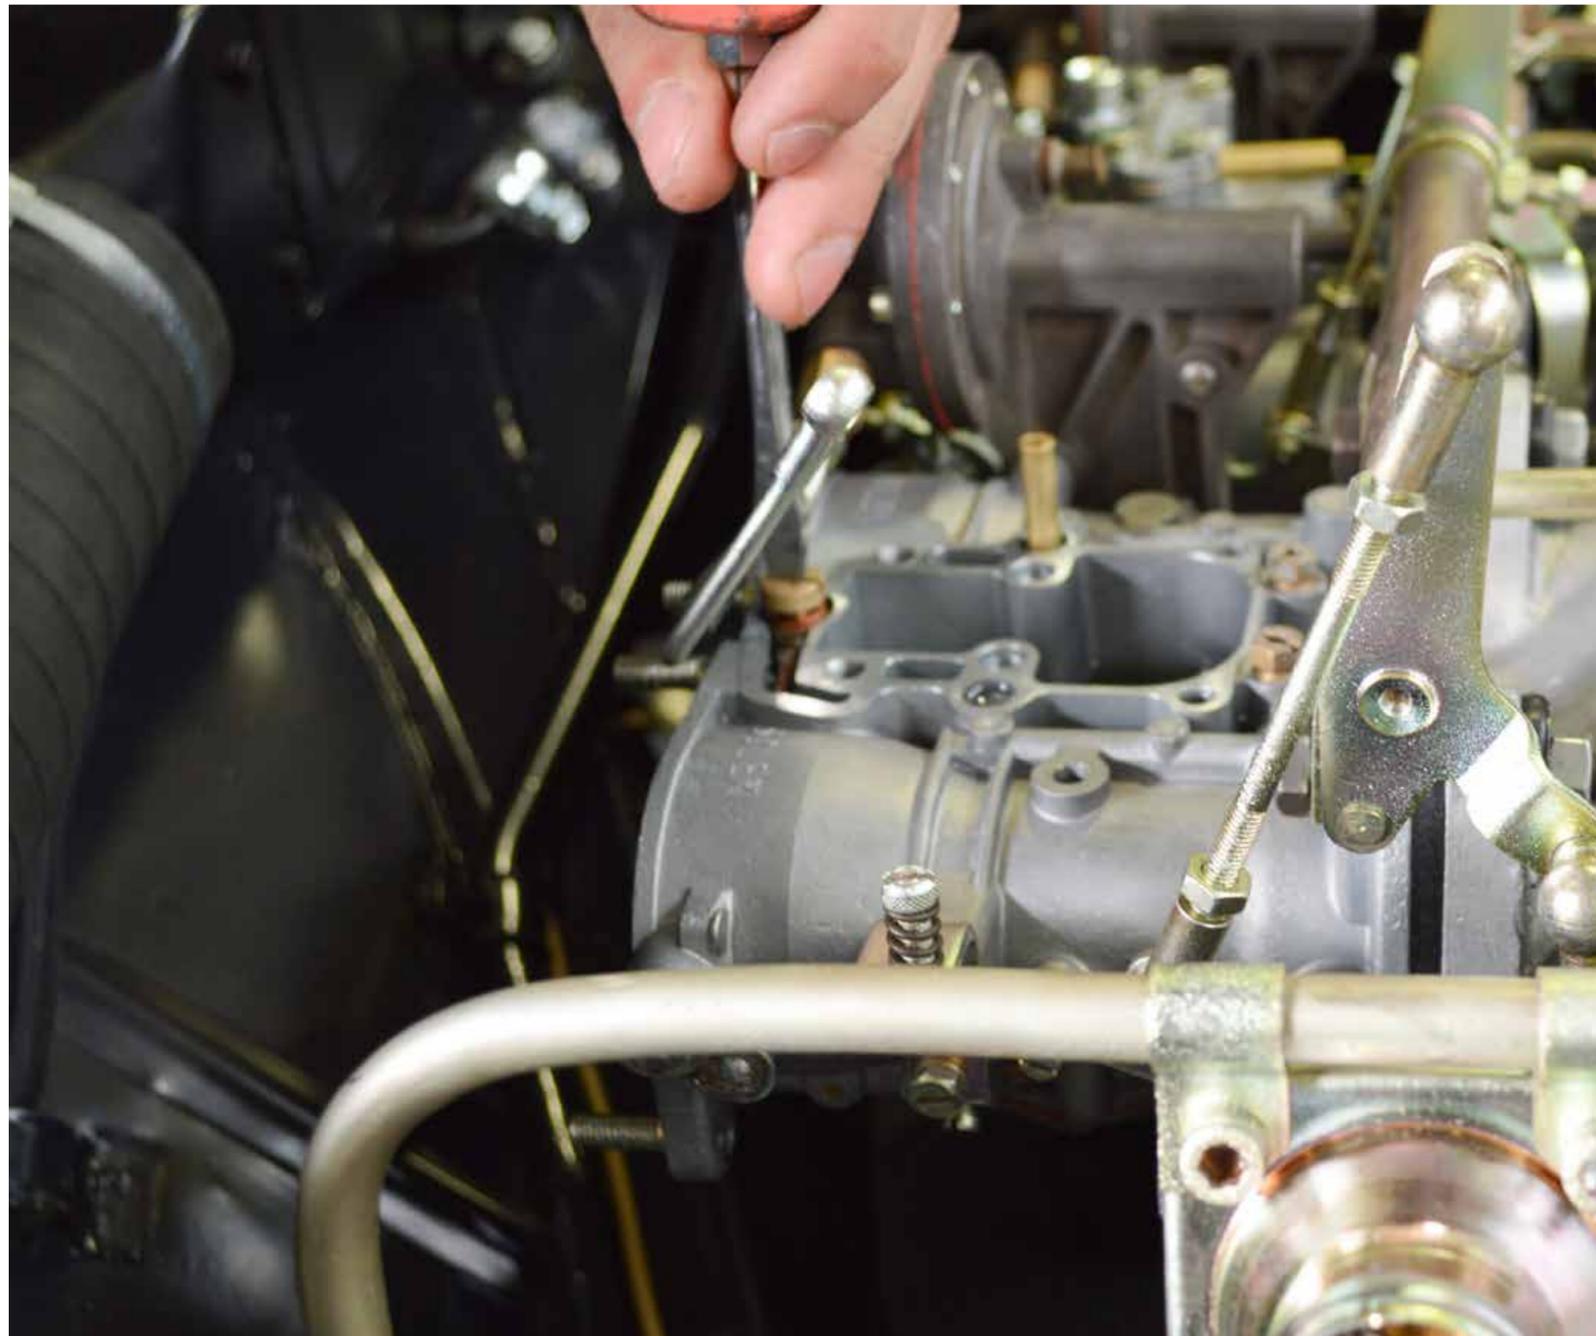
SOLEX 44 PHH CARBURETOR REBUILD

The carburetors were initially chemically cleaned to assist in removing nuts and bolts. Dismantling involved removing every nut, bolt, bracket and screw attached to the carburetor bodies and checking for wear. In parallel the linkages, fuel pipes, fuel overflow pipes, hot start mechanism and throttle linkage to the carburetors were stripped. The fuel pump and fuel filter were dismantled as part of the carburetor rebuild. All parts that had been clear-Cadmium plated at the factory were sent to platers to be cleaned, de-rusted and 'Yellow Zinc Passivate Plated' as Cadmium plating is no longer available through environmental legislation.

The stripped carburetor bodies were carefully checked for any cracks. The mating surfaces of the bodies were perfect with equal overall length of the two sets of bodies when placed on a measuring jig. The bores were checked to ensure that these were not distorted and free of the usual wear or grooves in the bores where the throttle plates close, indicating that the throttle plates could be re-used. This additionally indicated that the primary and secondary throttle shaft bores did not have excessive wear. As a matter of course the throttle shaft bores were bored out and new machined bushes were pressed in.

The carburetor bodies and all aluminium / brass parts (Idle mixture screws etc) were chemically cleaned in an 'Ultrasonic Cleaning tank'. The Vacuum Secondary Chambers are made of aluminium and the correct finish is brown anodizing and the Throttle Linkage was originally a phosphate finish.

With all parts cleaned the assembly was straight forward. New Mercedes-Benz gaskets, seals, fibre washers and diaphragms were used throughout. All linkages received new ball-ends and ball-caps. The throttle shaft carrier bushes were replaced and the new bushes reamed to the shafts.

The carburetor settings were checked against those suggested in the 190SL Supplement Workshop Manual and set up on the bench and flow tested with vacuum and an airflow Synchrometer. The secondaries indicated that no air was passing and the primaries Idle adjustment set to 5kg/h on each carburetor. Final set up is performed with the carburetors mounted on the engine and with the engine running.

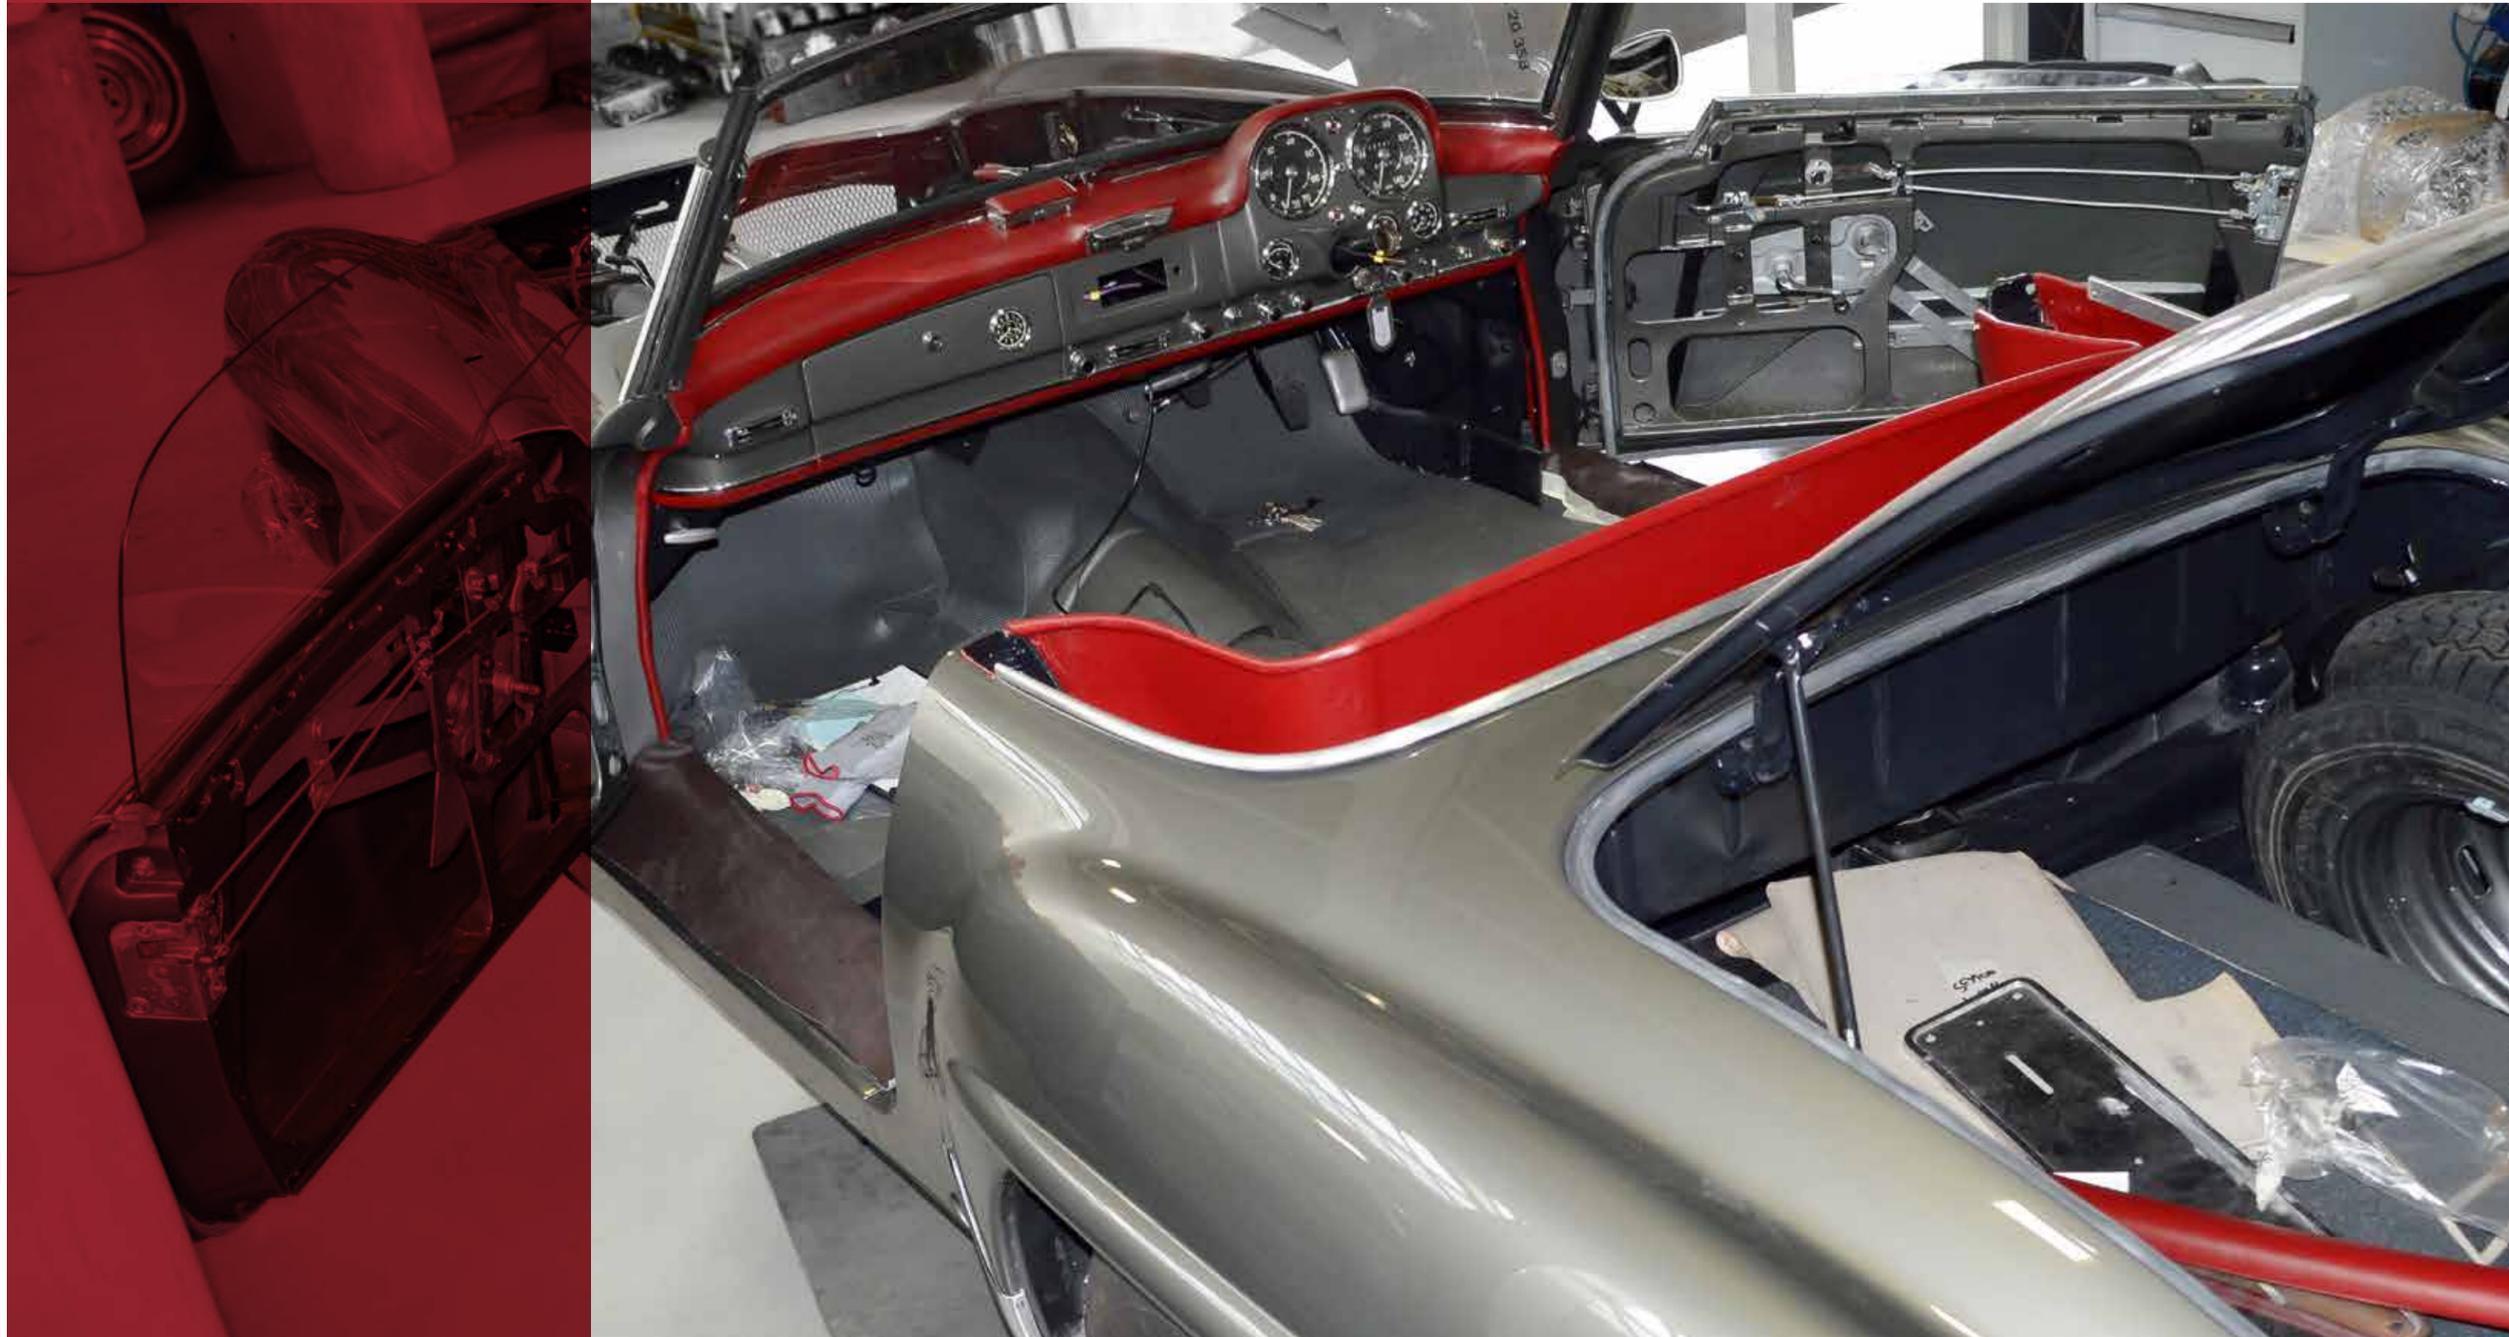
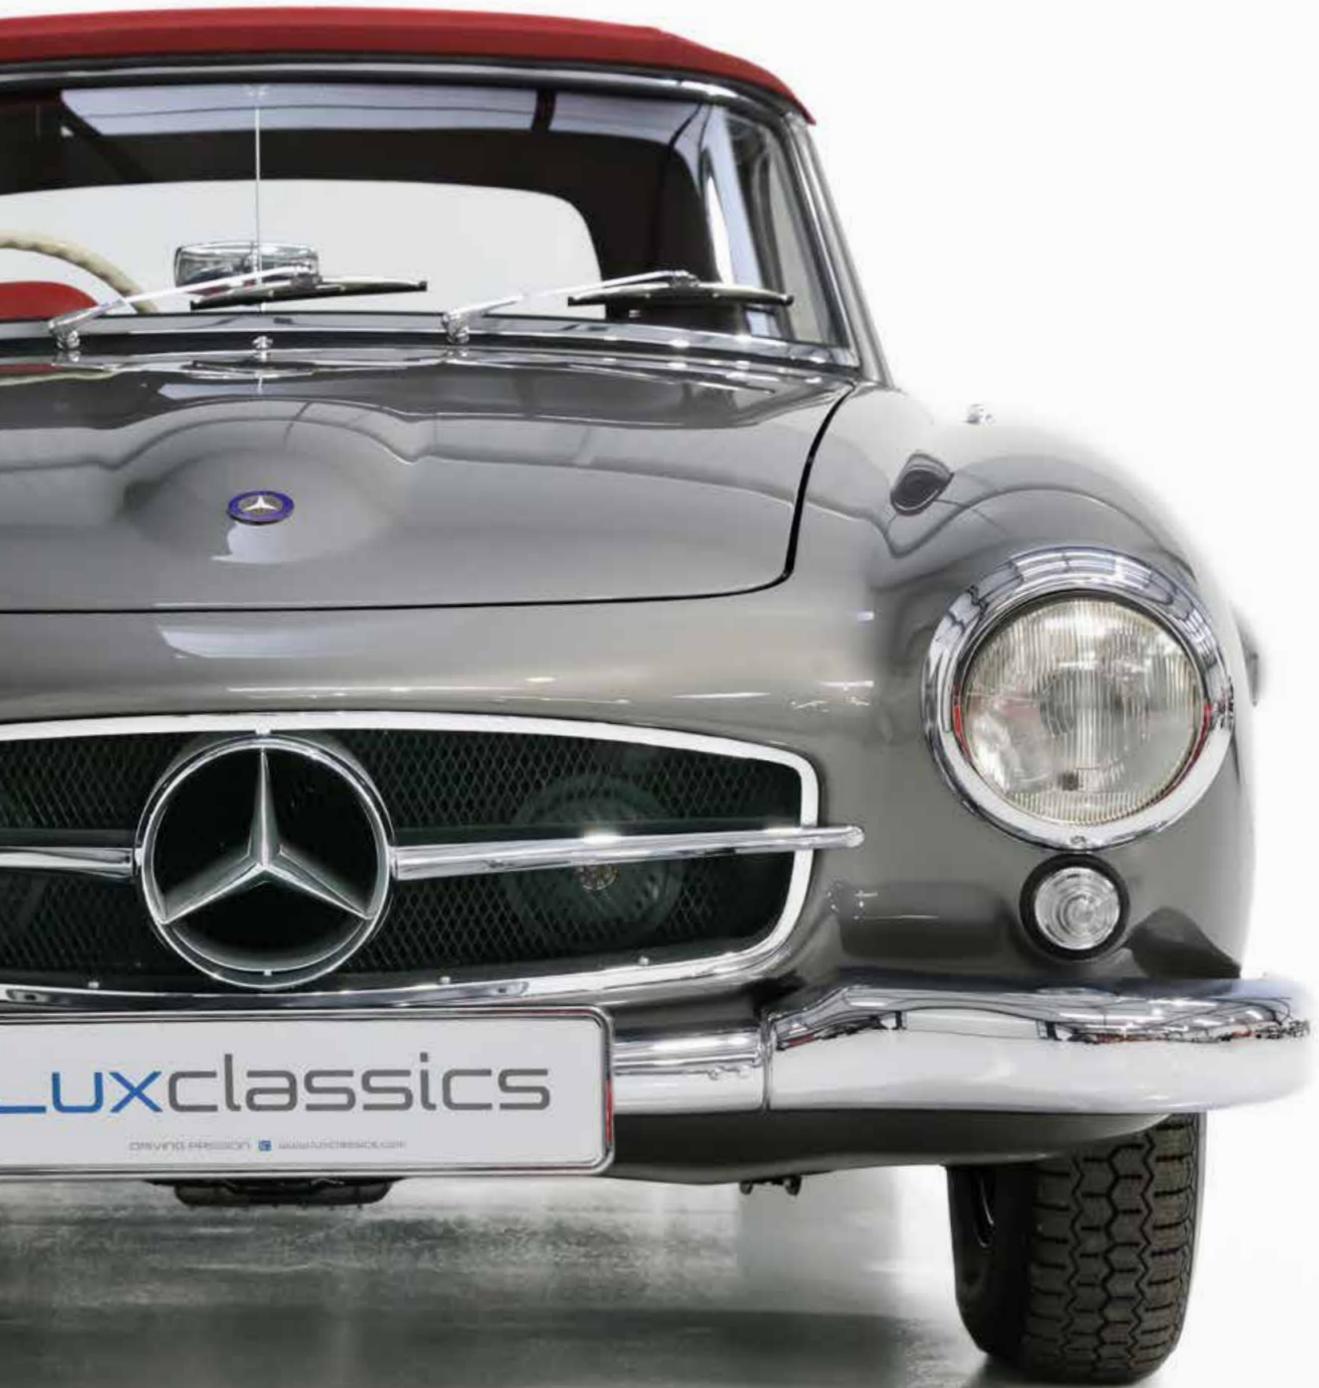
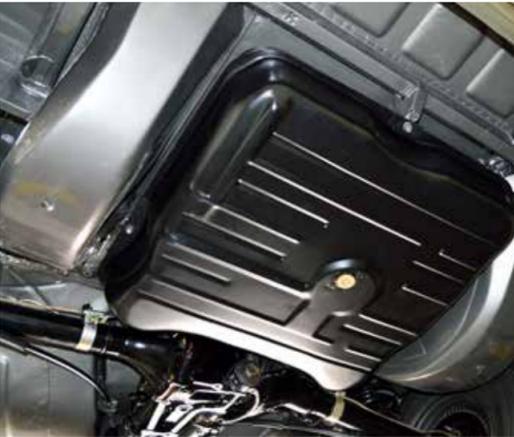
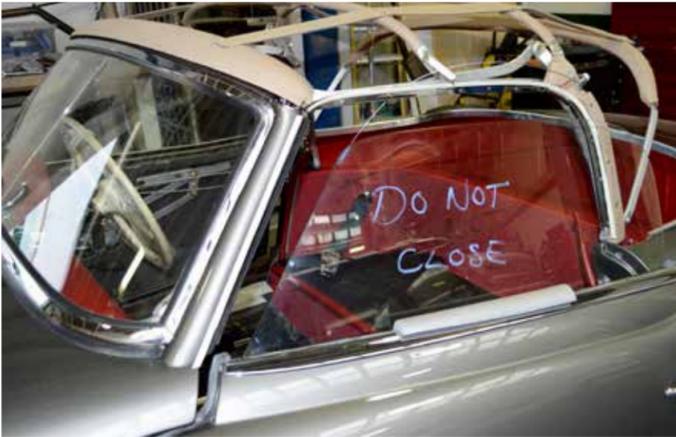
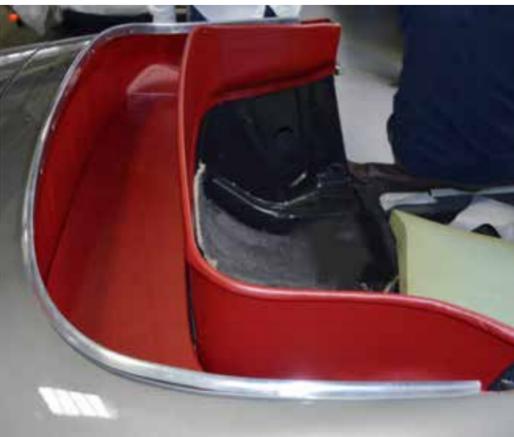
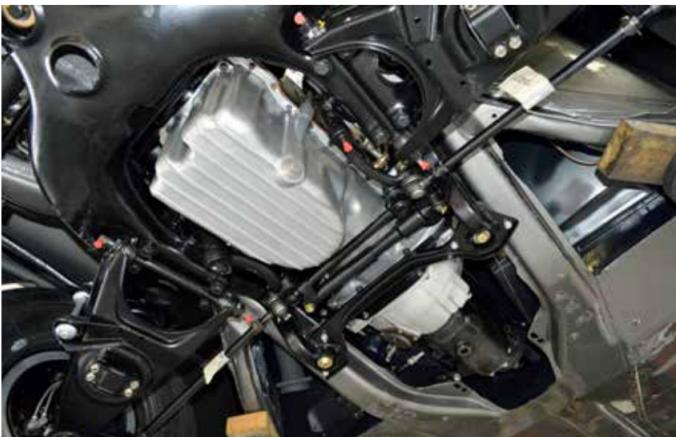
08 | FINAL ASSEMBLY

The first steps in reassembling the car was to install the brake and fuel lines (excluding the fuel tank at this stage). Next the under dash and floor sound insulation material was installed after which the wiring loom was fitted from inside the cockpit to the front of the body and to rear.

The next stage was to start assembly of all the components within the engine bay. First to go in was the fuse box and main battery wiring. Next the heater boxes and ventilation systems were installed. All components then attached to the under bonnet electrical systems. Bonnet latches, catches and rubber stops were installed. All installations were kept to ensure the highest possible standard of presentation as it would have appeared when the car left the Mercedes-Benz Zindelfingen factory in Germany when new.

At this stage the pedal assembly was completed from within and under the car. This allowed the brake master cylinder, reservoir and T50 booster assembly lines to be completed. The hand brake, arm and cable to the rear axle were feed and left in place. The Propshaft was temporarily placed within the enclosed transmission tunnel.

With the engine and gearbox mated the complete unit was wheeled under the car on the front sub-frame assembly and fixed to the frame. The rear suspension/axle was fitted with springs and shock absorbers. Next the Propshaft was connected at the rear axle and gearbox and finally secured at the centre bearing. The clutch linkage was connected and the remaining wiring to the gearbox finished together with the rubber brake hoses to the wheel cylinders and the system filled and bled. The fuel tank was fitted together with the exhaust system.

Next the starter motor and dynamo were fitted after which the inlet manifold, exhaust manifold and Solex PHH 44 carburetors were fitted. Accelerator linkages, cold and hot start cables were connected and checked for function. The steering column was installed and connected to the steering box. The final stage was to complete other under bonnet installations like the radiator and hoses.

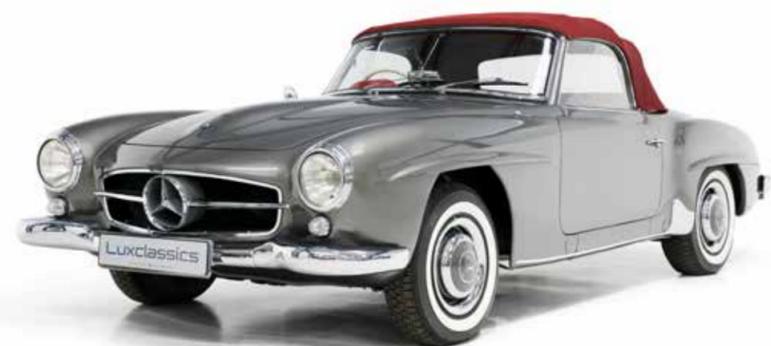
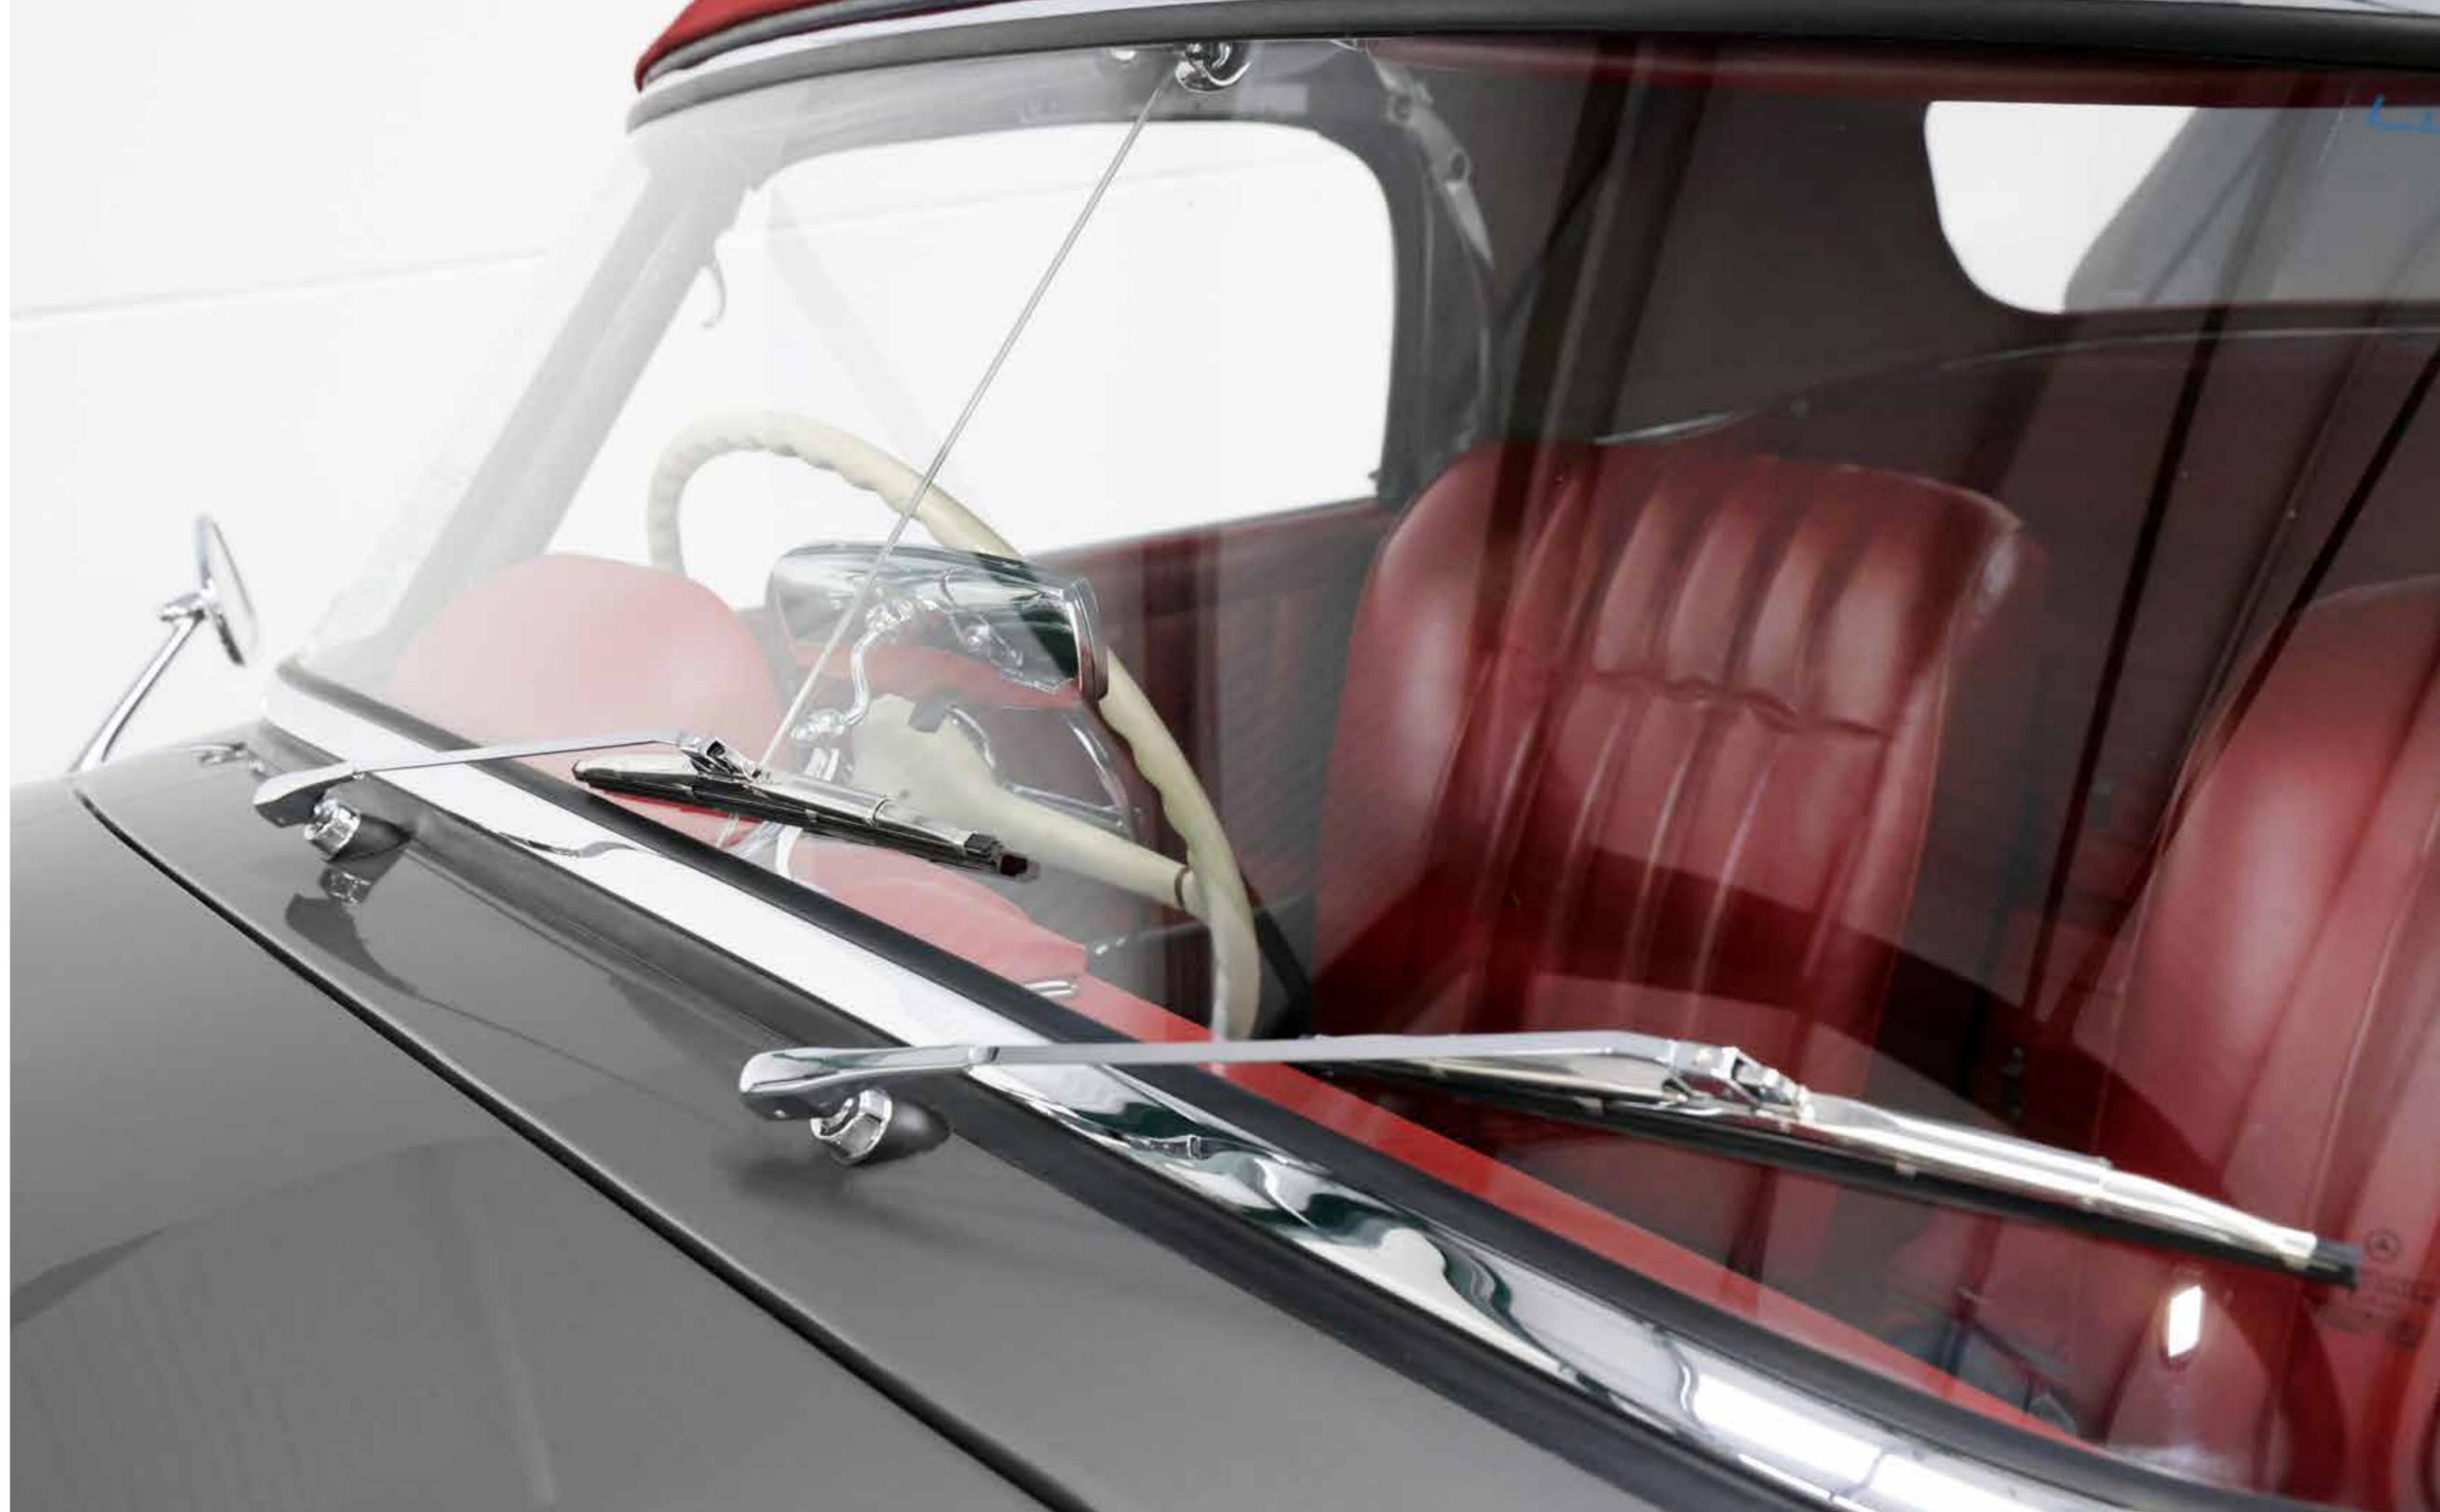
DOOR AND CHROME ASSEMBLY

The door top chrome strip was first to go on followed by the door latches and striker. The doors were built up with the window lifting and door opening mechanisms and the glass fitted. New door and boot rubbers were fitted. All chrome trim was re-plated and fitted carefully. This completed the remaining wiring on the head lights, tail lamps, indicator lights and number plate lights. Front and rear bumpers were fitted as well as a new chrome exhaust trim. The front grill, rear stone guard, sill / eye-brow mouldings and badges were fitted. Wiper motor, mechanism and linkages were rebuilt. Final assembly items like the wheels were attached and the car made ready for the interior trimming and soft top.
