MERCEDES-BENZ 190SL

A pictorial retrospective of the complete restoration

Parry Chana - LuxClassics

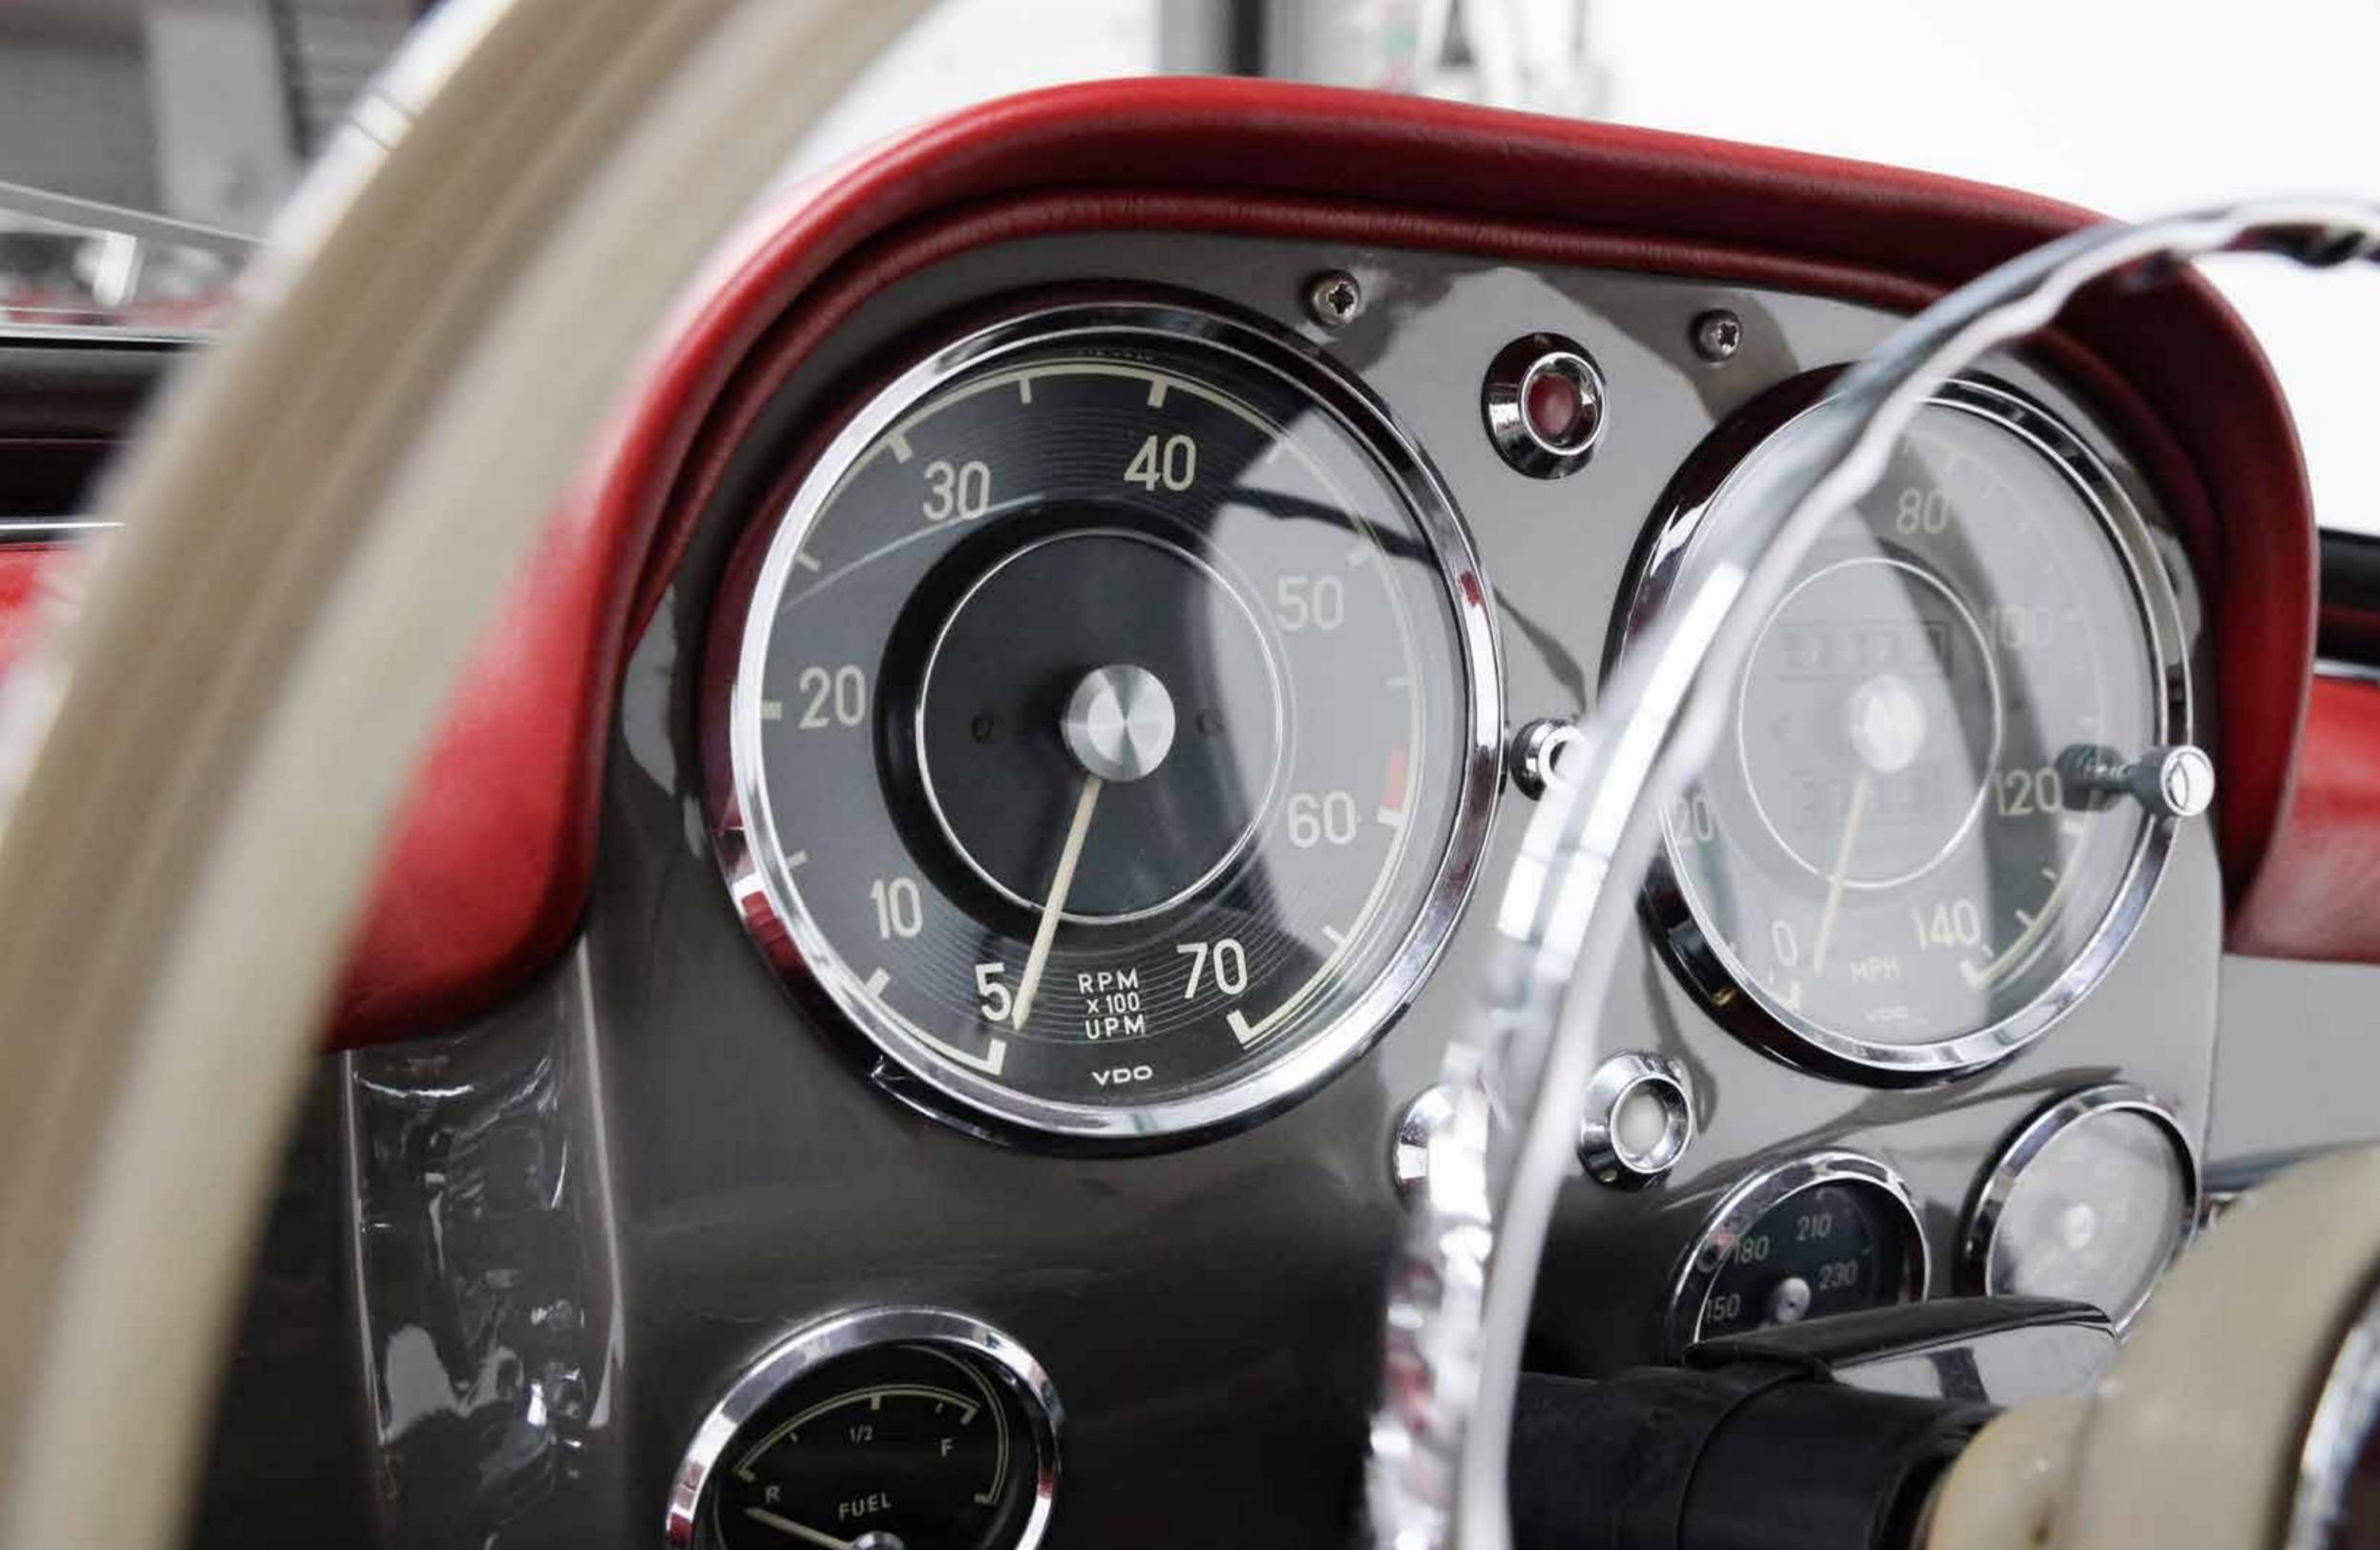
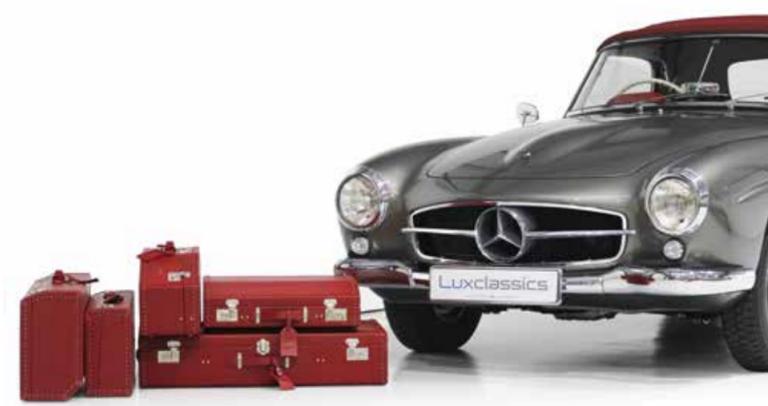
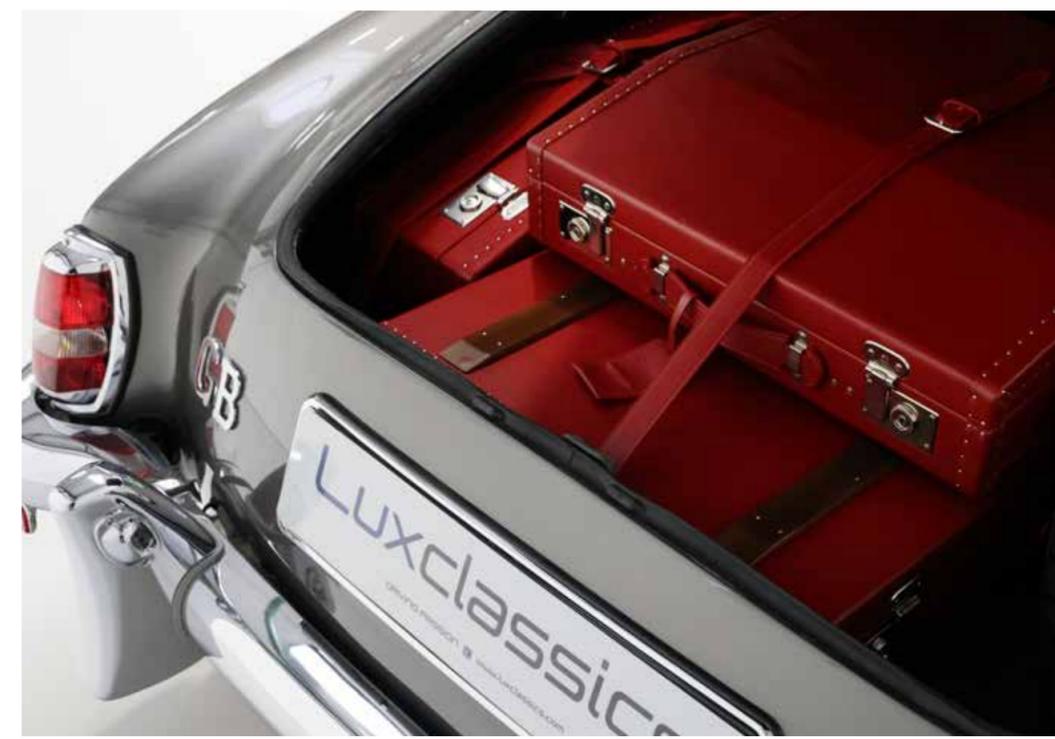
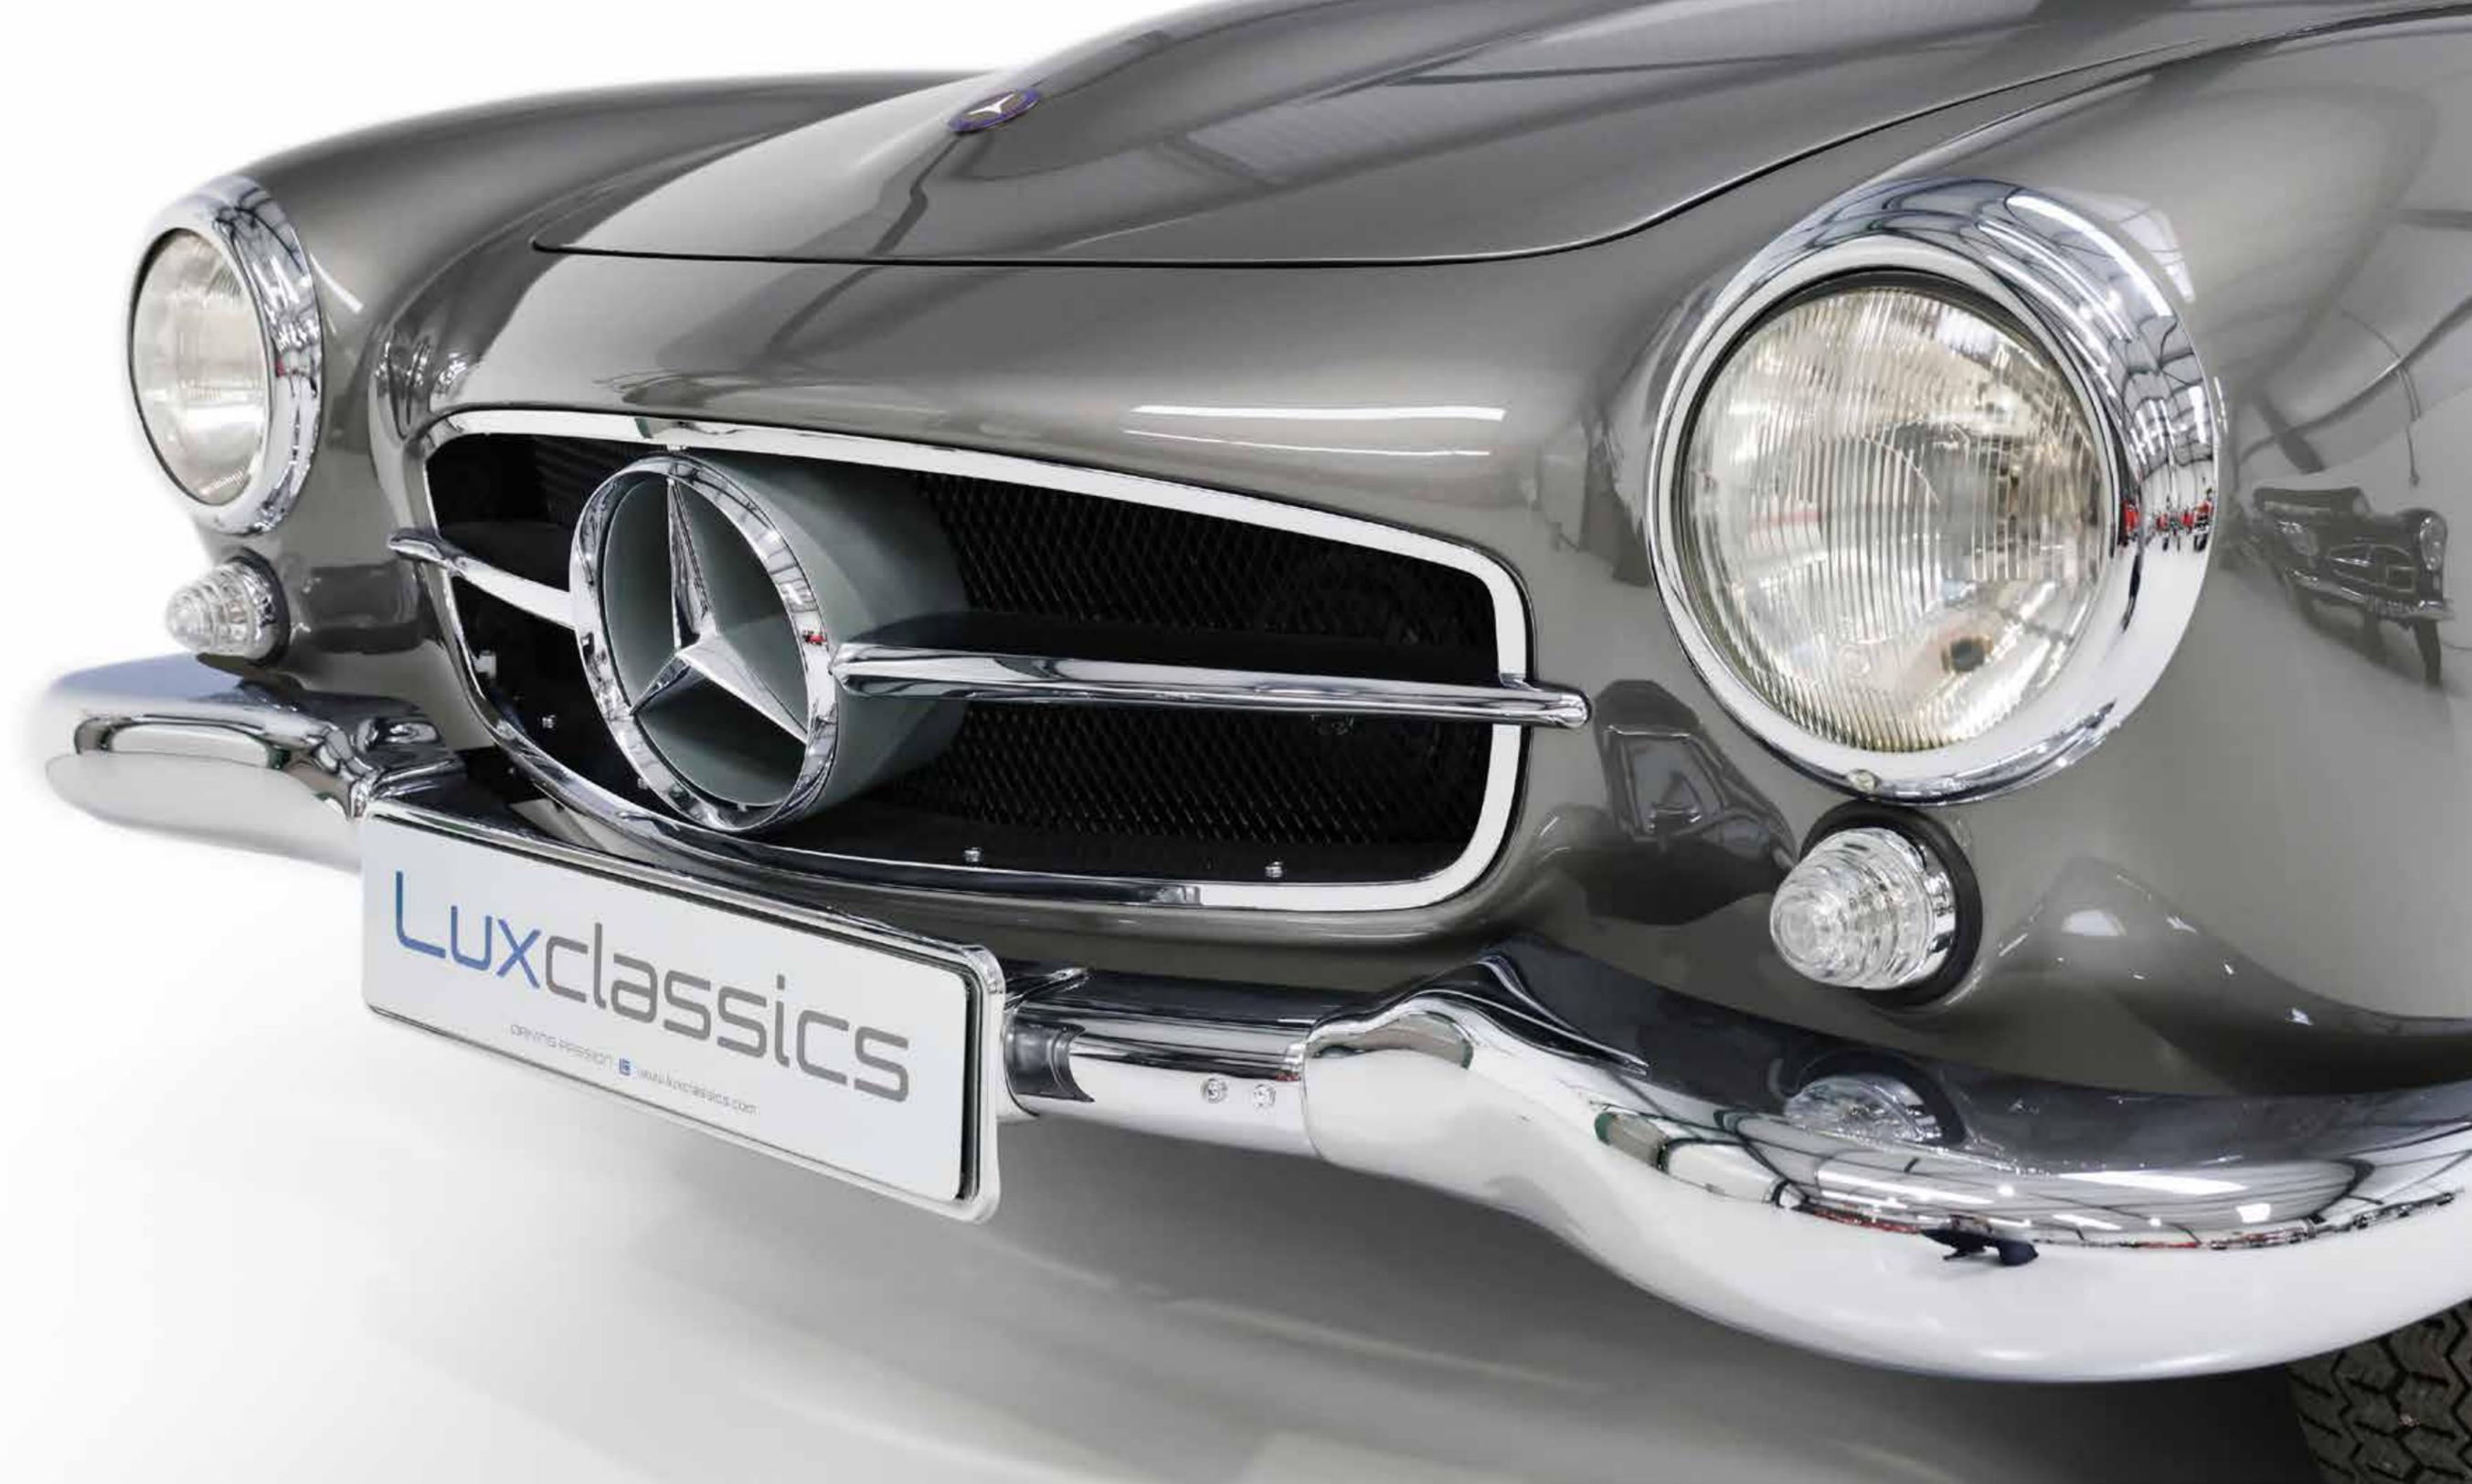
LEATHER TRIMMING AND INSTRUMENT PANEL ASSEMBLY

Trimming the car requires not only patience but also passion for the detail and workmanship that makes the Mercedes-Benz 190SL what it is. Re-covering the dashboard with leather is the most challenging single task in restoring a 190SL interior. The dash was carefully covered with German fine grain supple light grey leather. As the leather was skived (thinned to half its thickness) it was possible to cover the contours of the dash. The dash is first fitted, stretched and shrunk around the instrument hump, then stretched to fit the rest of the dashboard.

Welting strips were made to fit around the instrument hump and door 'A' and 'B' posts. The rear soft top compartment was additionally covered with the same leather. The seats and door panels were made up, using traditional materials to fill the seats. Next the instrument panel was covered using felt under the leather at knee curves and instruments and switches fitted to the panel. The glove compartment was covered in leather and the glove box lid was trimmed. The windscreen pillars were fitted. The chrome vent strips and vent levers were fitted before the front windscreen and chrome surround was fitted and the dash trimmed to fit. The instrument panel was fitted as were the remaining switches and gauges. The interior wiring was completed together with final fit of dash chrome and glove box lid. The door panels will be fitted once the soft top has been trimmed and final window adjustments.
